RENAULT Scenic: 1HAX559

Limited Technical Inspection

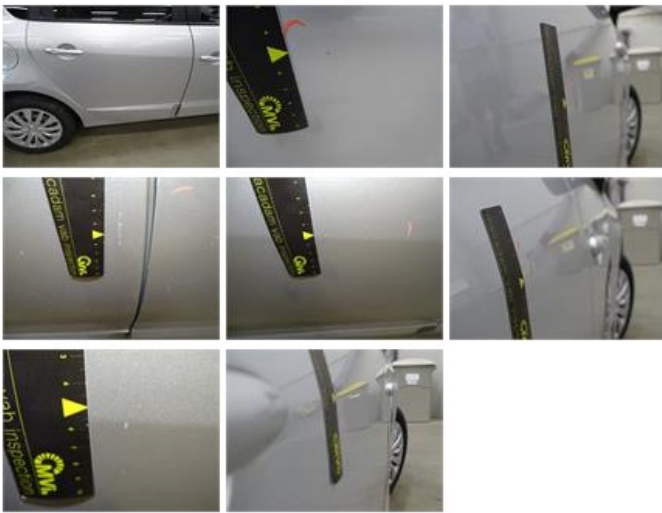
Total cost ex VAT	2012,32
Door R R, Dent(s) and scratch(es), LI - Repair and paint (complete)	318,35

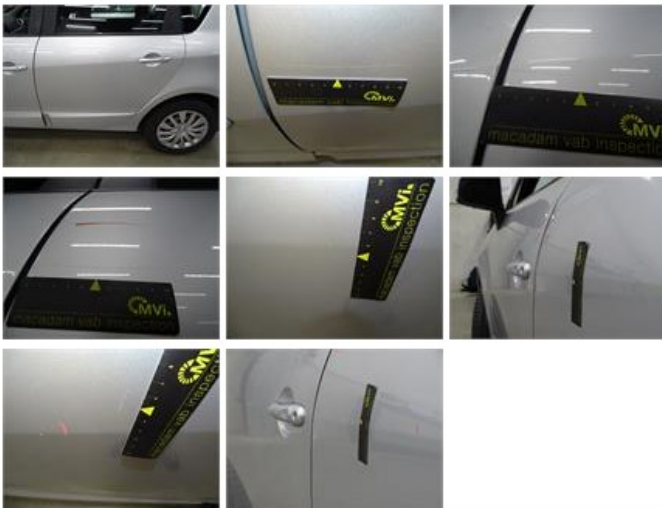
Door R L, Dent(s) and scratch(es), LI - Repair and paint (complete) 318,35

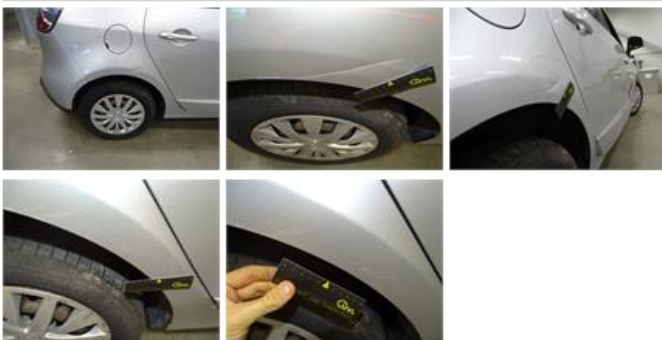
Wing R R, Dent(s) and scratch(es), LI - Repair and paint (complete) 308,20

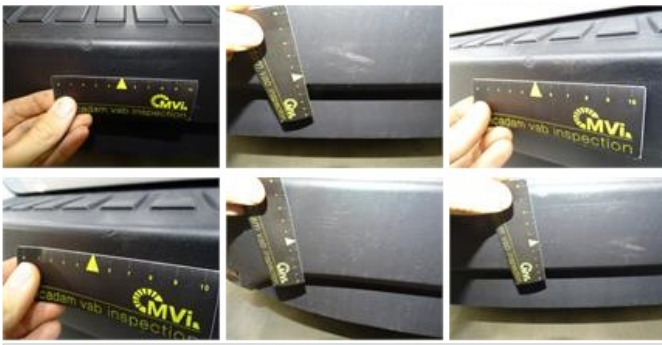
Bumper R, Dent(s) and scratch(es), Smart repair 110,64

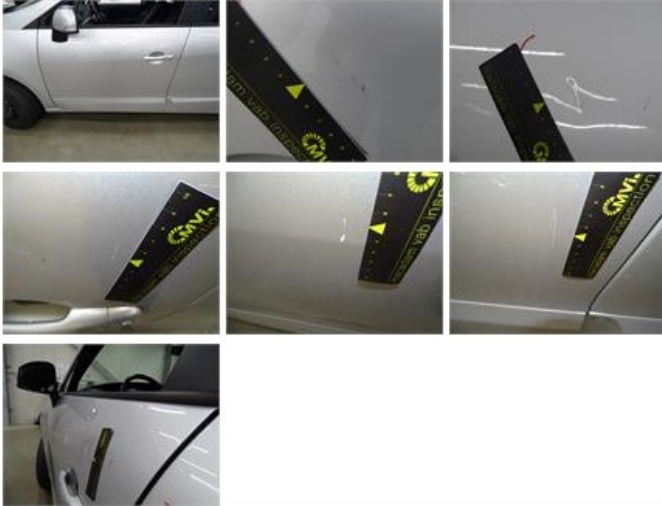
Door F L, Dent(s) and scratch(es), LI - Repair and paint (complete) 318,35

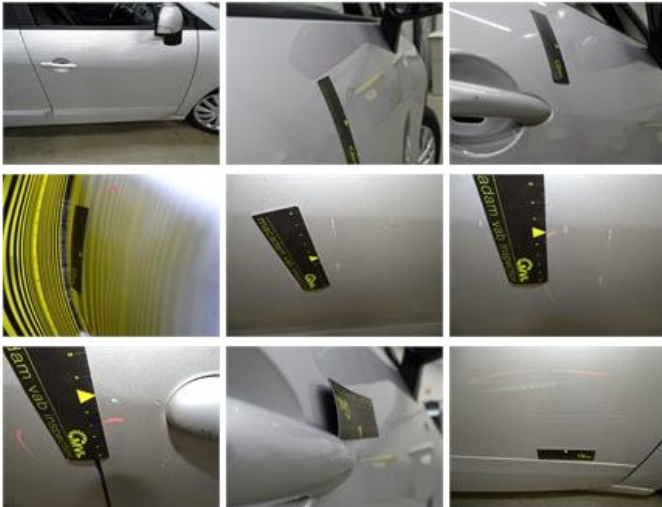
Door F R, Dent(s) and scratch(es), LI - Repair and paint (complete) 318,35

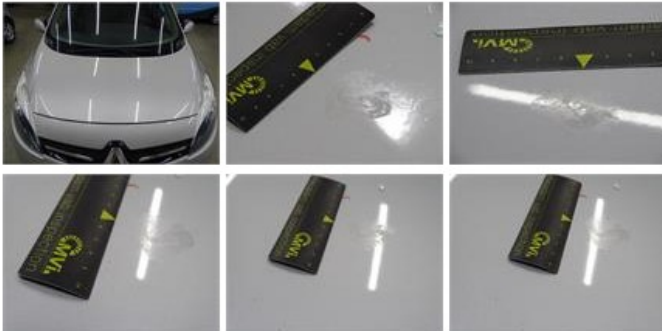
Bonnet, Chemical polution, LI - Repair and paint (complete) 290,08
