**VOLVO V40: 1LCJ150**

**Limited Technical Inspection**

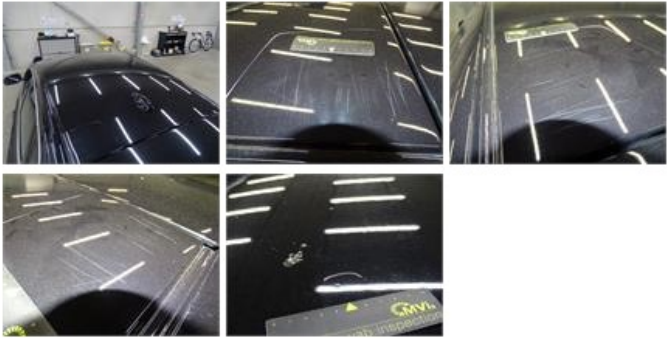
Alloy rim R L, Scratch(es), Acceptable	0,00
<i>No pictures to display</i>	
Rear Panel Internal Lining, Scratch(es), Acceptable	0,00
<i>No pictures to display</i>	
Roof, Dent(s) and scratch(es), Acceptable	0,00

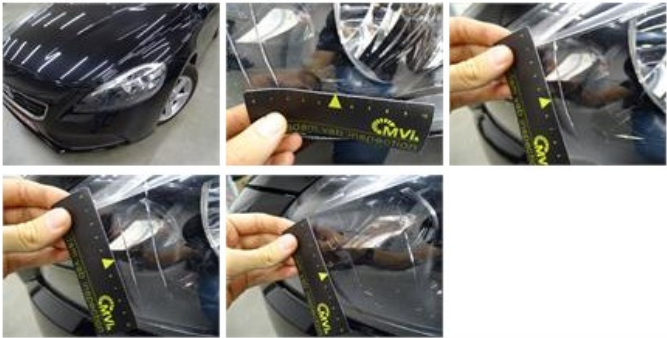
Wing F R, Scratch(es), Acceptable	0,00
<i>No pictures to display</i>	
Headlight L, Crack, Acceptable	0,00
