VOLVO V60: 1KNU009

Limited Technical Inspection

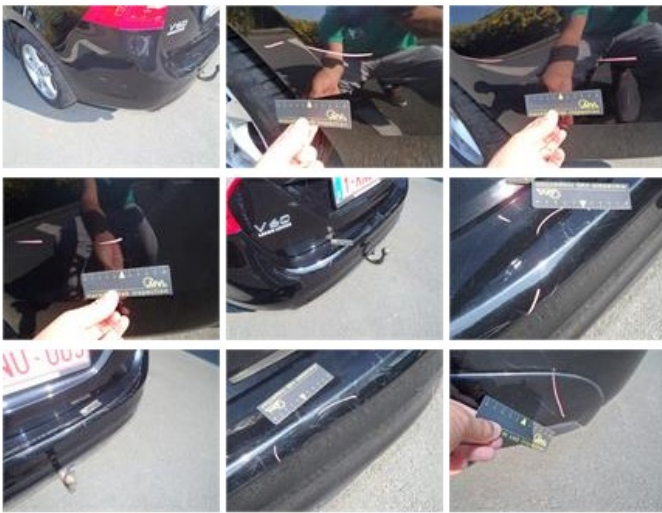
Bumper R, Scratch(es), LI - Repair and paint (complete) 211,80

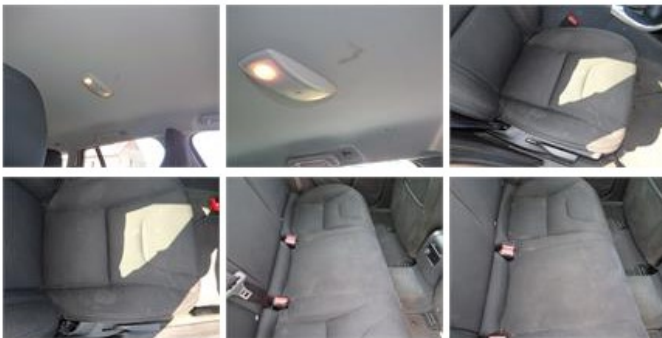
Interior, Dirty, Cleaning 50,00

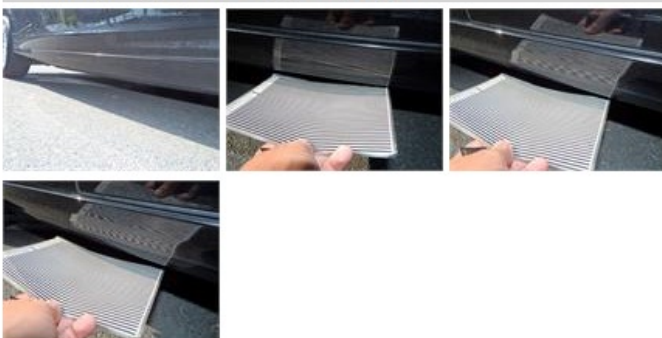
Sill trim R, Dent(s) and scratch(es), It - Spot repair 163,56

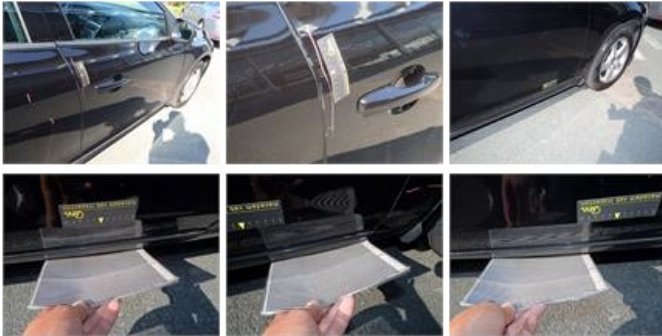
Door F R, Dent(s) and scratch(es), LI - Repair and paint (complete) 366,35
