SKODA Octavia: 1JAB200

Limited Technical Inspection

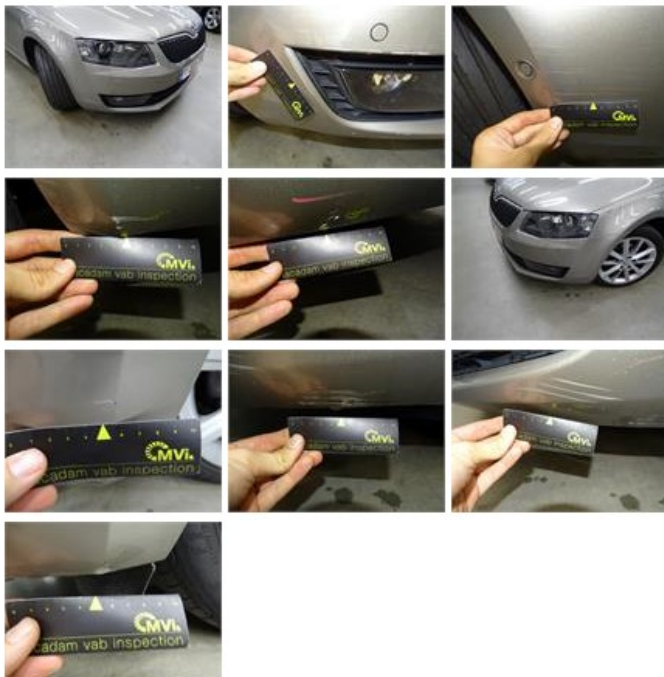
Bumper F, Scratch(es), LI - Repair and paint (complete)

211,80

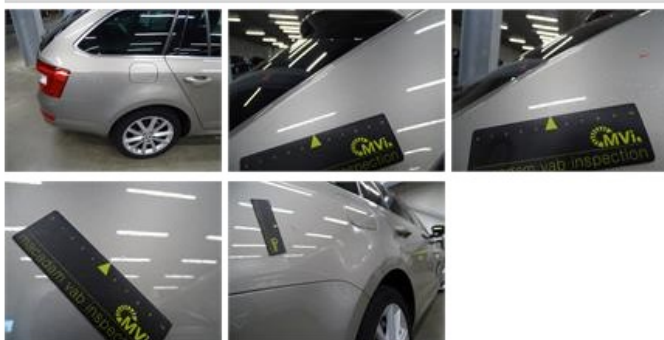
Wing R R, Bad repair, Acceptable

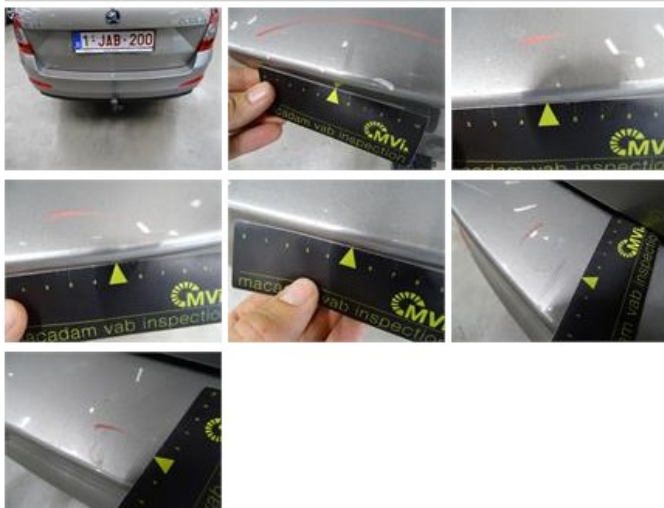
Bumper R, Scratch(es), LI - Repair and paint (complete)

211,80

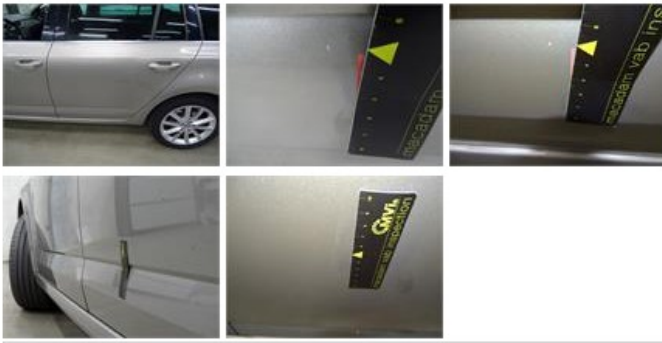
Door R L, Dent(s) and scratch(es), LI - Repair and paint (complete)

318,35

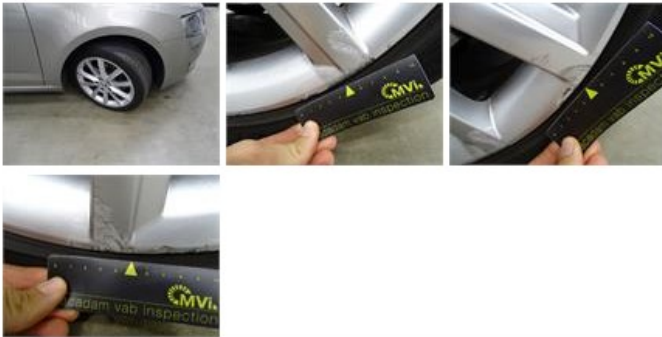
Alloy rim F R, Scratch(es), LI - Repair and paint (complete) 95,00
