VOLVO V40: 1RSY471

Limited Technical Inspection

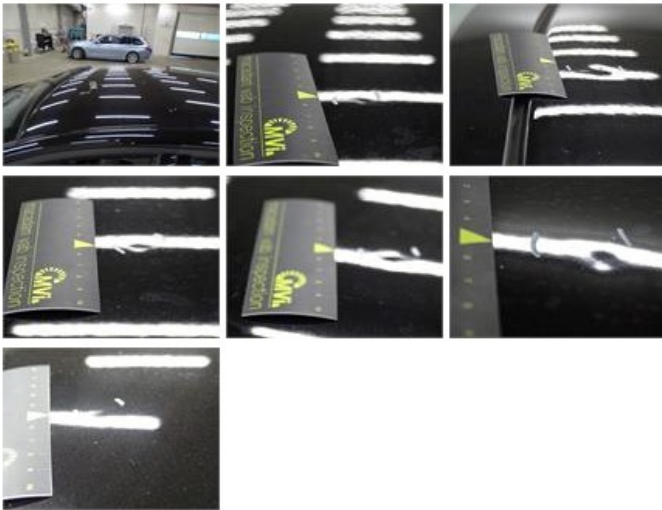
Roof, Hail damage, PDR - Hail 0,00

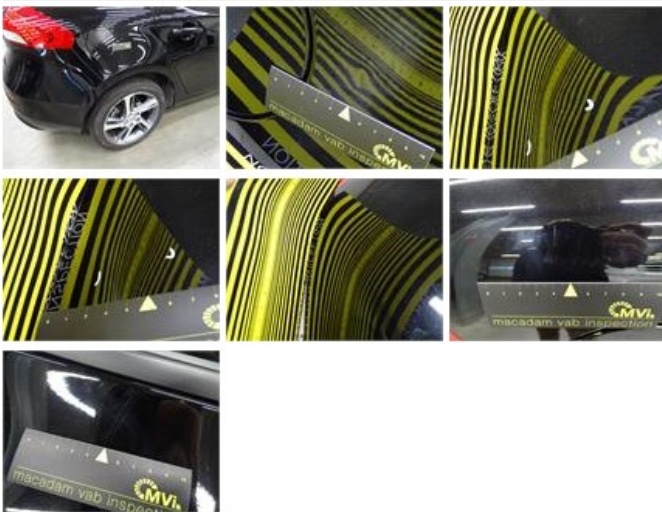
Wing R R, Dent(s) and scratch(es), LI - Repair and paint (complete) 308,20

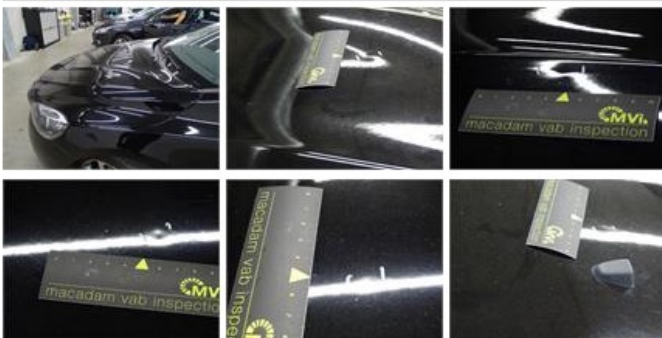
Bonnet, Hail damage, PDR - Hail 0,00

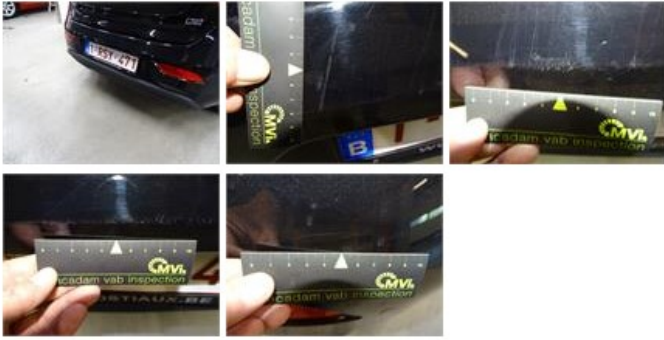
Bumper R, Scratch(es), LI - Repair and paint (complete) 211,80
