MERCEDES E BREAK: 1LUJ815

Limited Technical Inspection

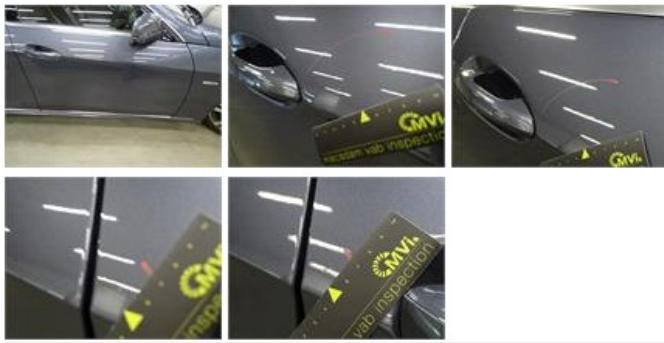
Total cost ex VAT	1535,55
Door F R, Bad repair, Acceptable	0,00

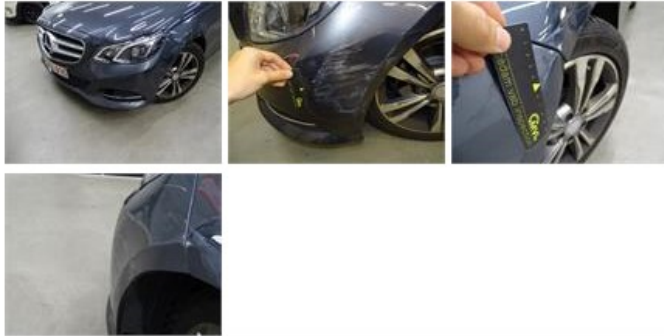
Bumper F, Dent(s) and scratch(es), LI - Repair and paint (complete) 254,16

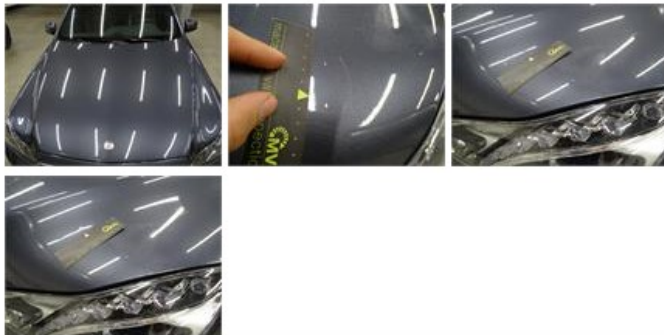
Bonnet, Stone chip(s), Acceptable 0,00

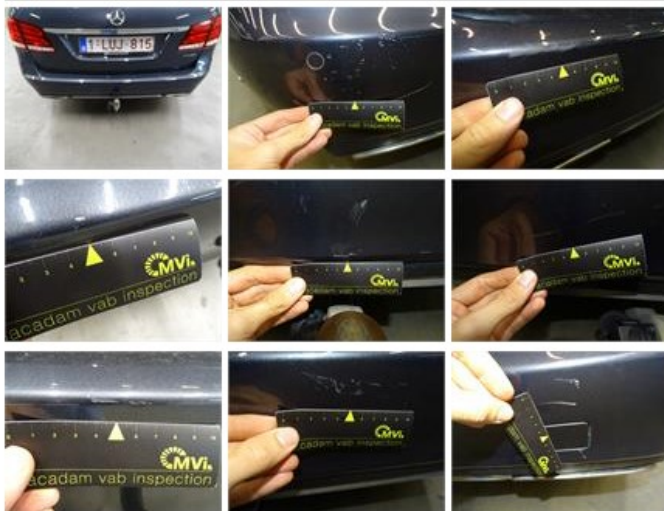
Bumper R, Scratch(es), LI - Repair and paint (complete) 254,16

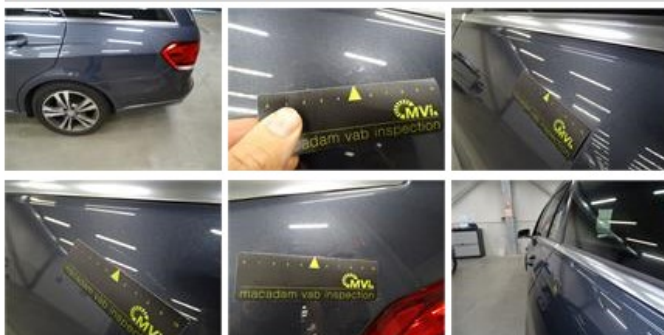
Wing R L, Bad repair, Acceptable 0,00

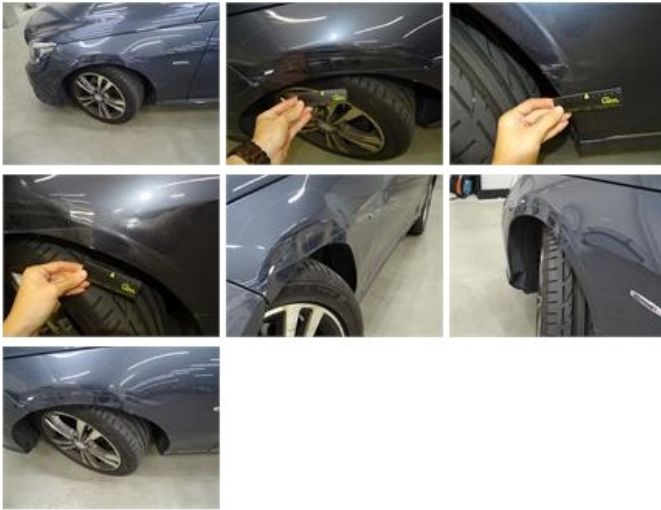
Wing F L, Dent(s) and scratch(es), LI - Repair and paint (complete)

360,21

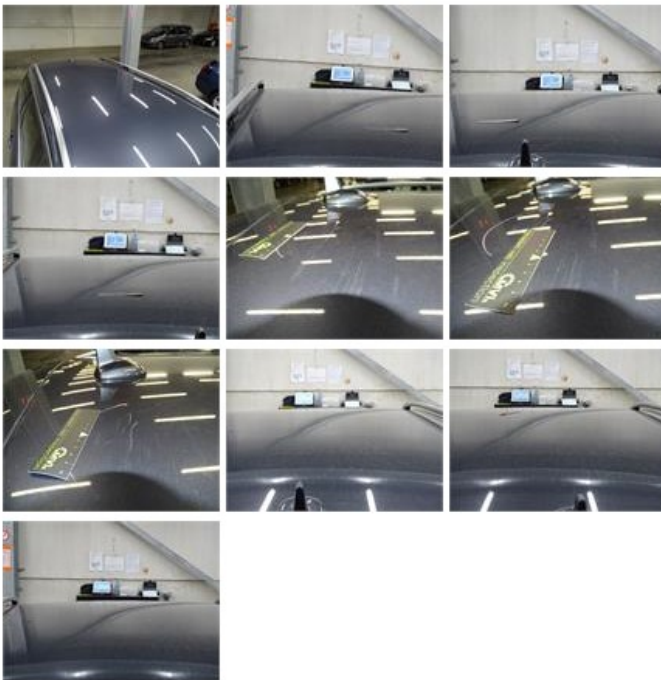
Roof, Dent(s) and scratch(es), LI - Repair and paint (complete)

0,00

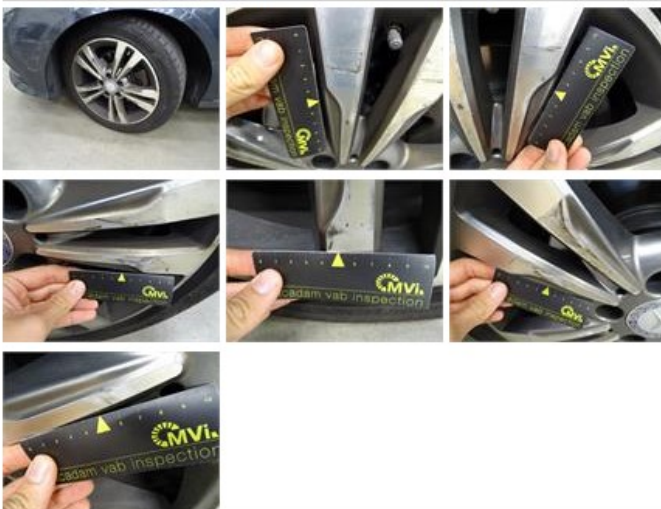
Alloy rim F L polished, Scratch(es), LI - Repair and paint (complete)

95,00
