**BMW 4 GRAN COUPE: 1LKJ927**

Vinnumber:	<b>WBA4E71000GS99732</b>	Versionname:	<b>2.0 418D (100KW) GRAN COUPE</b>
First Registrationdate:	<b>13/10/2015</b>	Fiscalpower:	
Expertise Mileage:	<b>83499</b>	Power Kw:	<b>100</b>
Bodytype:		Body color:	<b>Dark Brown</b>
Gearbox:	<b>MAN 6 VIT</b>	Paint type:	<b>Metalic</b>
Transmission:	<b>Back</b>	Rims summer:	<b>Aluminium</b>
Fueltype:	<b>Diesel</b>	Oil level:	<b>OK</b>
Battery functioning:	<b>Yes</b>	Parking lot:	<b>2306</b>
Number of doors:	<b>5</b>		
Number of seats:	<b>5</b>		
Number head rests:	<b>4</b>		
Rims summer:	<b>Aluminium</b>		
Category:	<b>Passenger Car</b>		
Oil level:	<b>OK</b>		
Registration Certificate Car (BE):	<b>Yes</b>

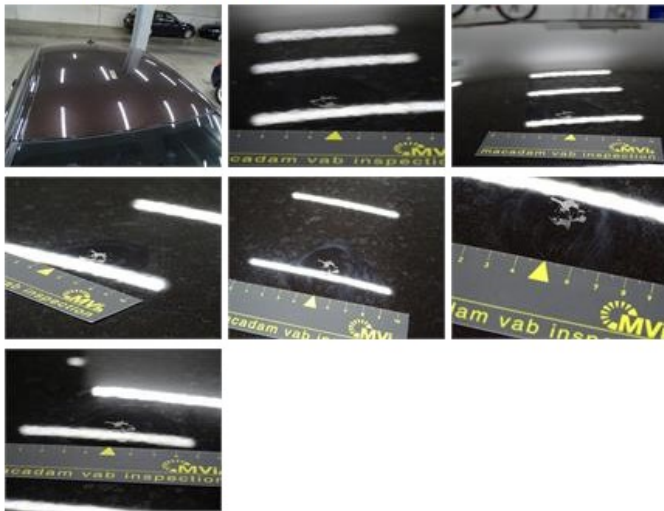
Roof, Chemical pollution, LI - Repair and paint (complete) 577,80

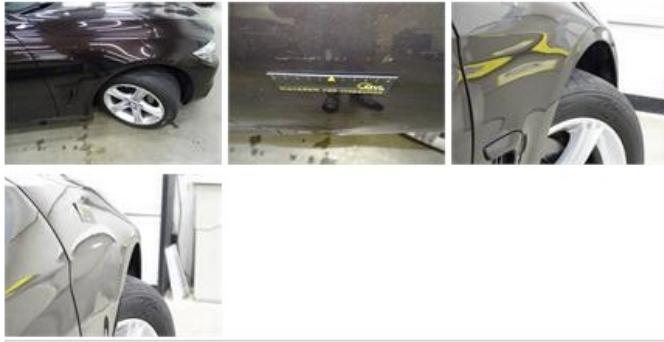
Wing F R, Dent(s) and scratch(es), LI - Repair and paint (complete) 264,21

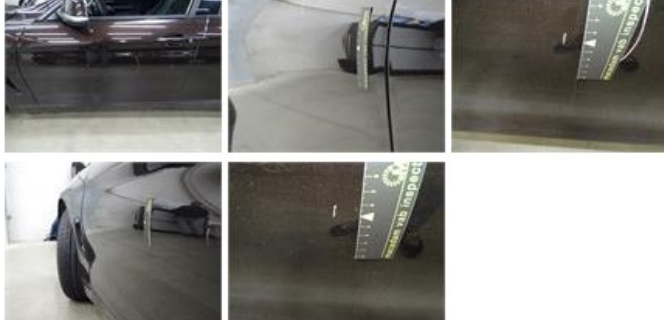
Door F L, Dent(s) and scratch(es), LI - Repair and paint (complete) 382,02
