BMW 3: 1HLD170

Limited Technical Inspection

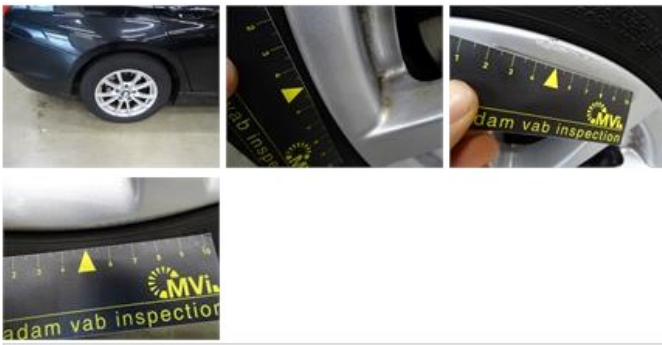
Alloy rim R R, Scratch(es), LI - Repair and paint (complete) 95,00

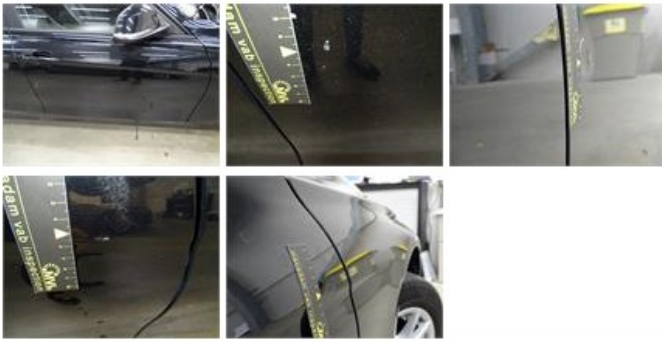
Door F R, Dent(s) and scratch(es), LI - Repair and paint (complete)

318,35

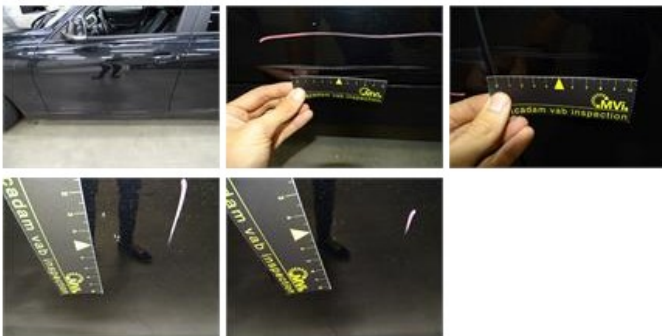
Door F L, Scratch(es), LI - Repair and paint (complete)

318,35

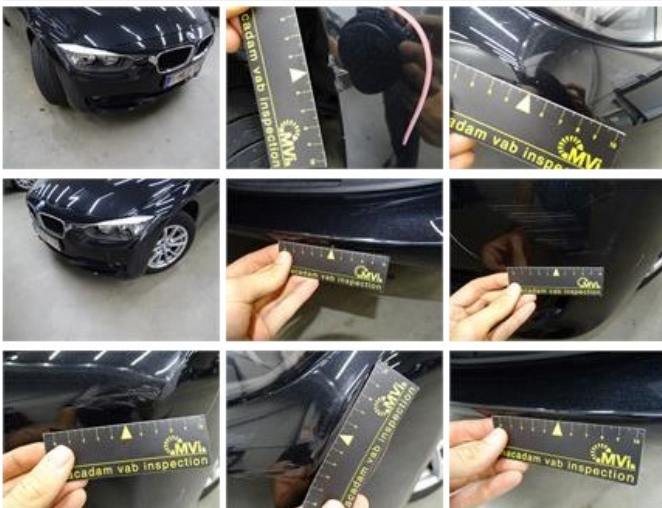
Bumper F, Scratch(es), LI - Repair and paint (complete)

211,80

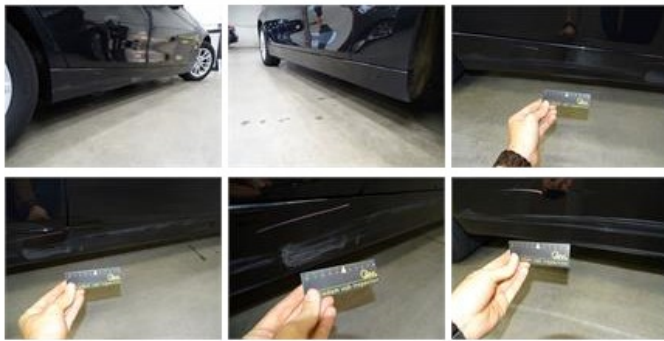
Sill outer R, Scratch(es), LI - Repair and paint (complete)

310,50

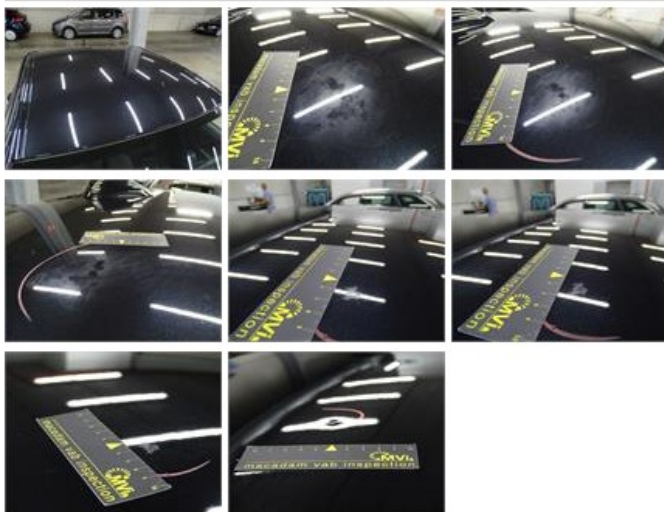
Roof, Chemical polution, LI - Repair and paint (complete)

481,50

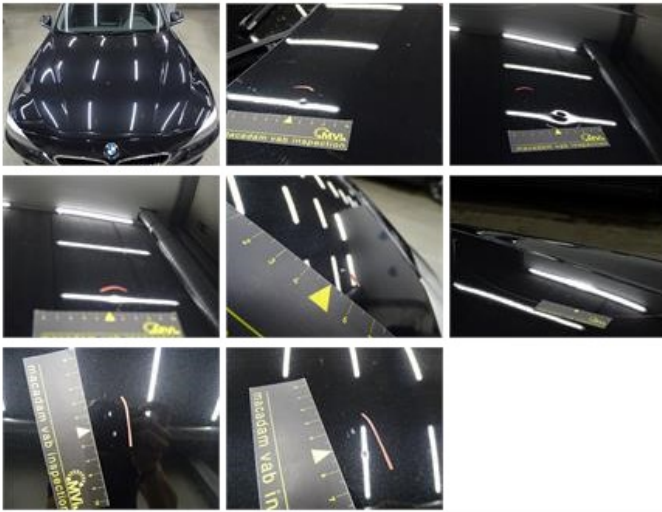
Bonnet, Dent(s), PDR - Paintless dent repair

162,00

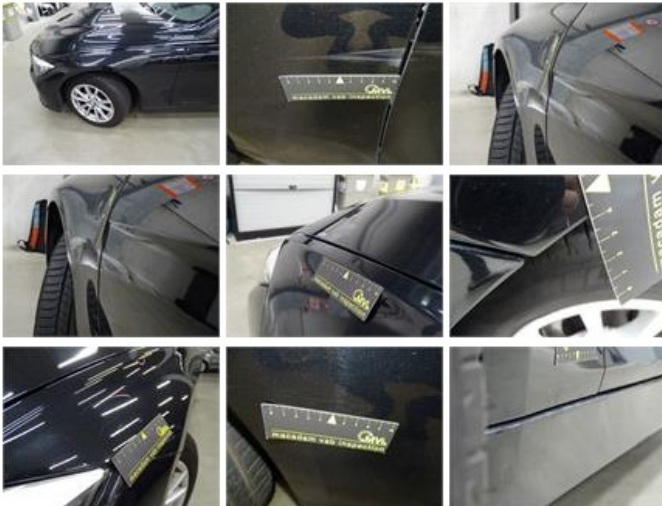
Wing F L, Dent(s) and scratch(es), LI - Repair and paint (complete)

220,18
