BMW 3: 1GRY590

Limited Technical Inspection

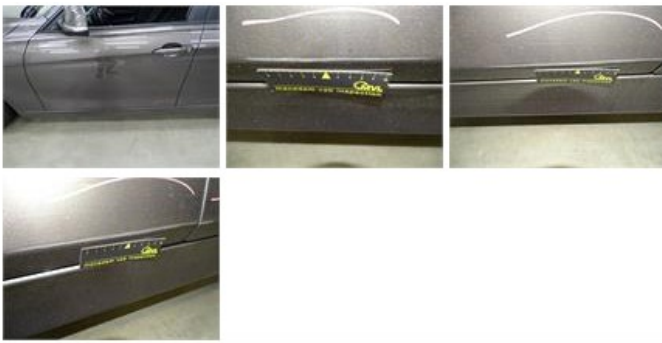
Door F L, Scratch(es), LI - Repair and paint (complete)	318,35
---	---------------

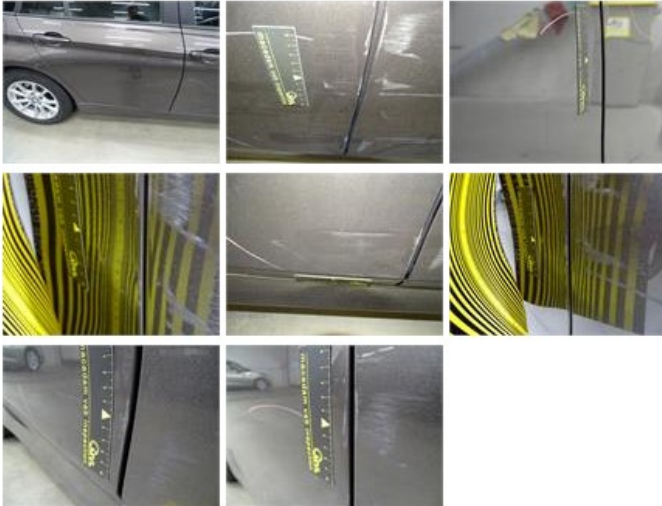
Door R R, Dent(s) and scratch(es), LI - Repair and paint (complete) 0,00

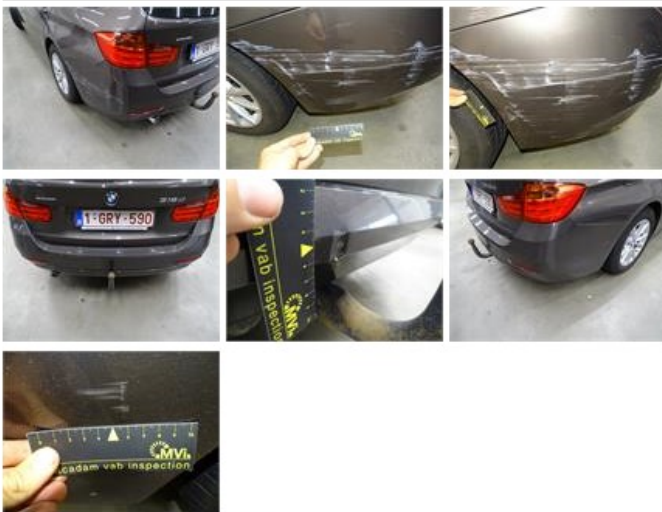
Bumper R, Dent(s) and scratch(es), LI - Repair and paint (complete) 211,80

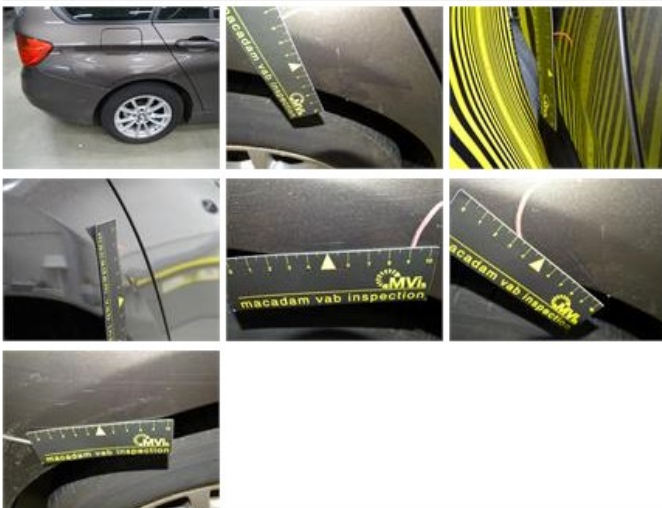
Wing R R, Dent(s) and scratch(es), LI - Repair and paint (complete) 0,00
