MERCEDES A: 1PSS763

| Vinnumber: | WDD1760121J524416 | Versionname: | A 180 d BlueEFFICIENCY Edition |

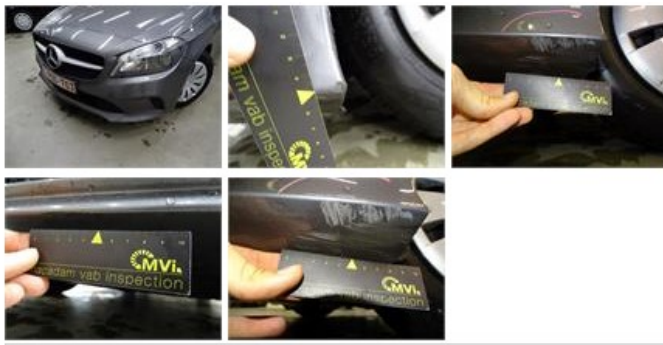
| Bumper F, Scratch(es), LI - Repair and paint (complete) | 211,80 |

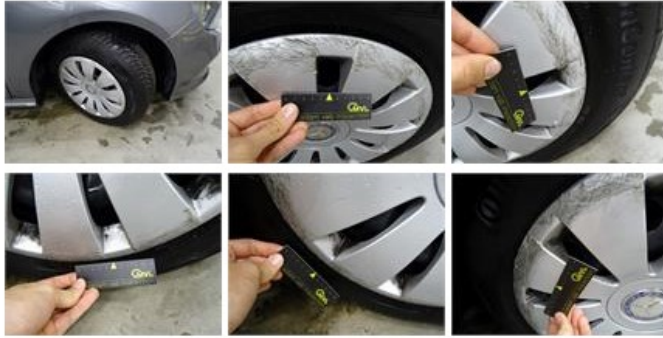
Wheel cover F R, Scratch(es), E - Replace

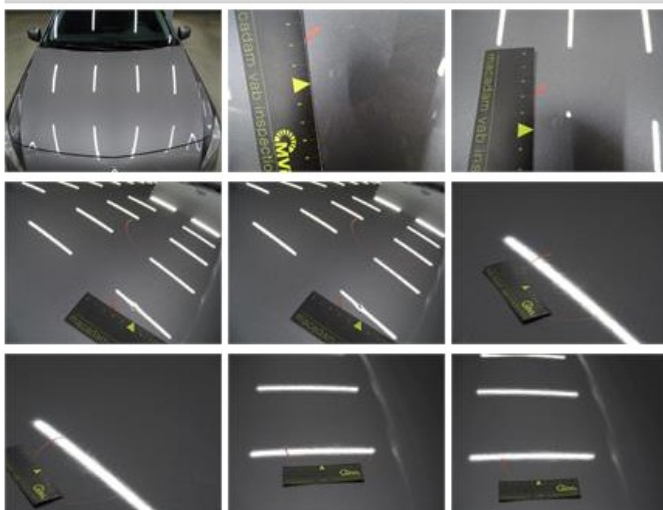
Bonnet, Dent(s) and scratch(es), LI - Repair and paint (complete)

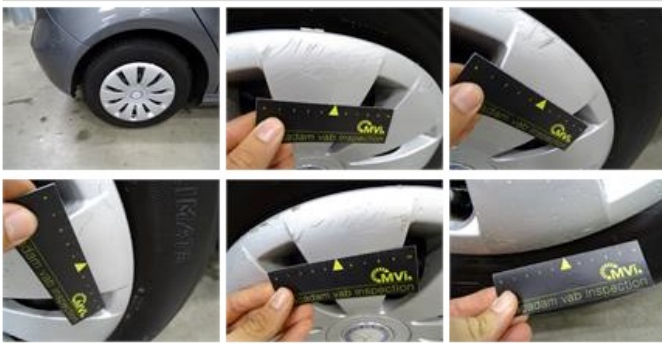
Wheel cover R R, Scratch(es), E - Replace

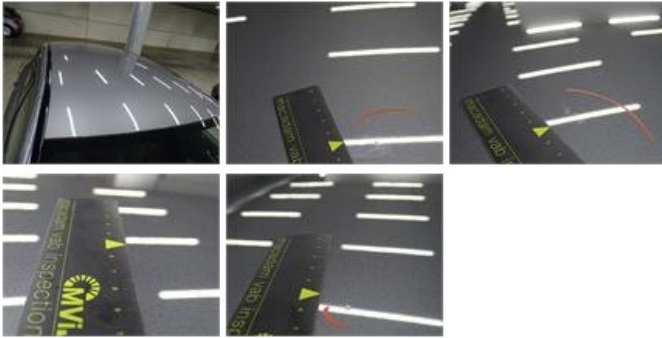
Roof, Bad repair, Acceptable 0,00

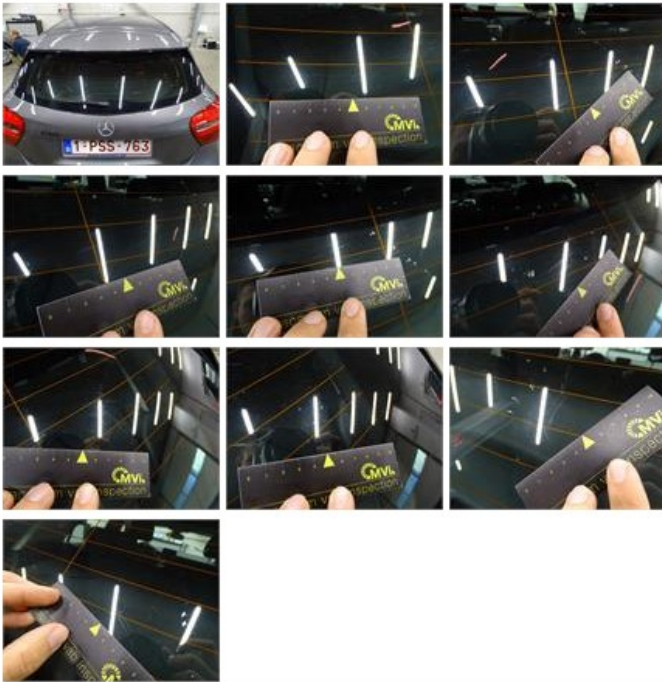
Rear window, Scratch(es), E - Replace 370,00
