FORD FOCUS CLIPPER: 1NXR729

Limited Technical Inspection

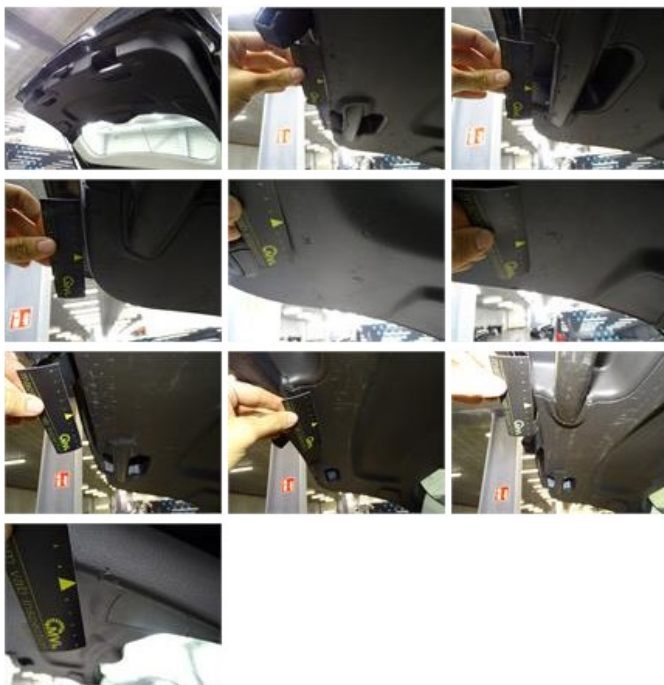
Total cost ex VAT	886,54
Trunk lid covering R, Scratch(es), Smart repair	110,64

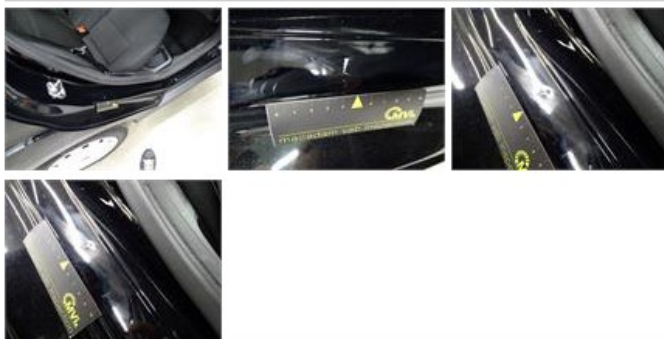
Rocker panel inner R R, Dent(s), LI - Repair and paint (complete)

115,56

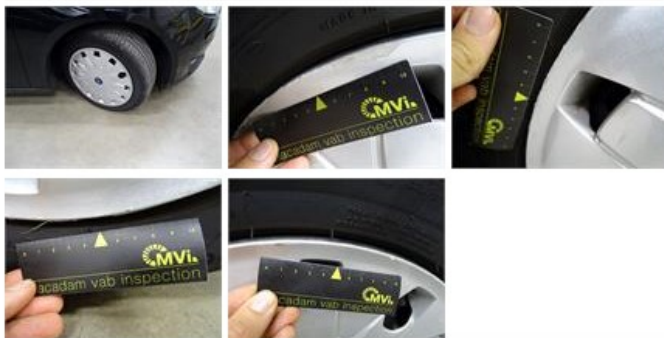
Wheel cover F R, Scratch(es), E - Replace

30,00

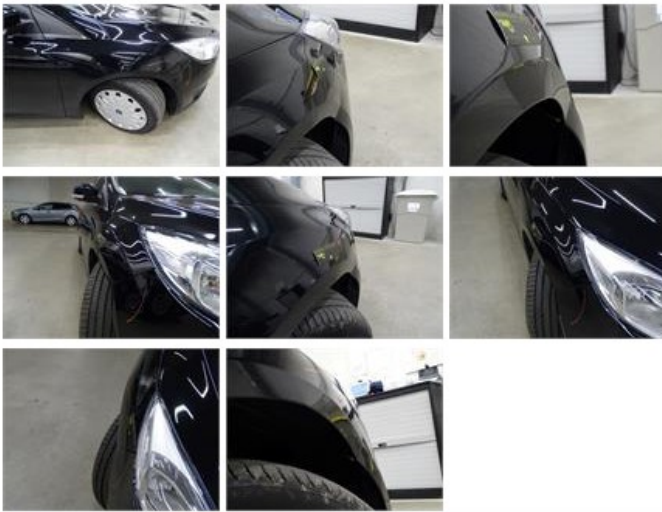
Wing F R, Deformed / Strained, LI - Repair and paint (complete) 220,18

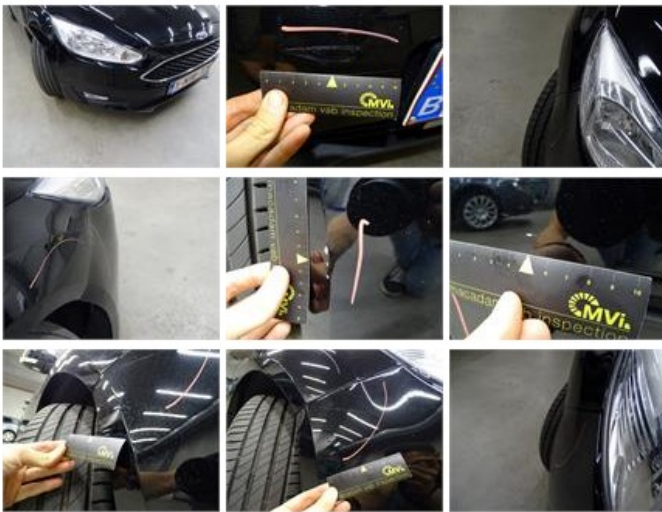
Bumper F, Dent(s) and scratch(es), LI - Repair and paint (complete) 211,80

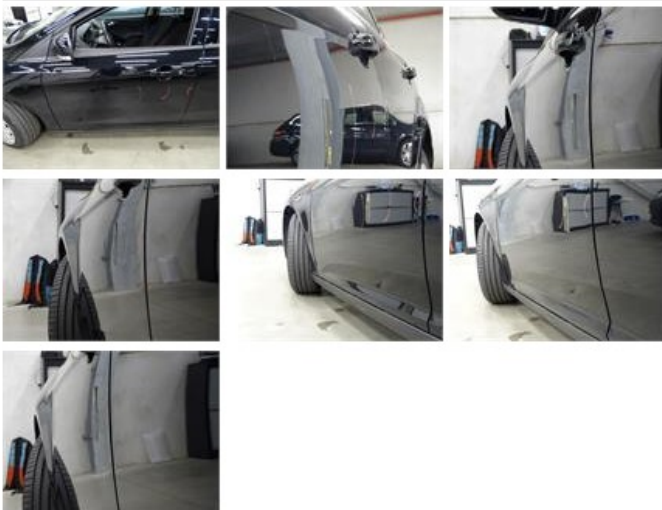
Door F L, Dent(s), PDR - Paintless dent repair 82,80
