**MERCEDES A: 1NTG329**

**Limited Technical Inspection**

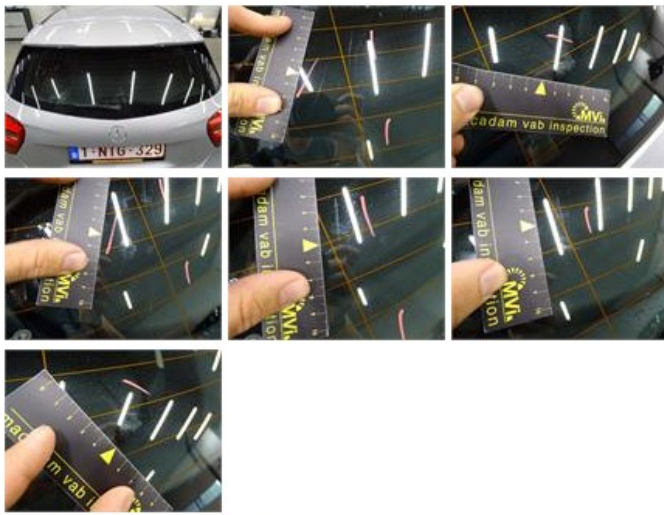
<b>Total cost ex VAT</b>	<b>2246,85</b>
<b>Rear window, Scratch(es), E - Replace</b>	<b>370,00</b>

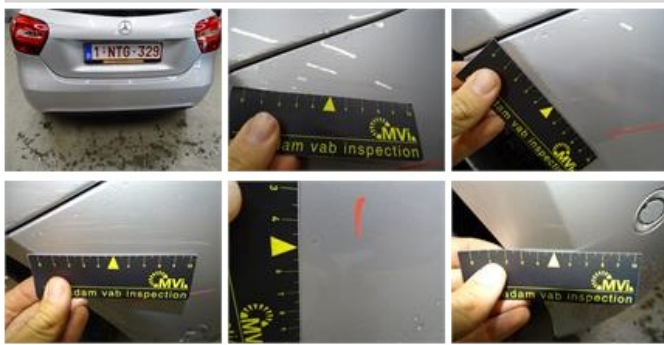
Bumper R, Scratch(es), LI - Repair and paint (complete) 211,80

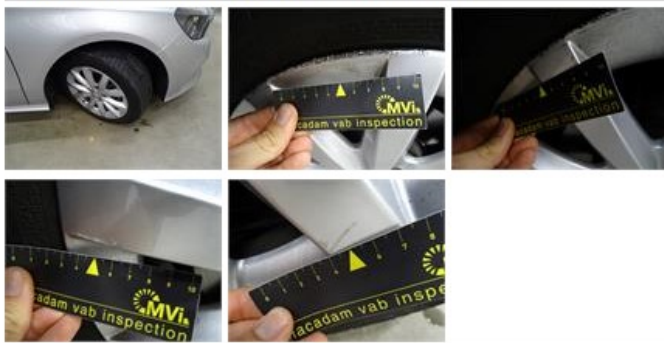
Alloy rim F R, Scratch(es), LI - Repair and paint (complete) 95,00

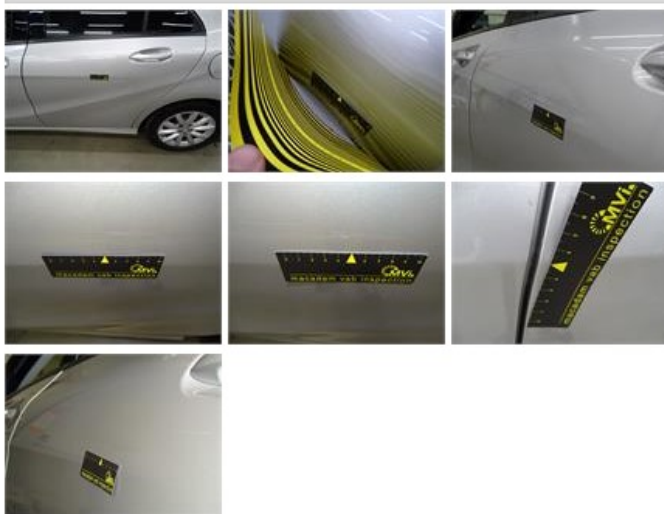
Door R L, Dent(s) and scratch(es), LI - Repair and paint (complete) 318,35

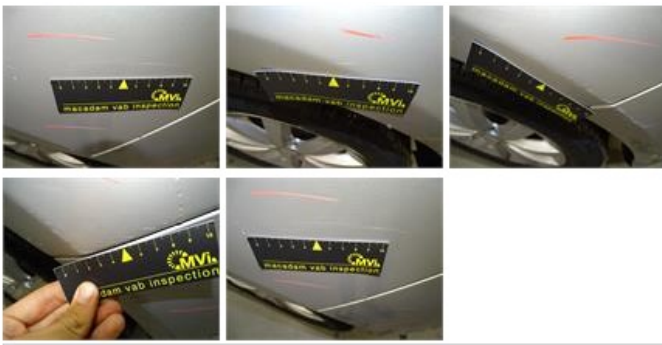
Wing R L, Scratch(es), LI - Repair and paint (complete) 308,20

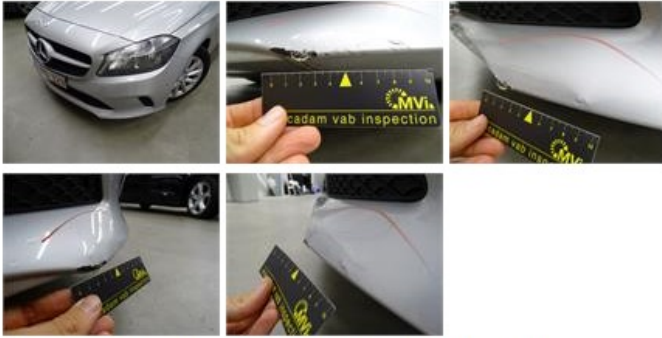
Bumper F, Dent(s) and scratch(es), LI - Repair and paint (complete)

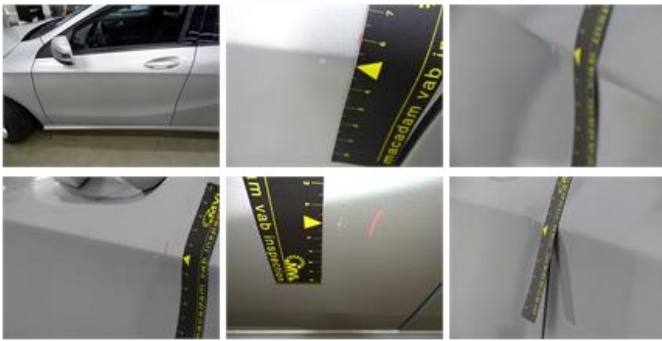
Door F L, Dent(s) and scratch(es), LI - Repair and paint (complete)

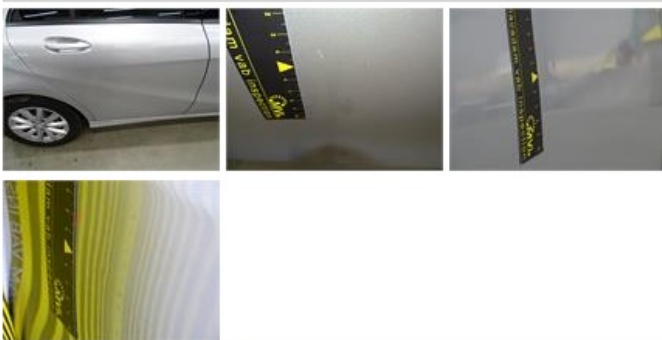
Door R R, Dent(s) and scratch(es), LI - Repair and paint (complete)

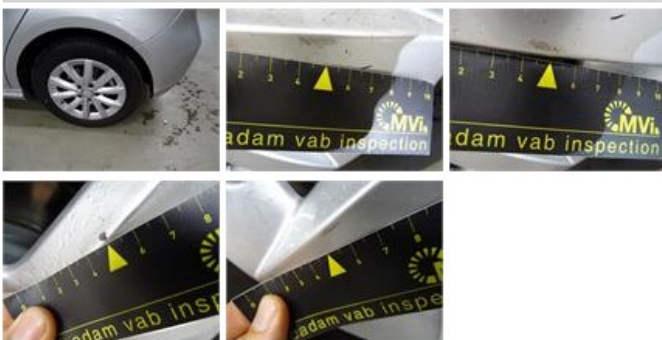
Alloy rim R L, Scratch(es), LI - Repair and paint (complete)
