**MERCEDES A: 1HJS304**

**Limited Technical Inspection**

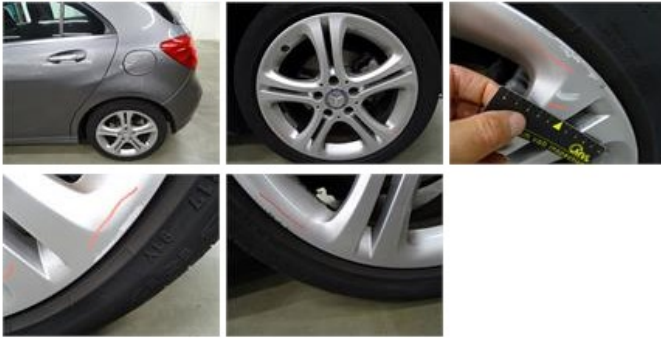
Alloy rim R L, Scratch(es), LI - Repair and paint (complete) 95,00

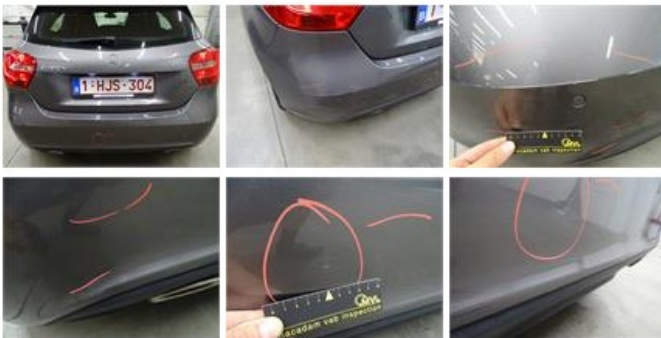
Bumper R, Dent(s) and scratch(es), LI - Repair and paint (complete) 211,80

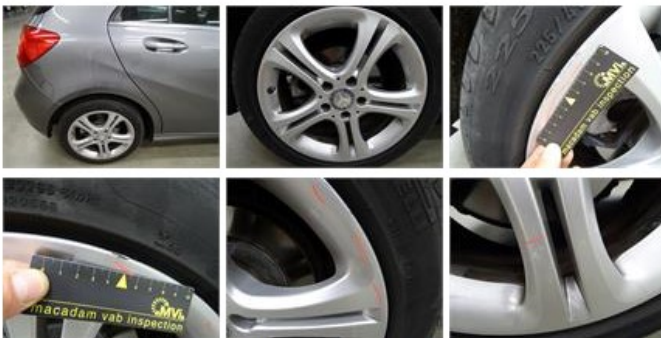
Alloy rim R R, Scratch(es), LI - Repair and paint (complete) 95,00

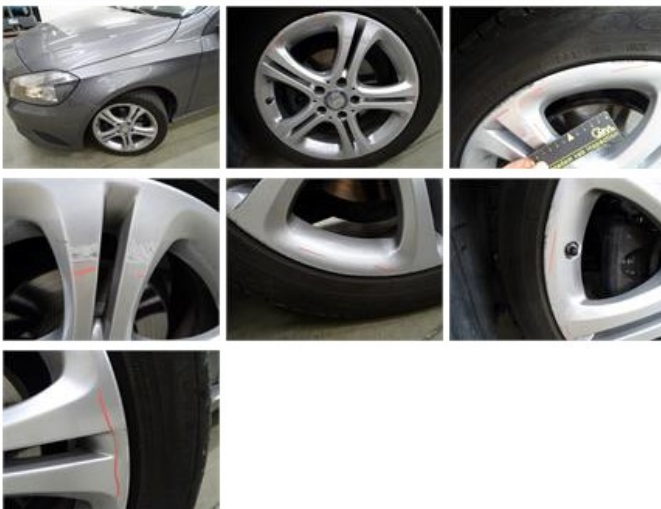
Alloy rim F L, Scratch(es), LI - Repair and paint (complete) 95,00

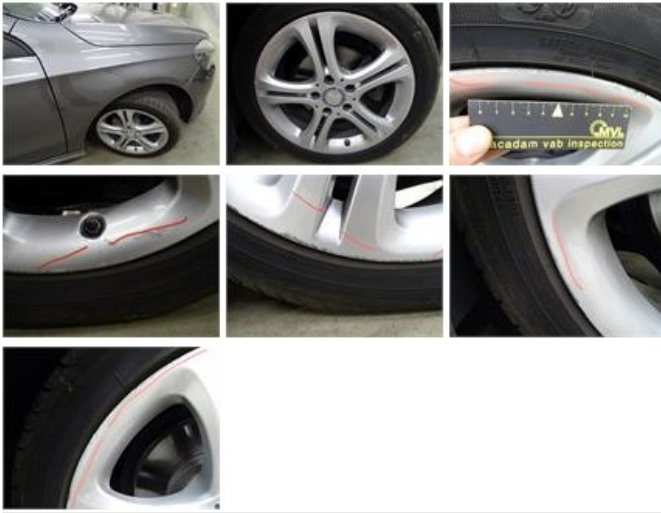
Alloy rim F R, Scratch(es), LI - Repair and paint (complete) 95,00
