MERCEDES A: 1HLC593

| Vinnumber: | WDD1760081J304544 | Versionname: | A 200 CDI 136PK |

Limited Technical Inspection

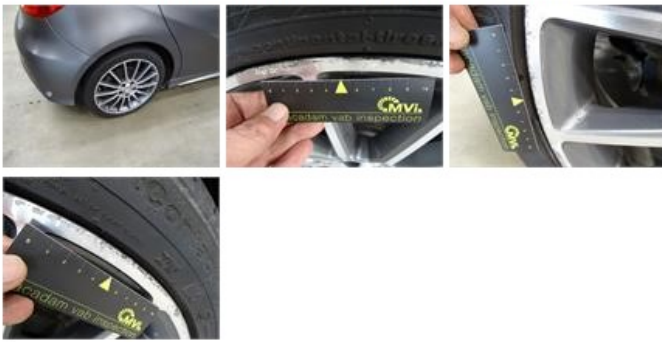
Alloy rim R R polished, Scratch(es), LI - Repair and paint (complete) 95,00

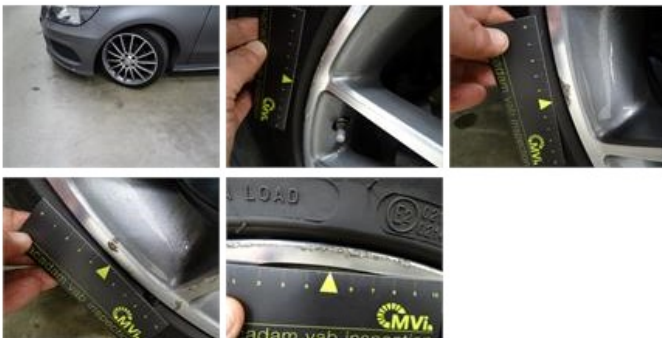
Alloy rim F L polished, Scratch(es), LI - Repair and paint (complete) 95,00

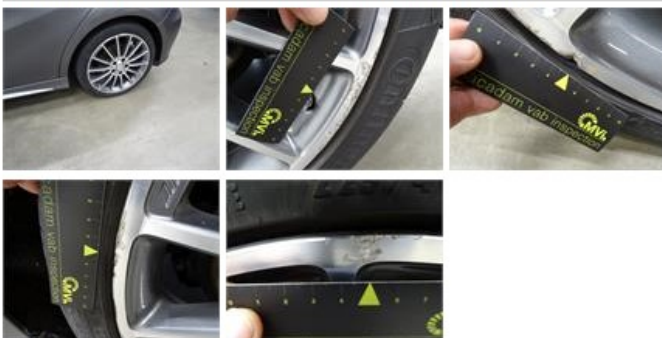
Alloy rim R L polished, Scratch(es), LI - Repair and paint (complete) 95,00

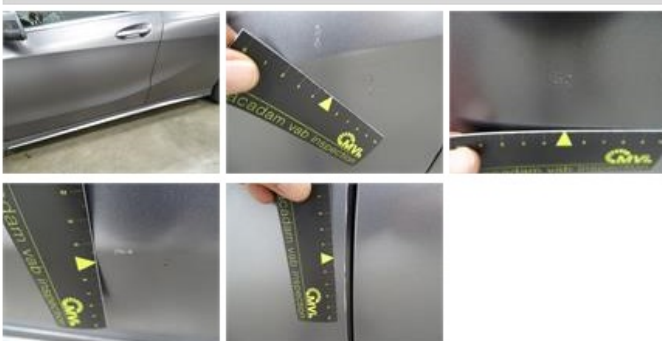
Door F L, Scratch(es), LI - Repair and paint (complete) 318,35

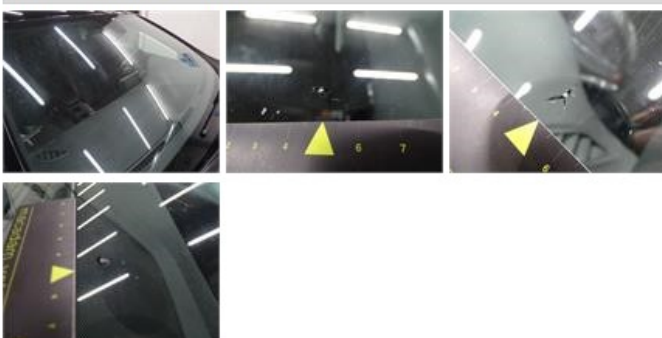
Windscreen, Crack, E - Replace 0,00
