BMW X3: 1JGR873

Vinnumber:	WBAWZ510X00L07667	Versionname:	X3 2.0dA xDrive20 163PK Aut.
First Registrationdate:	12/12/2014	Fiscalpower:	
Expertise Mileage:	154516	Power Kw:	120
Bodytype:	SUV	Body color:	Light Grey
Gearbox:	Automatic	Paint type:	Metalic
Transmission:	4 Weel	Rims summer:	Aluminium
Fueltype:	Diesel	Oil level:	OK
Battery functioning:	Yes	Parking lot:	2121
Number of doors:	5		
Number of seats:	5		
Number head rests:	5		
Rims summer:	Aluminium		
Category:	Passenger Car		
Oil level:	OK		
Registration Certificate Car (BE):	Yes

Limited Technical Inspection

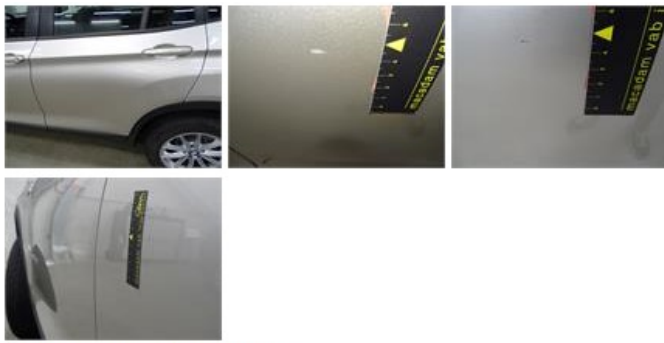
Total cost ex VAT	1885,62
Door R L, Dent(s) and scratch(es), LI - Repair and paint (complete)	382,02

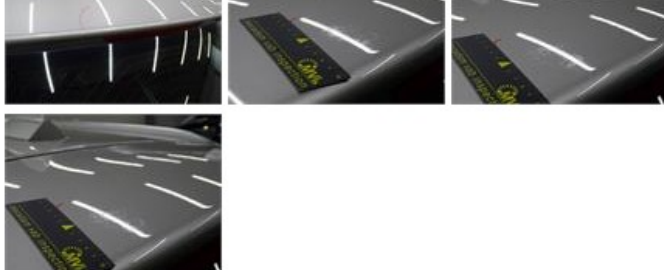
Rear spoiler, Chemical polution, LI - Repair and paint (complete) 115,56

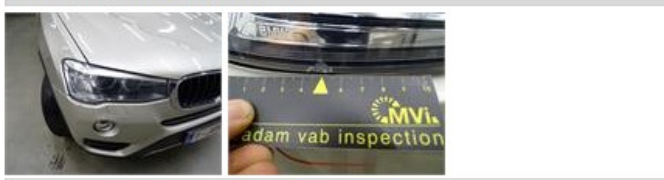
Headlight R, Scratch(es), Acceptable 0,00

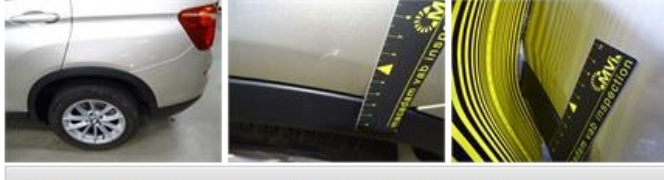
Wing R L, Dent(s) and scratch(es), LI - Repair and paint (complete) 369,84

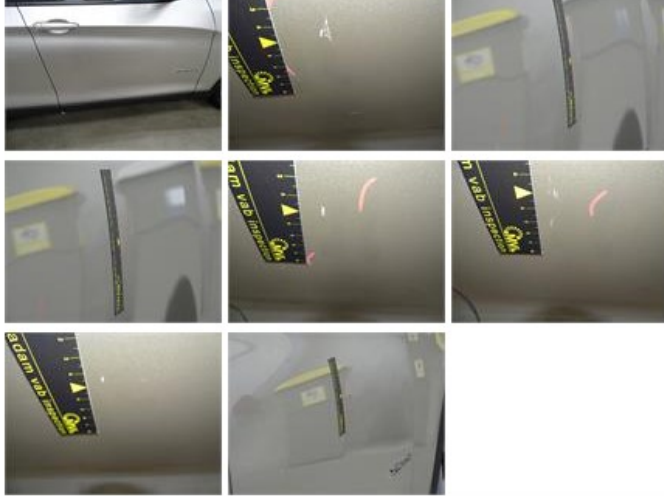
Door F R, Dent(s) and scratch(es), LI - Repair and paint (complete) 382,02
