BMW 5 TOURING: 1KEY215

Vinnumber:	WBA5L31080G080245	Versionname:	2.0 520D (120KW) TOURING
First Registrationdate:	17/04/2015	Fiscalpower:	
Expertise Mileage:	79816	Power Kw:	120
Bodytype:	Break	Body color:	Dark Grey
Gearbox:	Automatic	Paint type:	Metalic
Transmission:	Back	Rims summer:	Aluminium
Fueltype:	Diesel	Oil level:	OK
Battery functioning:	Yes	Parking lot:	2226
Number of doors:	5		
Number of seats:	5		
Number head rests:	5		
Rims summer:	Aluminium		
Category:	Passenger Car		
Oil level:	OK		
Registration Certificate Car (BE):	Yes

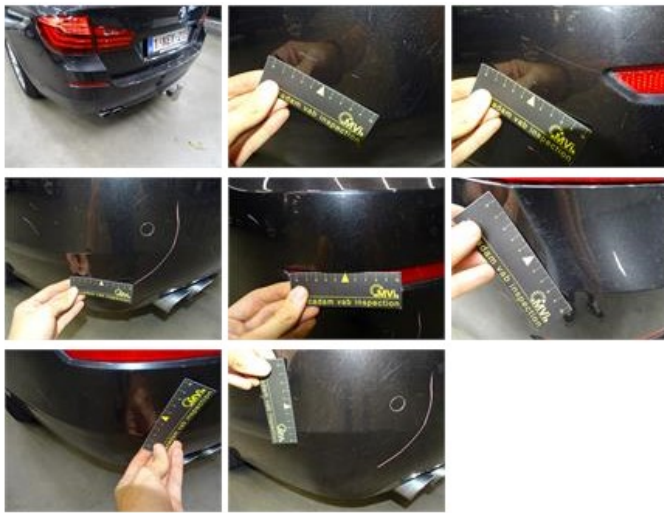
Total cost ex VAT	1798,78
Bumper R, Scratch(es), LI - Repair and paint (complete)	254,16

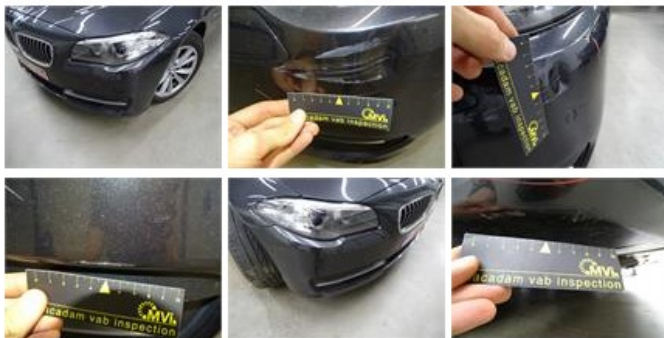
Bumper F, Dent(s) and scratch(es), LI - Repair and paint (complete) 254,16

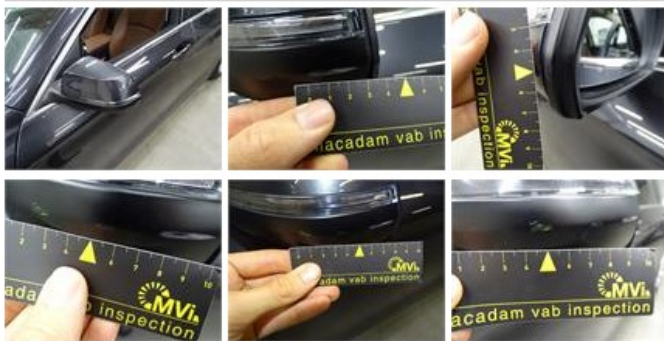
Rearview mirror basis L, Scratch(es), Smart repair 110,64

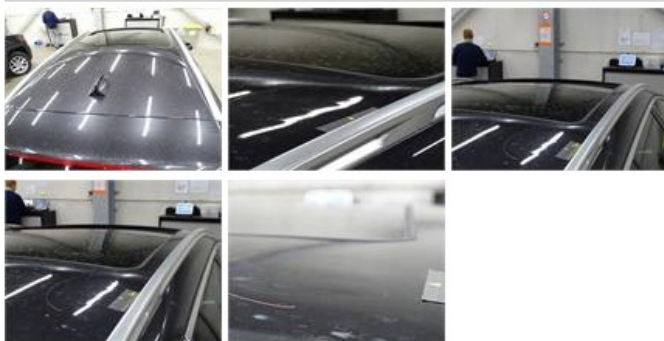
Roof, Dent(s), PDR - Paintless dent repair 122,40

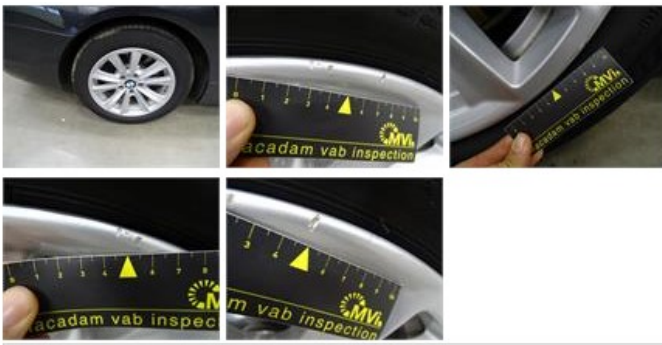
Alloy rim R R, Scratch(es), LI - Repair and paint (complete) 95,00

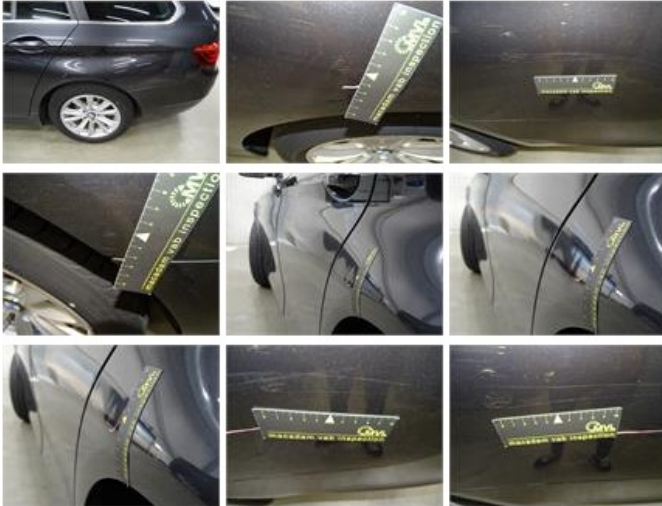
Wing R L, Dent(s) and scratch(es), LI - Repair and paint (complete) 369,84

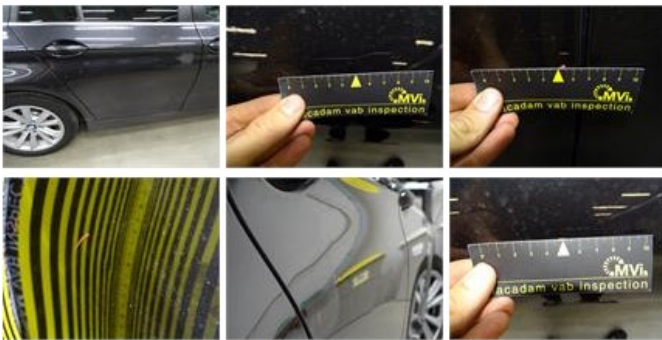
Door R R, Dent(s) and scratch(es), LI - Repair and paint (complete) 382,02

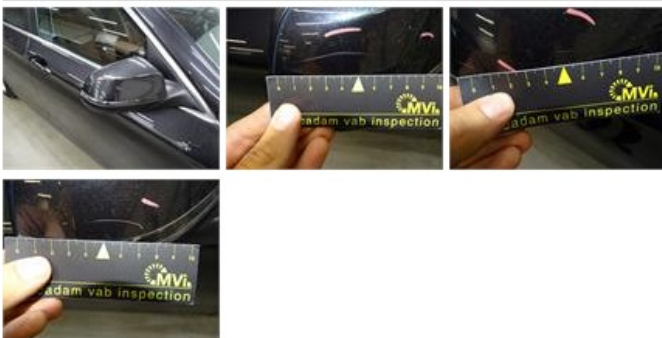
Rearview mirror housing R, Scratch(es), LI - Repair and paint (complete) 115,56
