FORD Grand C-Max: 1JHV058

Limited Technical Inspection

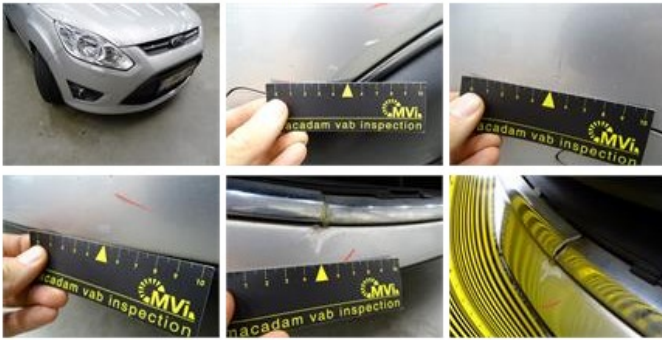
Bumper F, Dent(s) and scratch(es), LI - Repair and paint (complete)

211,80

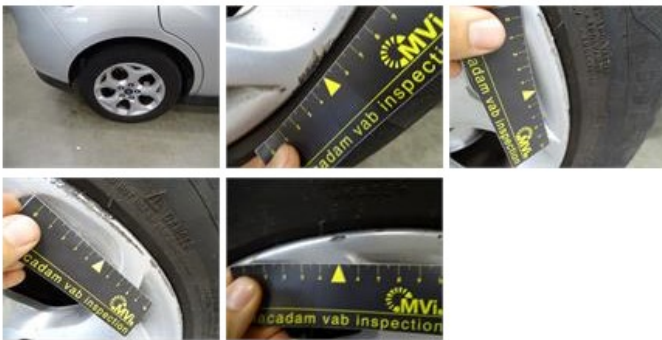
Alloy rim R R, Scratch(es), LI - Repair and paint (complete)

95,00

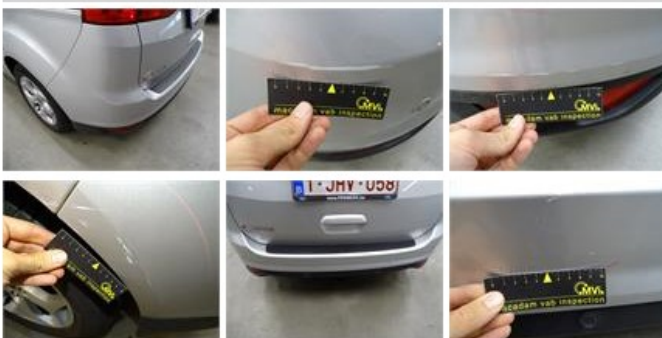
Bumper R, Scratch(es), LI - Repair and paint (complete)

211,80

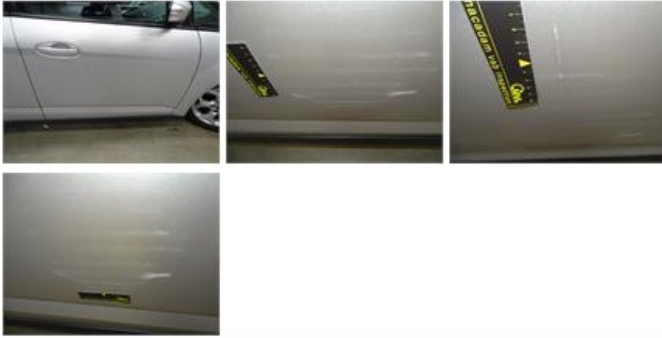
Door F R, Scratch(es), LI - Repair and paint (complete) 318,35

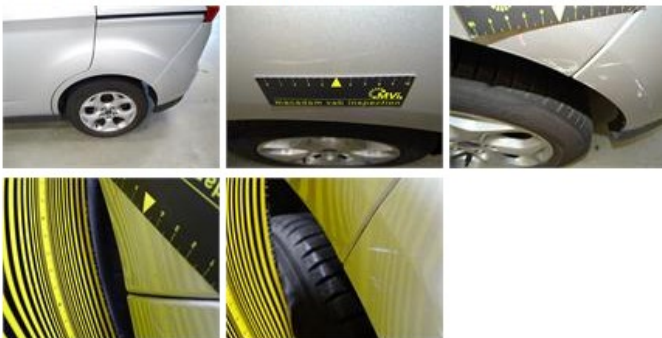
Wing R L, Dent(s) and scratch(es), LI - Repair and paint (complete) 0,00
