VOLKSWAGEN Golf: 1HLF939

Limited Technical Inspection

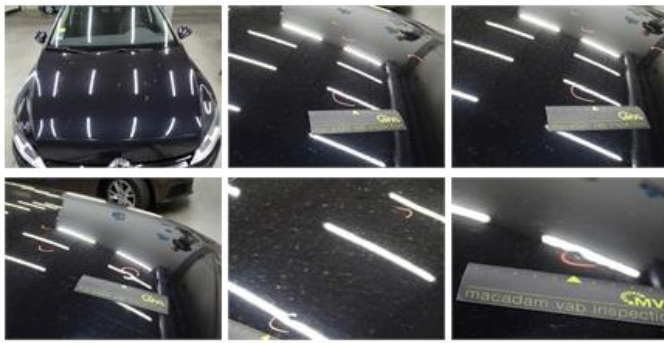
Total cost ex VAT	1285,14
Door F R, Scratch(es), Acceptable	0,00
<i>No pictures to display</i>	
Bonnet, Dent(s), PDR - Paintless dent repair	221,40

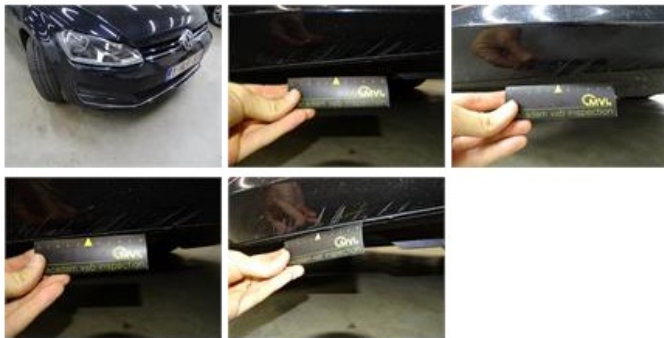
Bumper F, Scratch(es), LI - Repair and paint (complete) 211,80

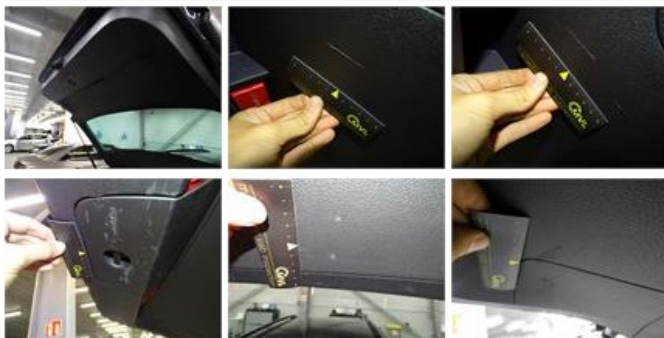
Trunk lid covering R, Scratch(es), Smart repair 110,64

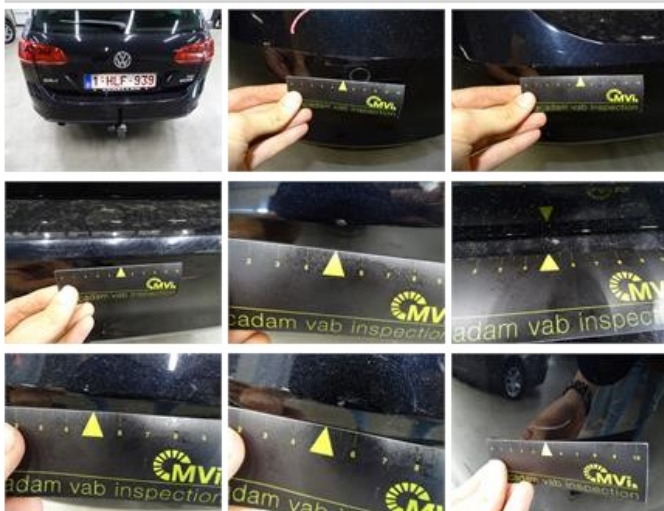
Bumper R, Scratch(es), LI - Repair and paint (complete) 211,80
