**VOLVO XC60: 1HGB561**

**Limited Technical Inspection**

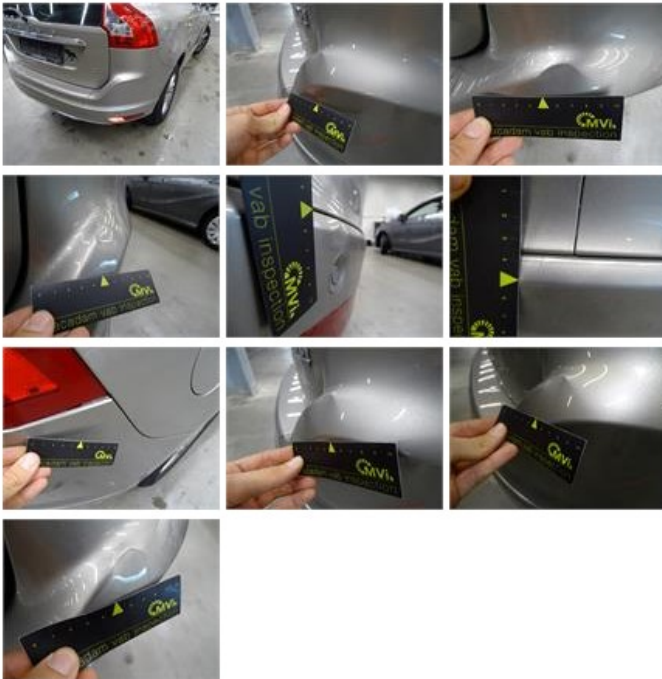
Bumper R, Dent(s) and scratch(es), LI - Repair and paint (complete) 254,16

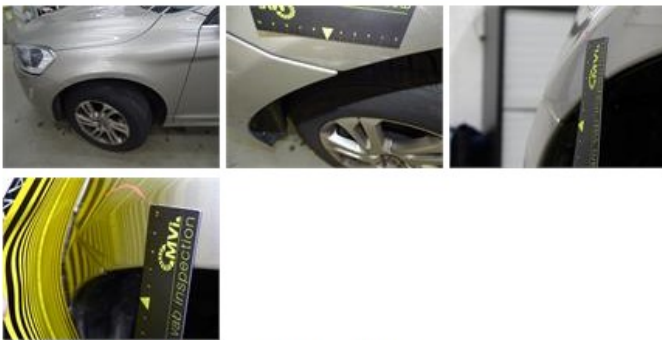
Wing F L, Dent(s) and scratch(es), LI - Repair and paint (complete) 264,21

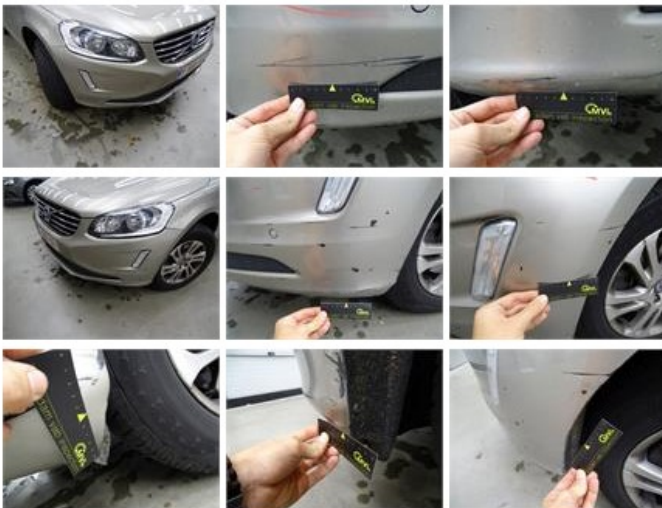
Bumper F, Dent(s) and scratch(es), LI - Repair and paint (complete) 0,00
