PEUGEOT 308 SW: 1KTJ988

Limited Technical Inspection

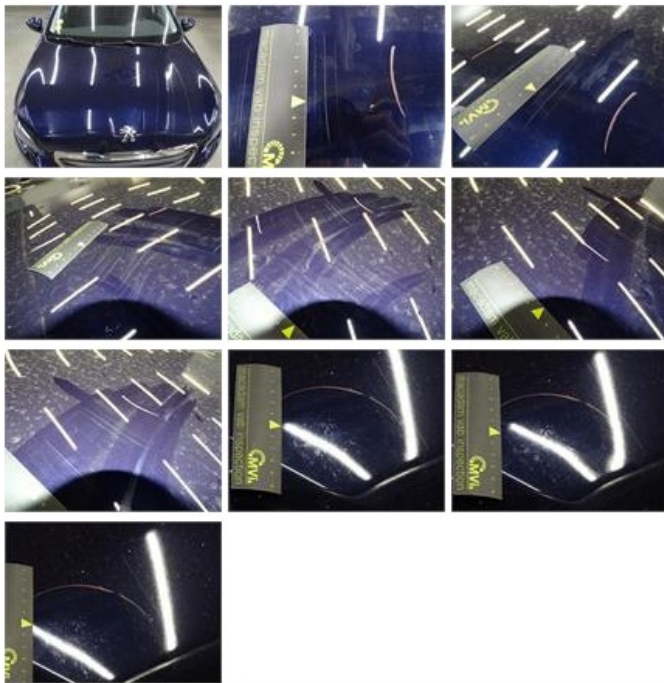
Total cost ex VAT	2303,79
Door F R, Scratch(es), Acceptable	0,00
<i>No pictures to display</i>	
Bonnet, Scratch(es), LI - Repair and paint (complete)	290,08

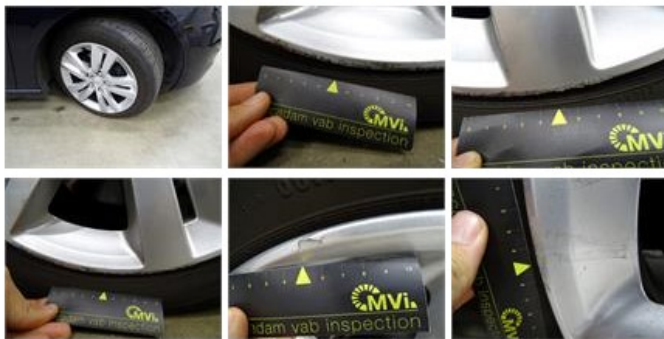
Alloy rim F R, Scratch(es), LI - Repair and paint (complete)

95,00

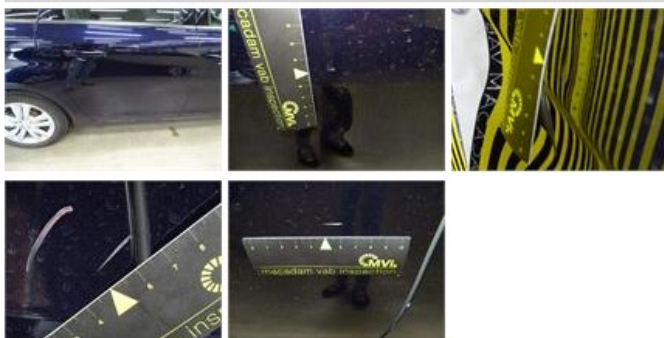
Door R R, Dent(s) and scratch(es), LI - Repair and paint (complete)

318,35

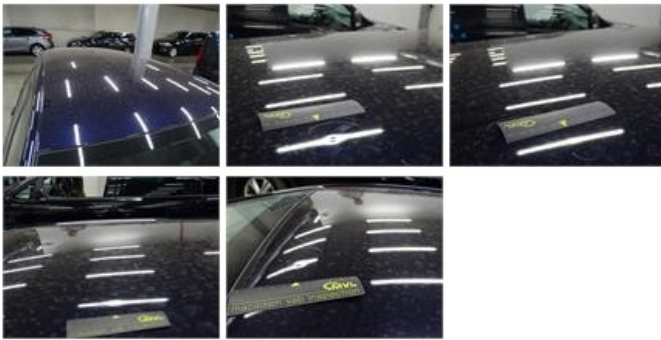
Roof, Dent(s), PDR - Paintless dent repair 122,40

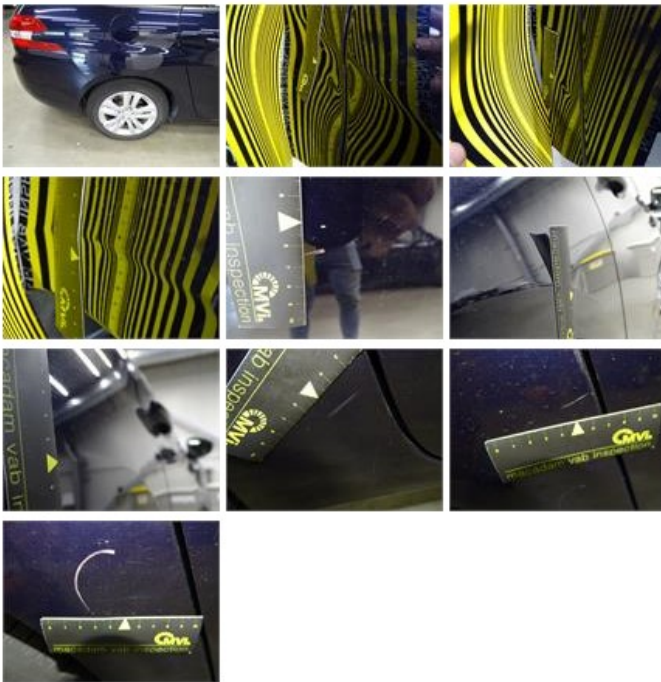
Wing R R, Dent(s) and scratch(es), LI - Repair and paint (complete) 308,20

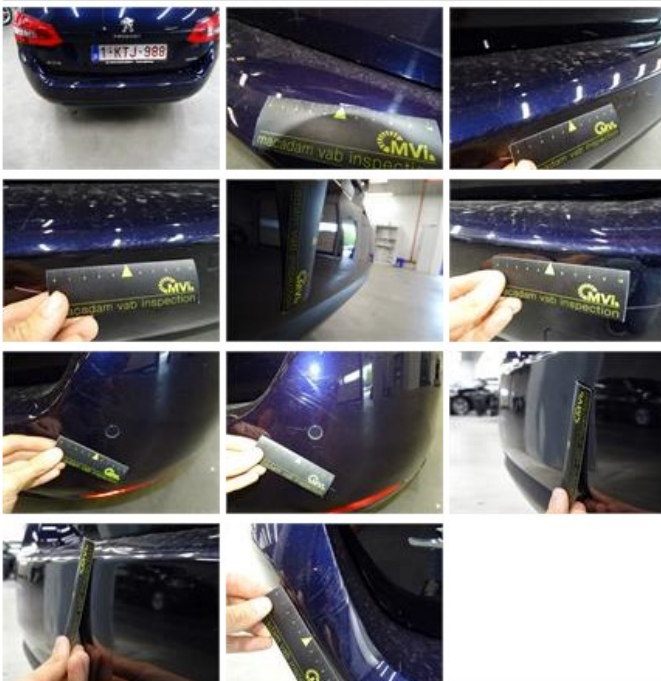
Bumper R, Dent(s) and scratch(es), LI - Repair and paint (complete) 211,80

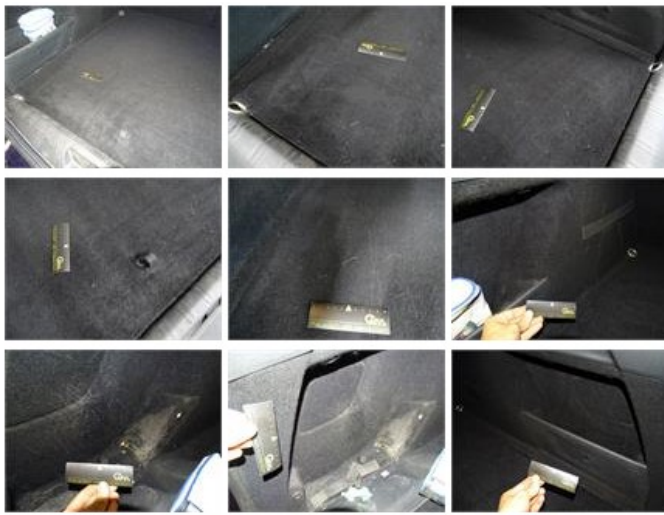
Interior, Dirty, Chemical cleaning 25,00

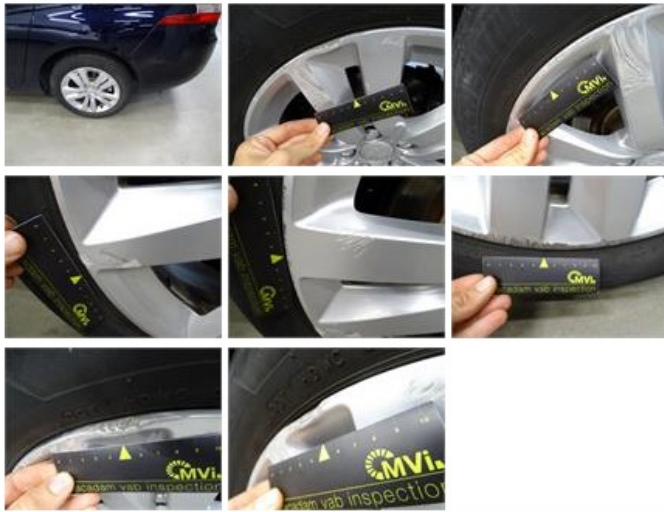
Alloy rim R L, Deformed / Strained, E - Replace 235,20

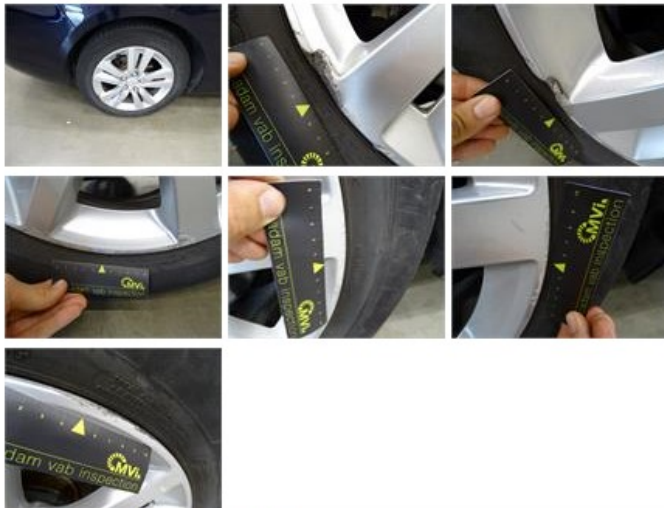
Alloy rim R R, Deformed / Strained, E - Replace 235,20
