PEUGEOT 308 SW: 1LAH431

Limited Technical Inspection

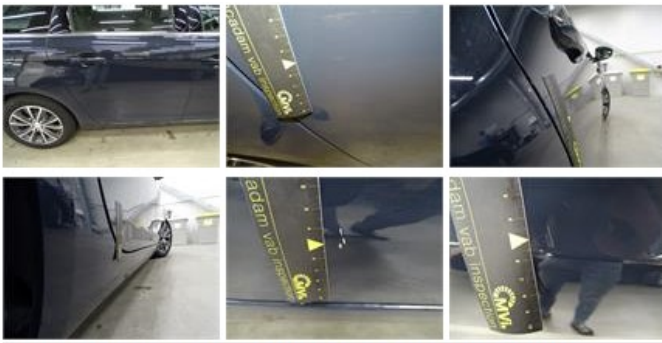
Total cost ex VAT	4221,24
Door R R, Dent(s) and scratch(es), LI - Repair and paint (complete)	318,35

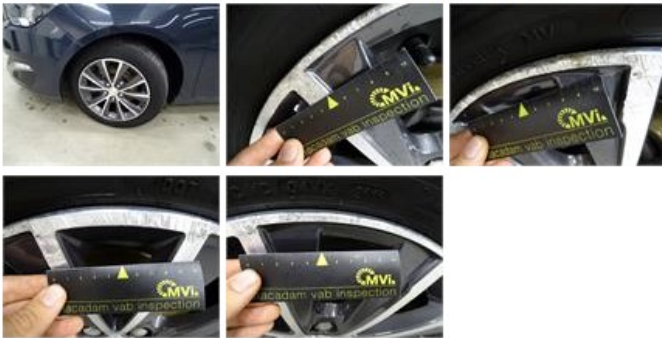
Alloy rim F L polished, Scratch(es), LI - Repair and paint (complete) 95,00

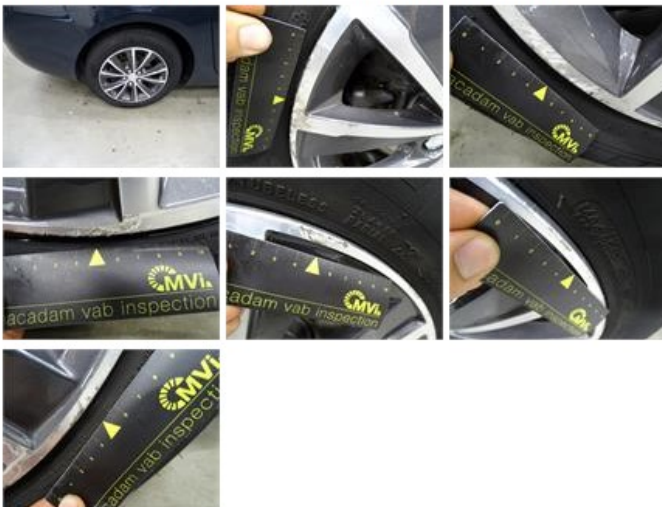
Alloy rim R R polished, Scratch(es), LI - Repair and paint (complete) 95,00

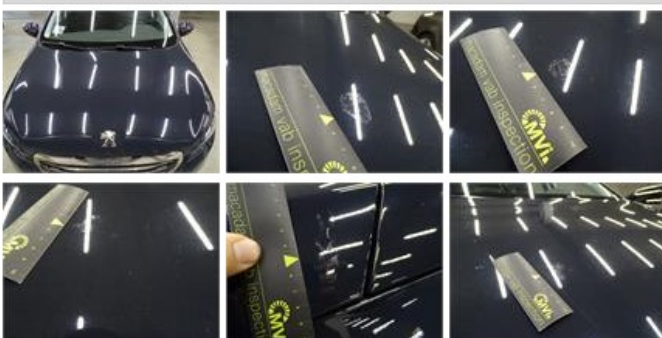
Bonnet, Chemical polution, LI - Repair and paint (complete) 290,08

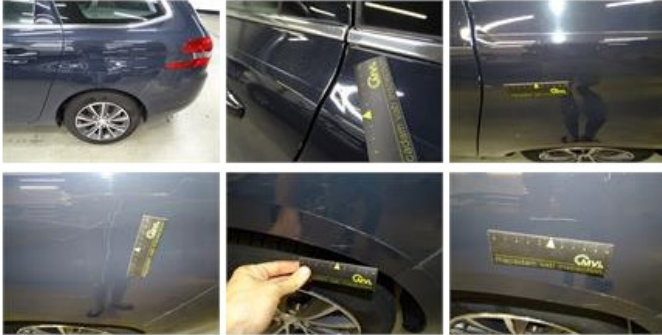
Wing R L, Dent(s) and scratch(es), LI - Repair and paint (complete) 308,20

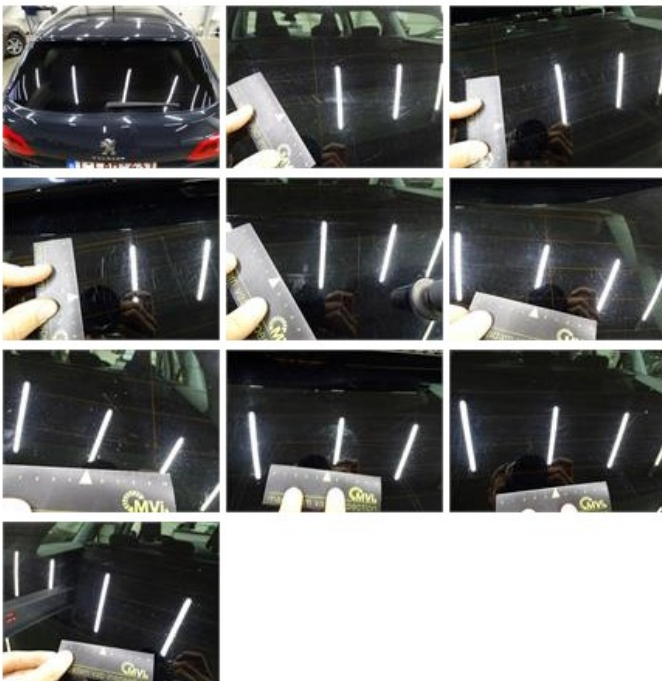
Rear window, Scratch(es), E - Replace 0,00

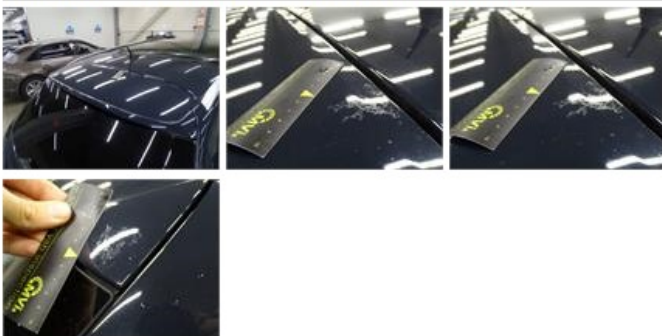
Rear spoiler, Chemical polution, LI - Repair and paint (complete) 115,56

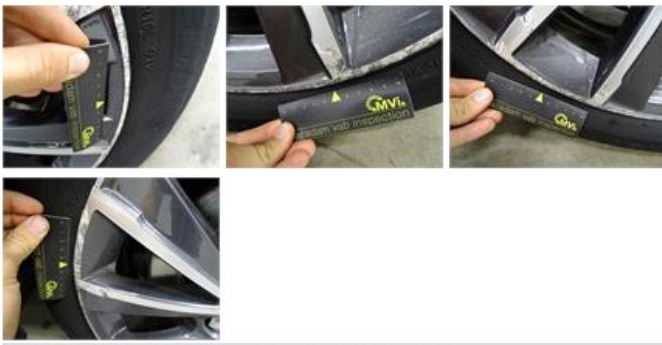
Alloy rim F R polished, Scratch(es), LI - Repair and paint (complete) 95,00

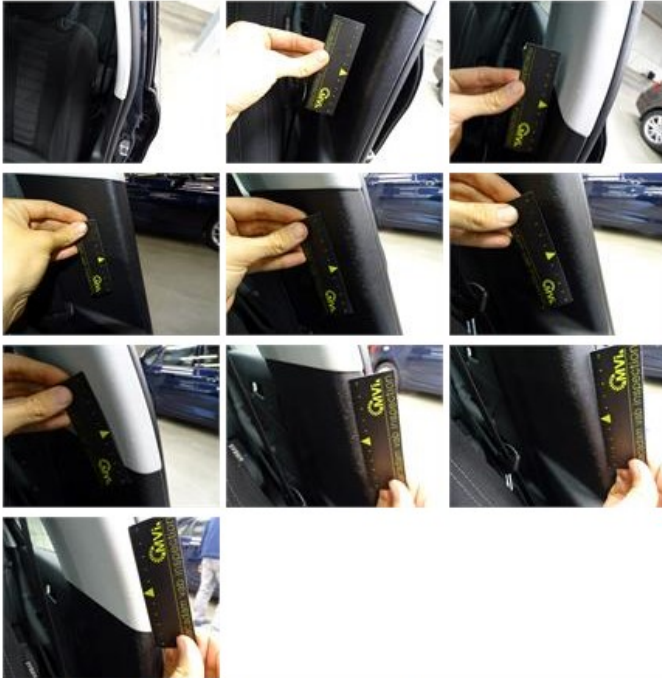
Covering interior B pillar L, Scratch(es), Smart repair

110,64

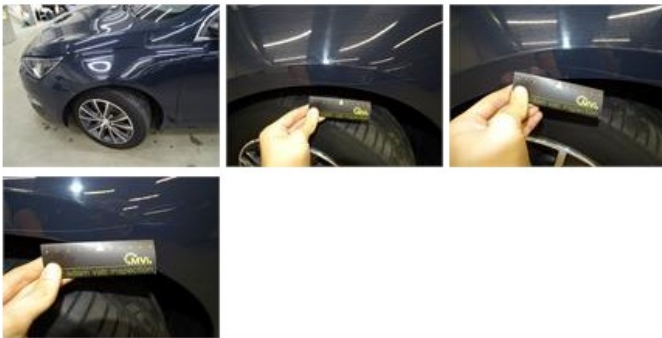
Wing F L, Scratch(es), LI - Repair and paint (complete)

220,18

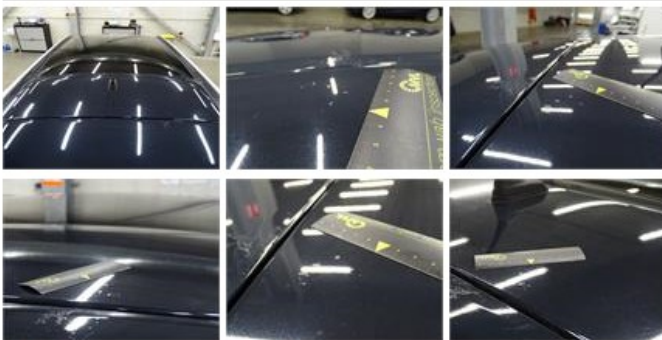
Roof, Chemical pollution, LI - Repair and paint (complete)

481,50

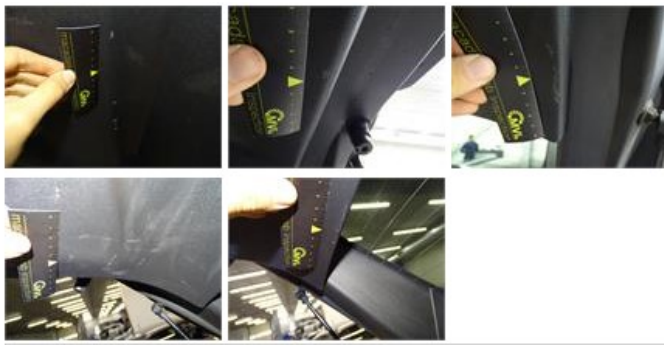
Trunk lid covering R, Scratch(es), Smart repair

110,64

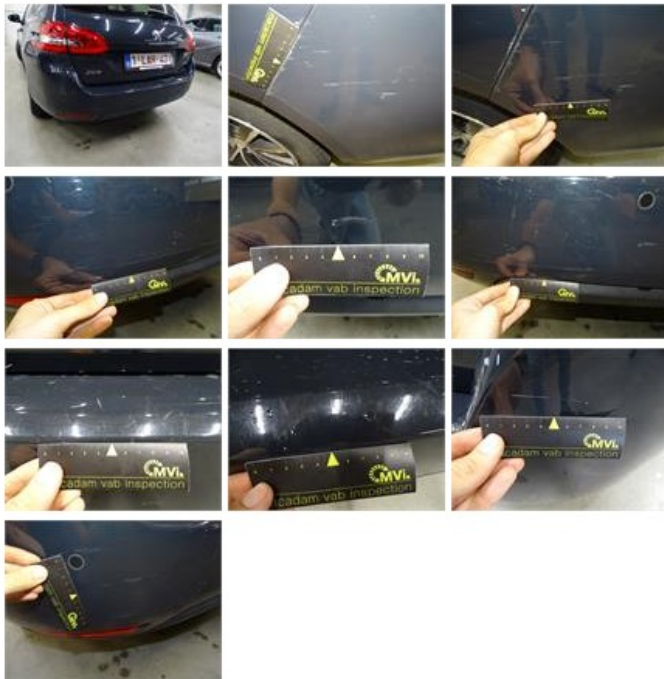
Bumper R, Scratch(es), LI - Repair and paint (complete)

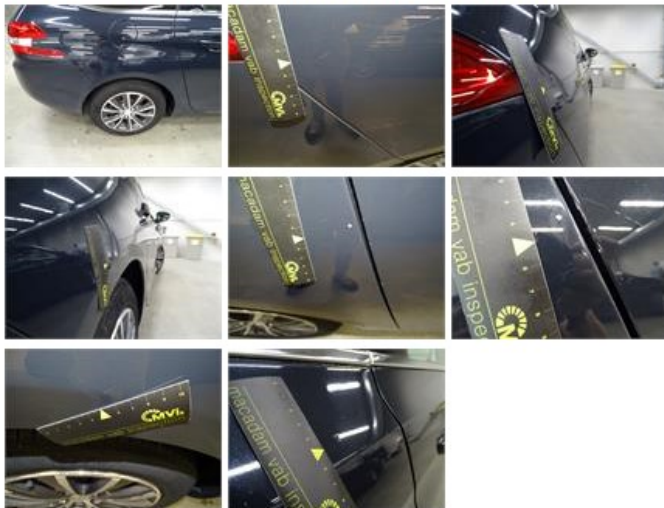
Wing R R, Dent(s) and scratch(es), LI - Repair and paint (complete)

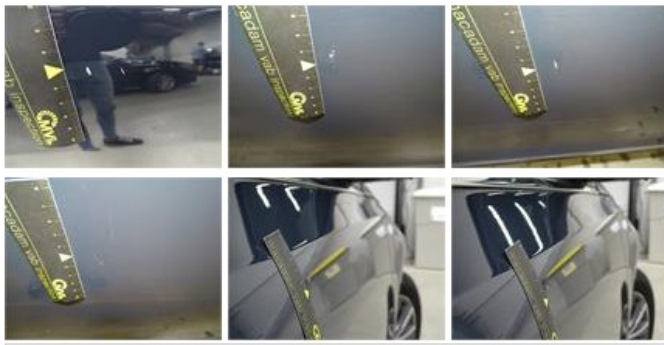
Door F R, Dent(s) and scratch(es), LI - Repair and paint (complete)

318,35

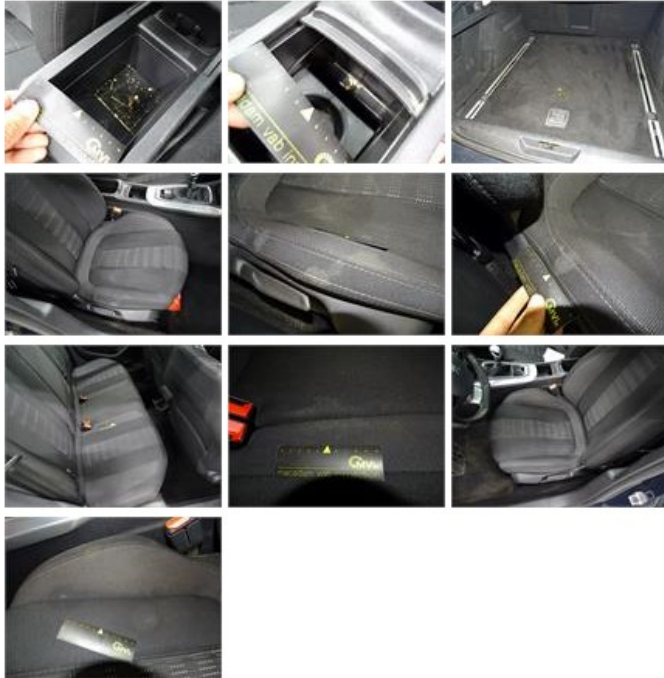
Interior, Dirty, Cleaning

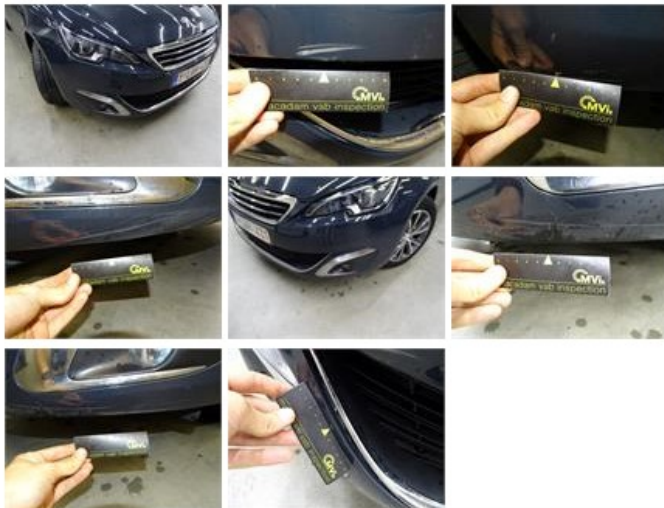
Bumper F, Scratch(es), LI - Repair and paint (complete)

211,80

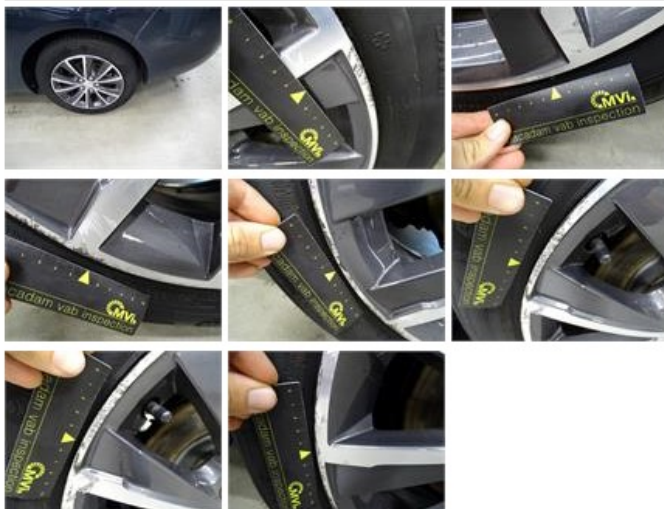
Alloy rim R L polished, Scratch(es), LI - Repair and paint (complete)

95,00
