**OPEL INSIGNIA SPORTS TOURER: 1KRL083**

**Limited Technical Inspection**

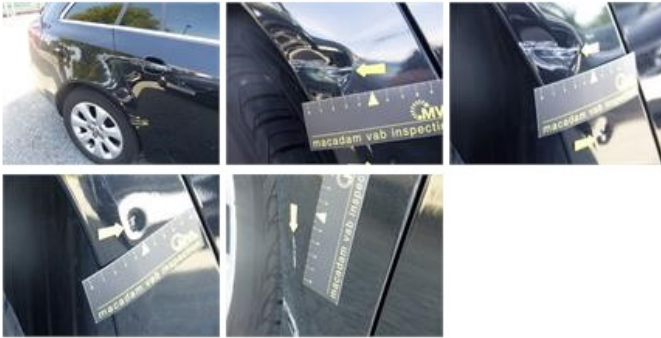
Wing R R, Dent(s) and scratch(es), LI - Repair and paint (complete) 380,20

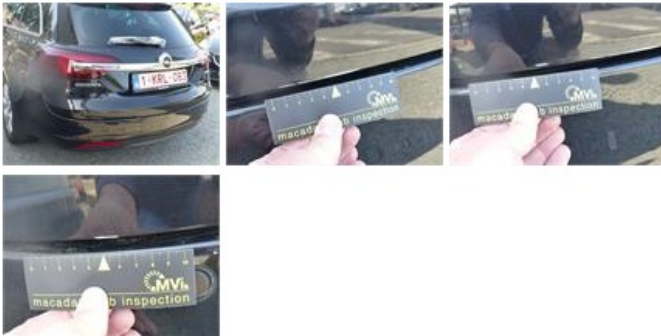
Tailgate, Scratch(es), LI - Repair and paint (complete) 301,68

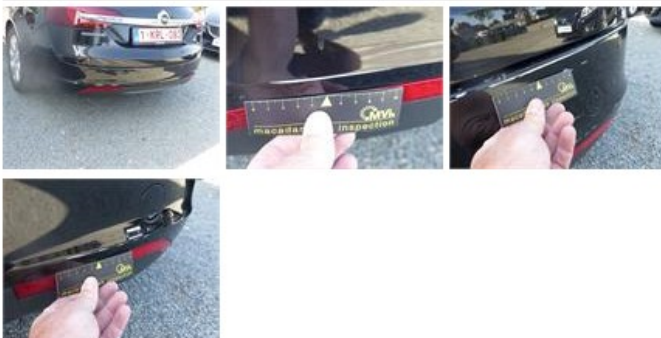
Bumper R, Scratch(es), LI - Repair and paint (complete) 211,80
