VOLVO V40: 1KUK351

Limited Technical Inspection

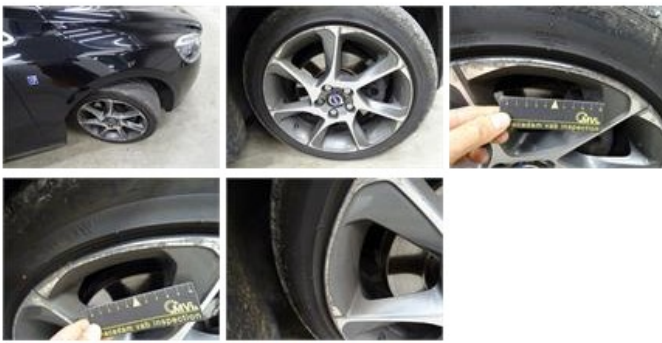
Alloy rim F R polished, Scratch(es), LI - Repair and paint (complete) 95,00

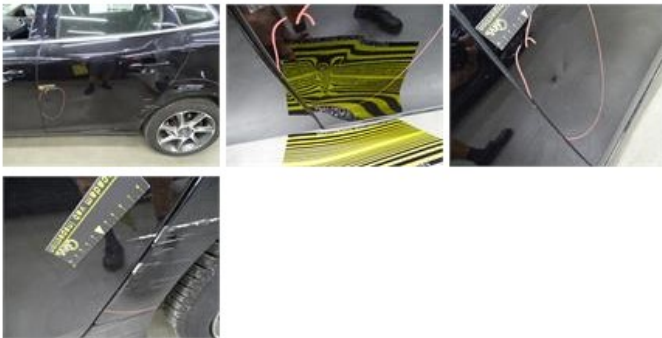
Door R L, Dent(s), LI - Repair and paint (complete) 318,35

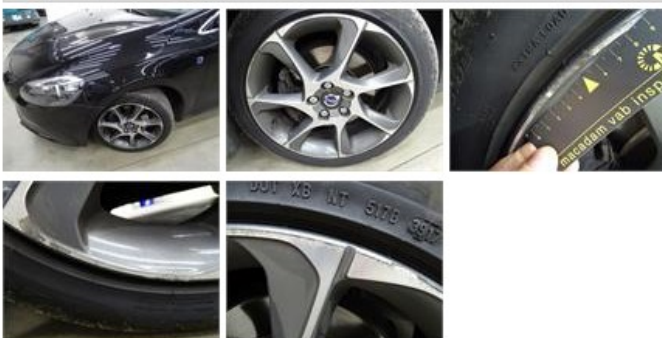
Alloy rim F L polished, Scratch(es), LI - Repair and paint (complete) 95,00

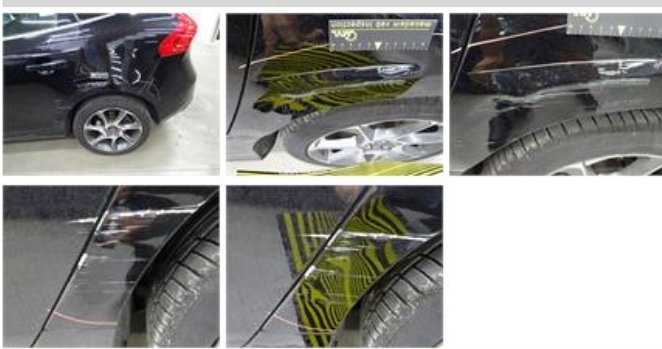
Wing R L, Dent(s) and scratch(es), LI - Repair and paint (complete) 308,20

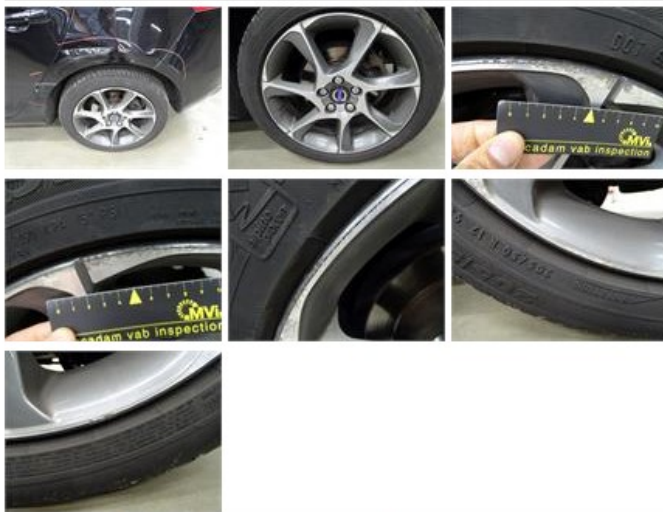
Alloy rim R L polished, Scratch(es), LI - Repair and paint (complete) 95,00

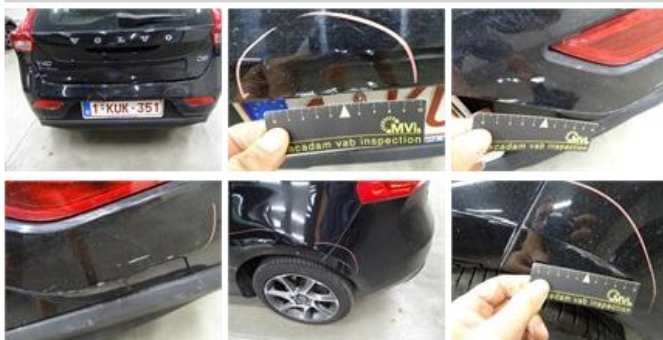
Bumper R, Scratch(es), LI - Repair and paint (complete) 211,80
