VOLVO S60: 1HSR509

Limited Technical Inspection

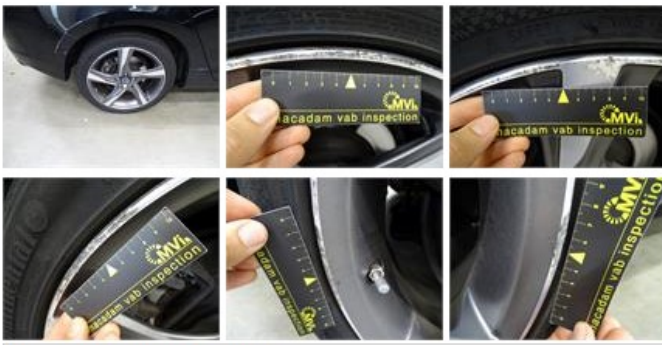
Alloy rim R R, Scratch(es), LI - Repair and paint (complete) 95,00

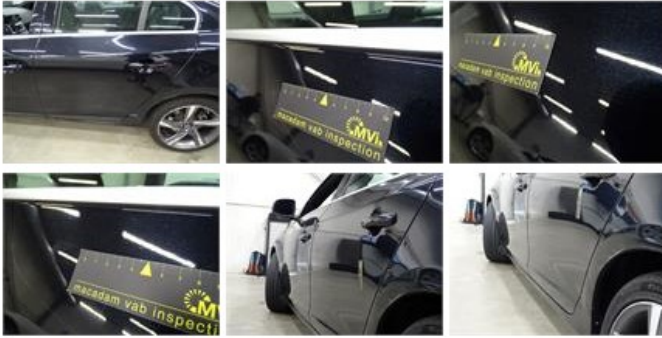
Door R L, Bad repair, Acceptable

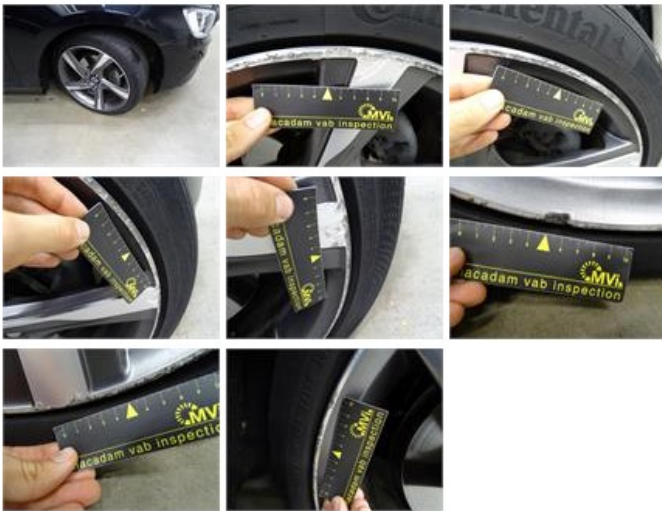
Alloy rim F R, Scratch(es), LI - Repair and paint (complete)

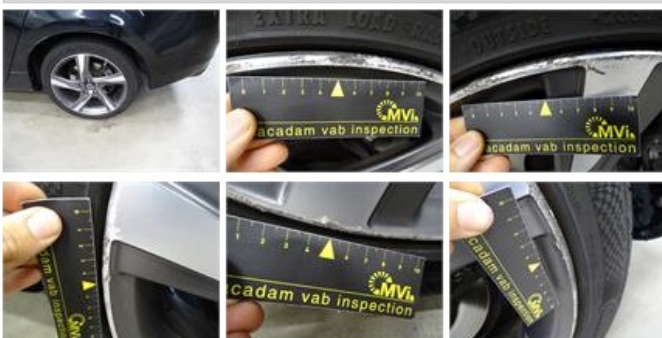
Alloy rim R L, Scratch(es), LI - Repair and paint (complete)

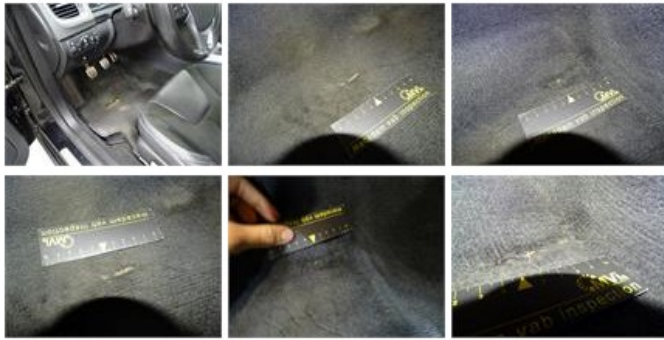
Floor covering F L, Hole, Acceptable

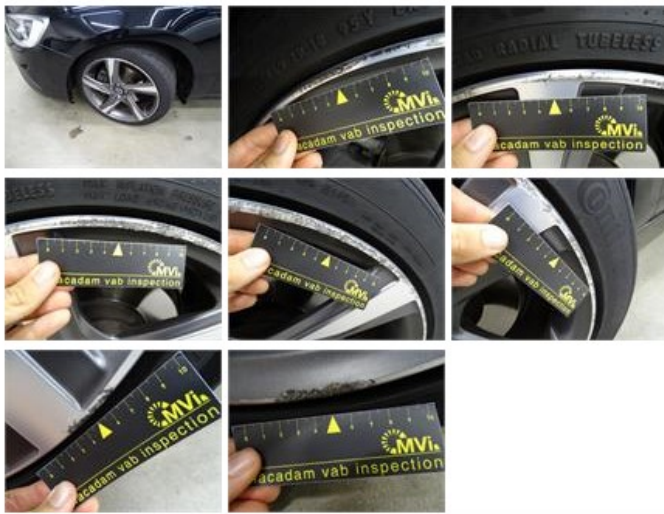
Alloy rim F L, Scratch(es), LI - Repair and paint (complete)

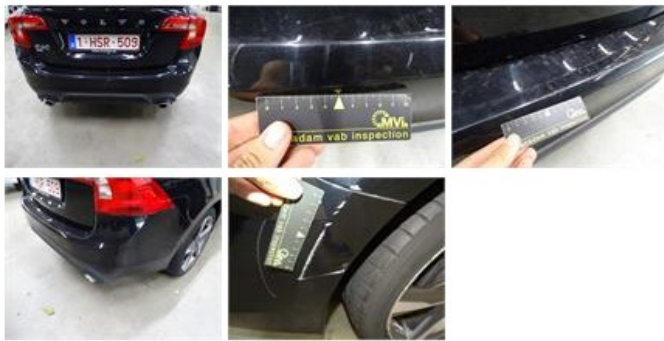
Bumper R, Scratch(es), LI - Repair and paint (complete)

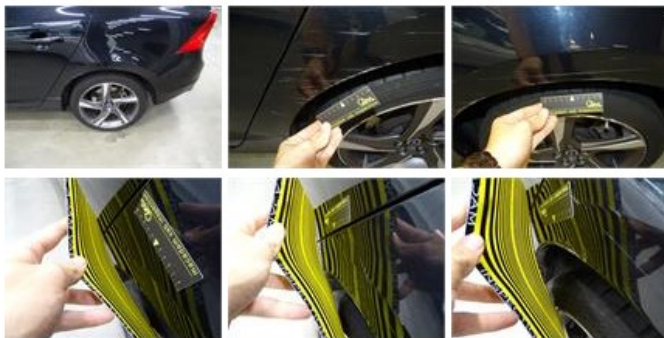
Wing R L, Scratch(es), LI - Repair and paint (complete)
