VOLVO V90: 1U1FH060

Limited Technical Inspection

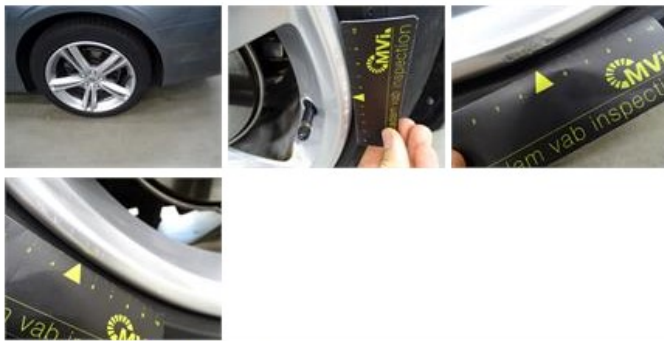
Alloy rim R L, Scratch(es), LI - Repair and paint (complete)

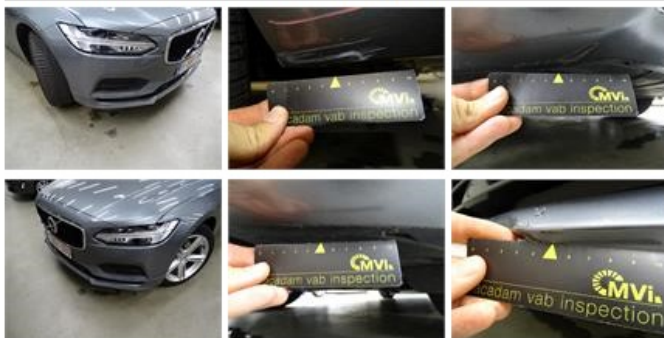
Bumper F, Scratch(es), LI - Repair and paint (complete)
