**VOLKSWAGEN Touran: 1HBV878**

**Limited Technical Inspection**

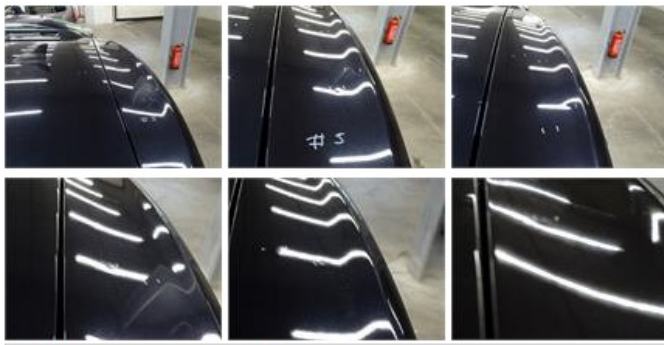
Total cost ex VAT	1499,00
Tailgate, Hail damage, PDR - Hail	125,00

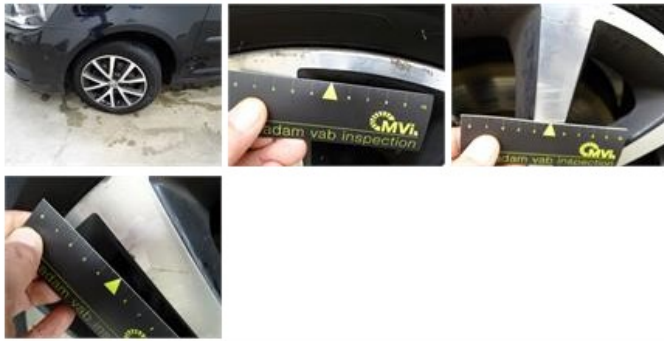
Alloy rim F L polished, Scratch(es), LI - Repair and paint (complete) 95,00

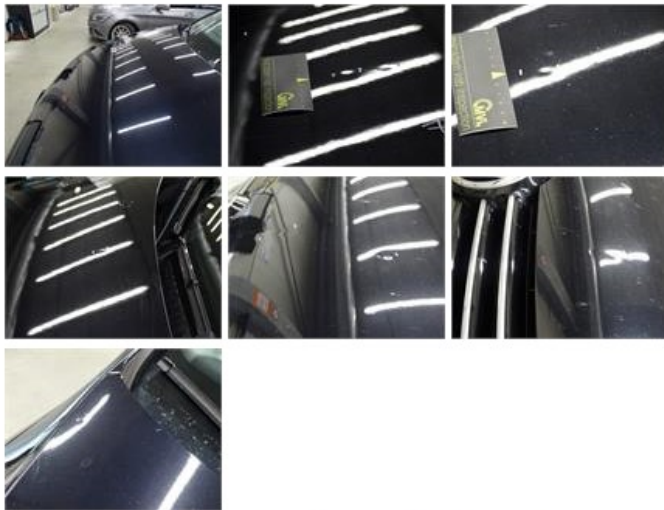
Bonnet, Hail damage, PDR - Hail 225,00

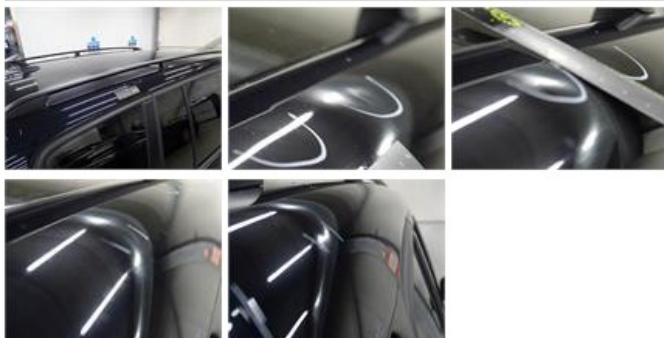
Roof pillar R, Hail damage, PDR - Hail 100,00

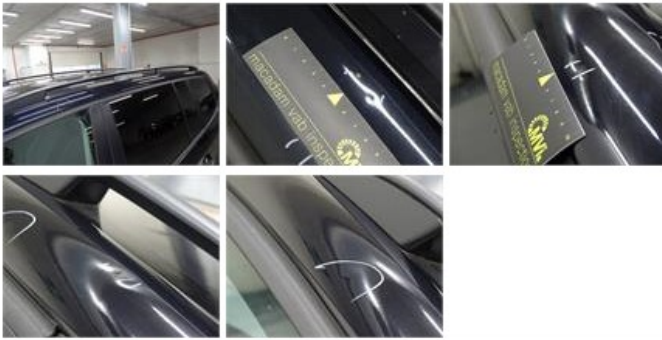
Roof pillar L, Hail damage, PDR - Hail 100,00

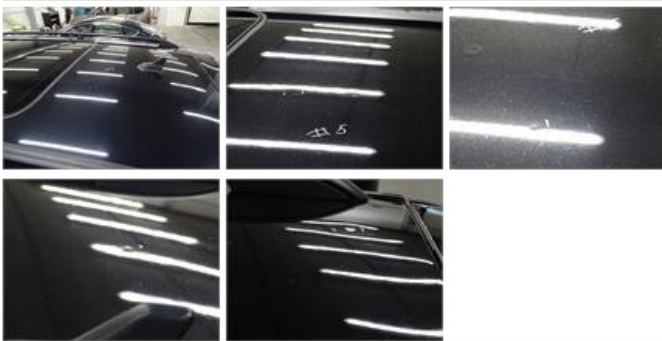
Roof, Hail damage, PDR - Hail 125,00

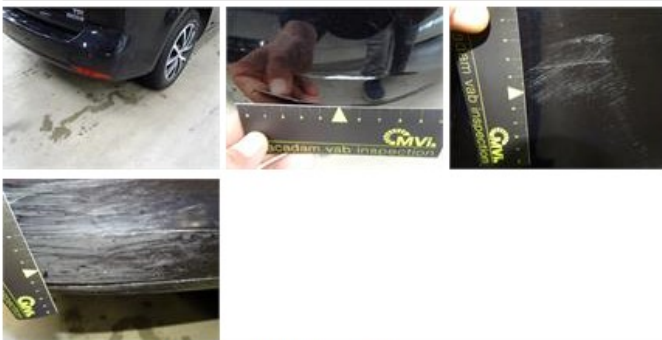
Bumper R, Scratch(es), LI - Repair and paint (complete) 211,80
