BMW 3: 1HAB011

Limited Technical Inspection

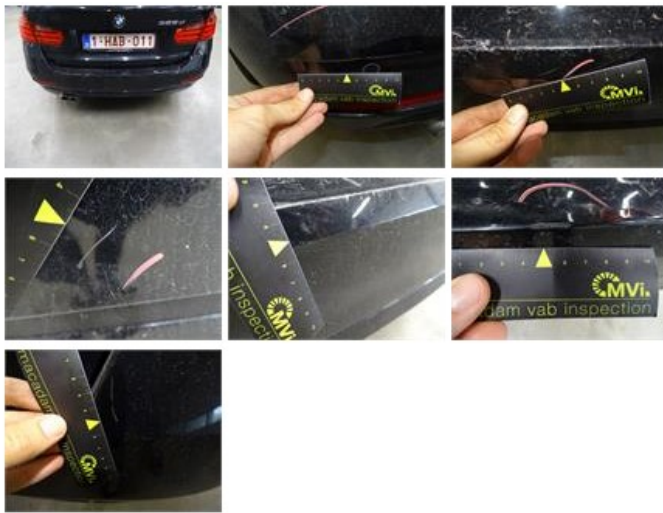
Total cost ex VAT		1968,68
Bumper R, Scratch(es), LI - Repair and paint (complete)		211,80

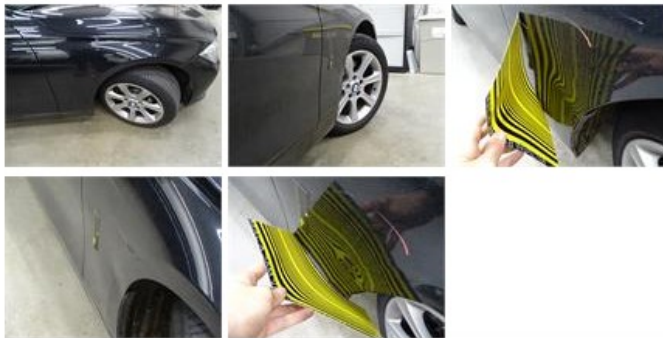
Wing F R, Dent(s), LI - Repair and paint (complete) 220,18

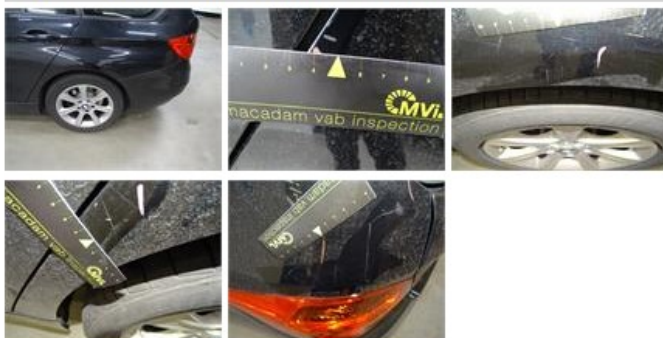
Wing R L, Scratch(es), LI - Repair and paint (complete) 308,20

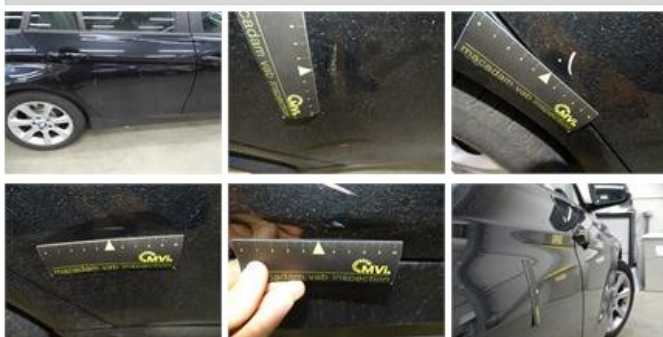
Door R R, Dent(s) and scratch(es), LI - Repair and paint (complete) 318,35

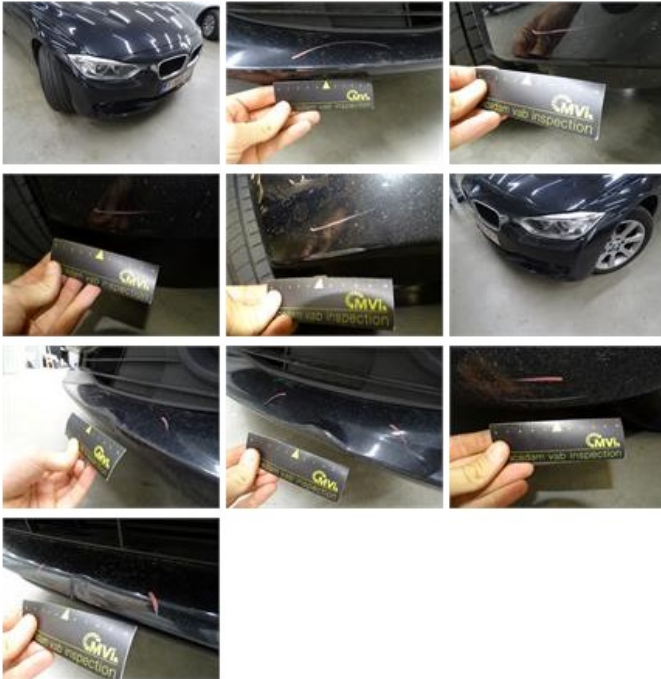
Bumper F, Dent(s) and scratch(es), LI - Repair and paint (complete)

211,80

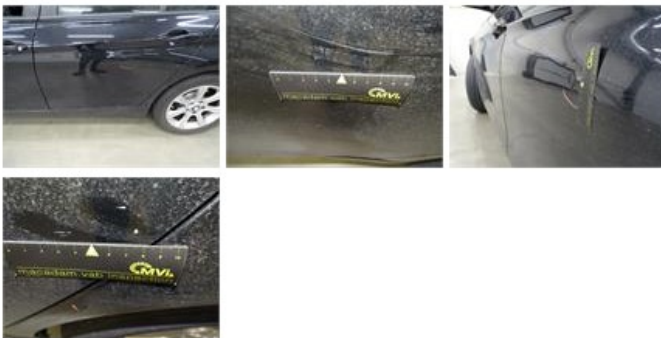
Door R L, Dent(s) and scratch(es), LI - Repair and paint (complete)

318,35

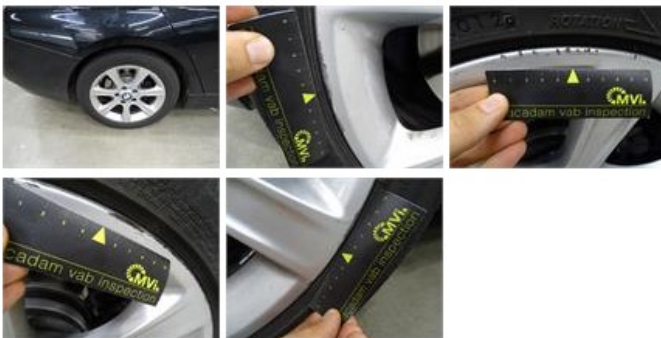
Alloy rim R R, Scratch(es), LI - Repair and paint (complete)

95,00
