BMW 5: 1HHL037			
Vinnumber:	WBA5J11020D065929	Versionname:	5 TOURING 518dA 143PK Aut.
First Registrationdate:	24/07/2014	Fiscalpower:	
Expertise Mileage:	155349	Power Kw:	105
Bodytype:	Break	Body color:	Dark Grey
Gearbox:	Automatic	Paint type:	Metalic
Transmission:	Back	Rims summer:	Aluminium
Fueltype:	Diesel	Oil level:	OK
Battery functioning:	Yes	Parking lot:	4123
Number of doors:	5		
Number of seats:	5		
Number head rests:	5		
Rims summer:	Aluminium		
Category:	Passenger Car		
Oil level:	OK		
Registration Certificate Car (BE):	Yes

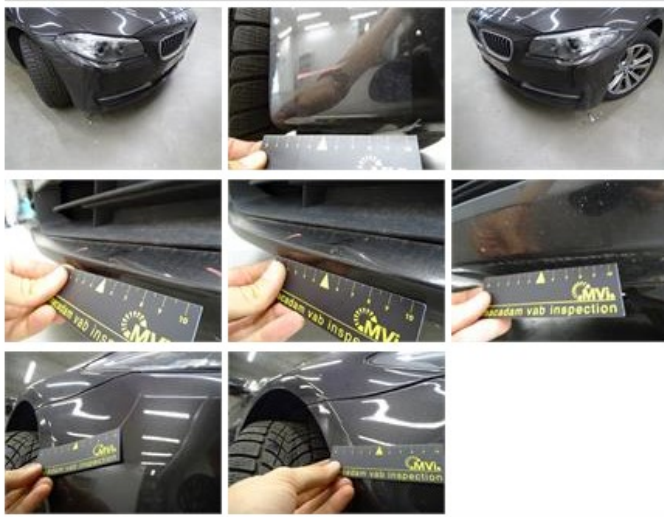
Bumper F, Dent(s) and scratch(es), LI - Repair and paint (complete) 254,16

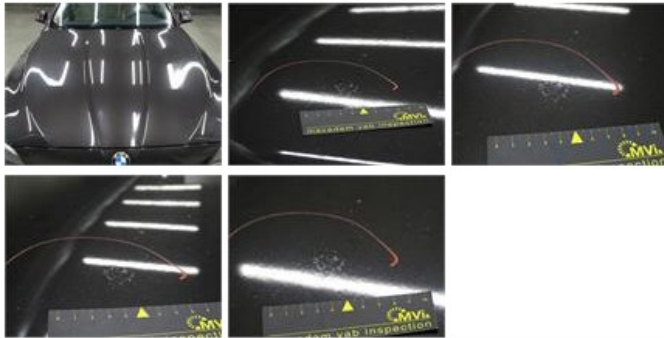
Bonnet, Chemical polution, LI - Repair and paint (complete) 348,09

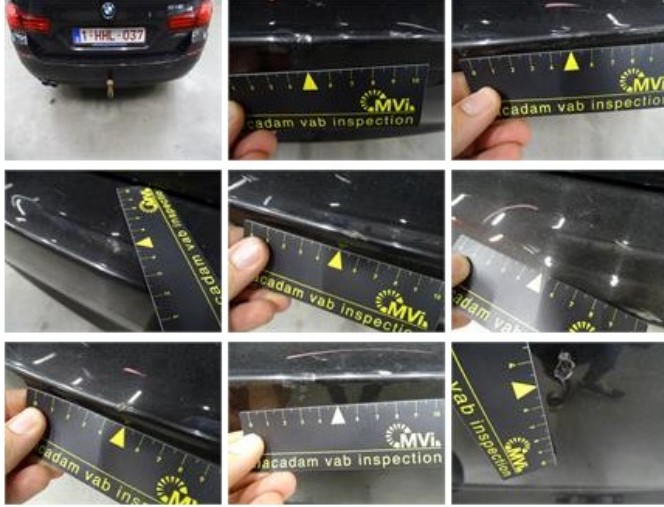
Bumper R, Scratch(es), LI - Repair and paint (complete) 254,16
