**BMW 4 GRAN COUPE: 1LBD561**

**Limited Technical Inspection**

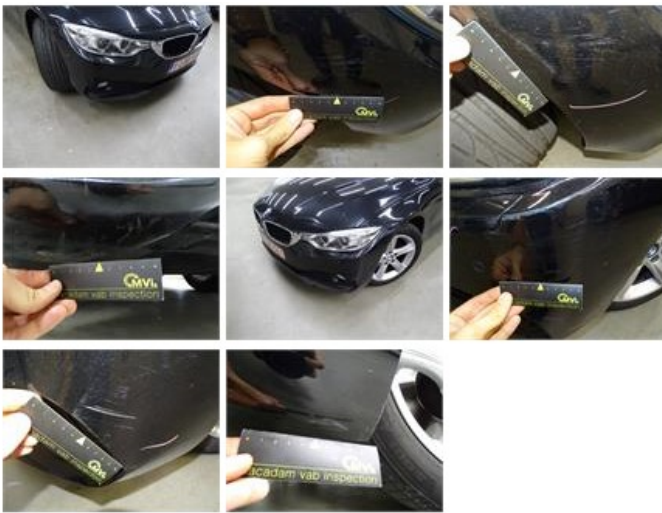
Total cost ex VAT	<b>395,96</b>
Bumper F, Scratch(es), LI - Repair and paint (complete)	<b>0,00</b>

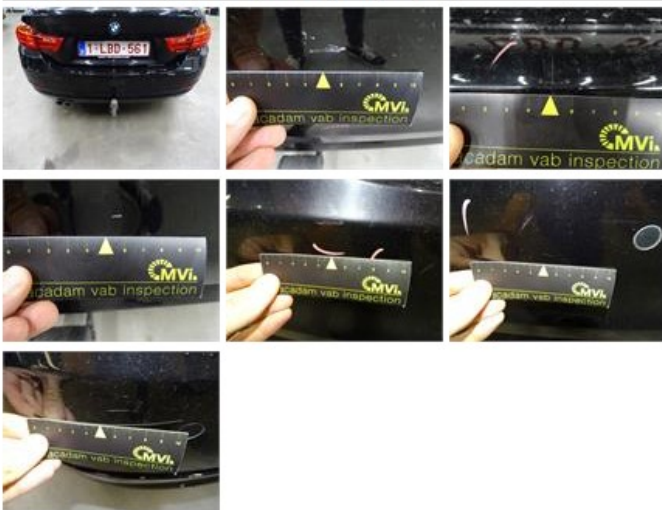
Bumper R, Scratch(es), LI - Repair and paint (complete) 0,00

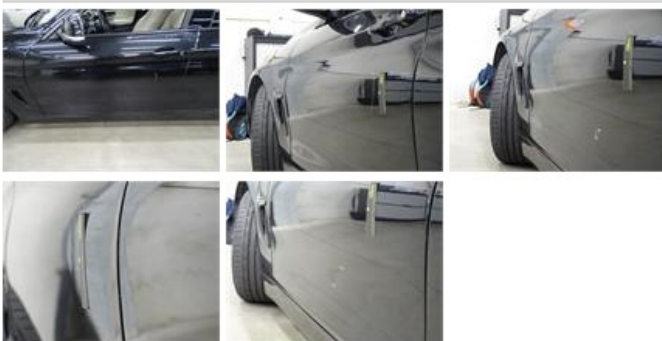
Door F L, Dent(s), PDR - Paintless dent repair 63,00

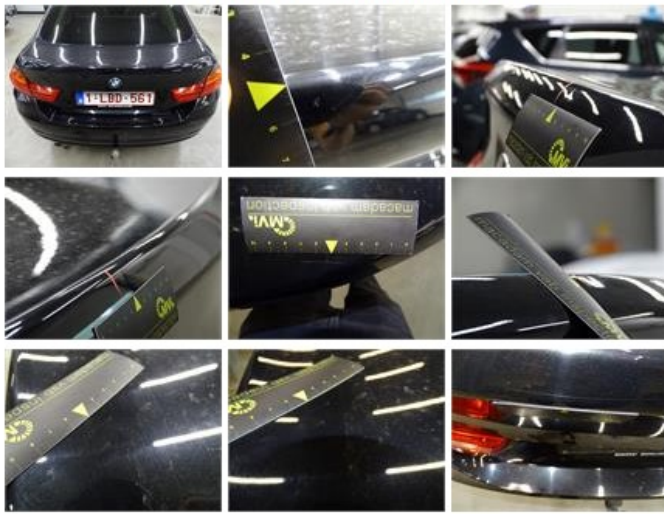
Tailgate, Dent(s) and scratch(es), LI - Repair and paint (complete)

0,00

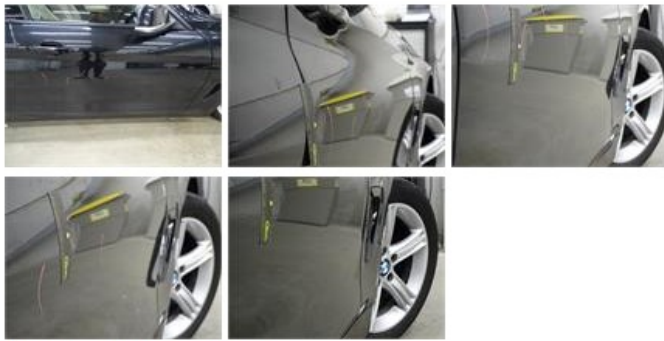
Door F R, Dent(s), PDR - Paintless dent repair

122,40

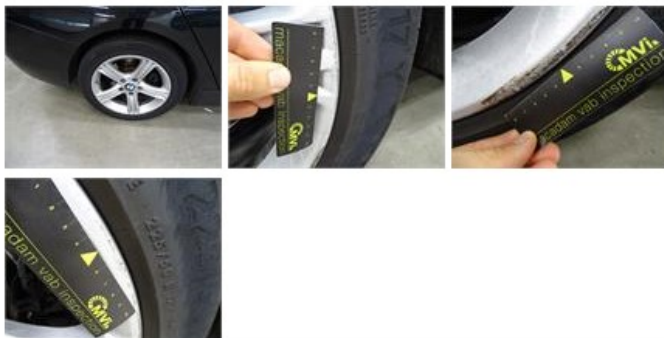
Alloy rim R R, Scratch(es), LI - Repair and paint (complete)

95,00
