PEUGEOT 308: 1HXG305

| Vinnumber: | VF3LCBHXHES245804 | Versionname: | 308 SW BlueHDi Allure STT 116PK |

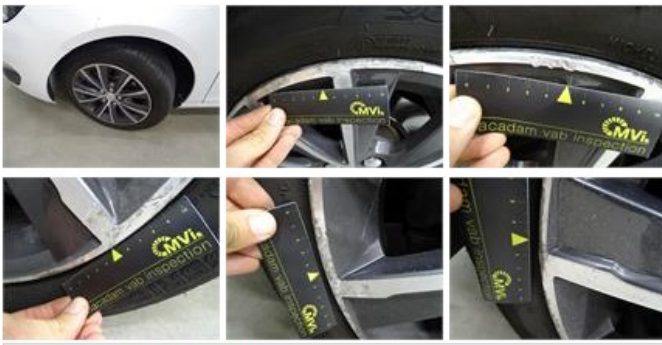
| Alloy rim F L polished, Scratch(es), LI - Repair and paint (complete) | 95,00 |

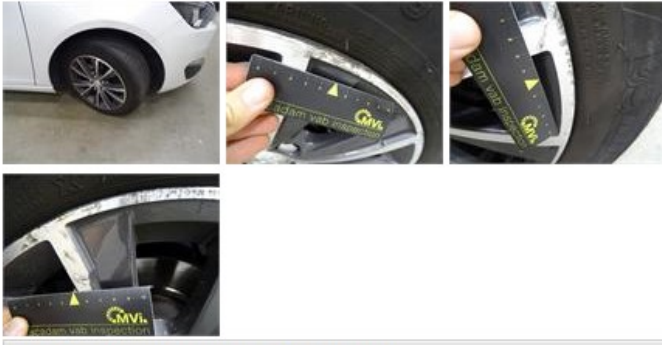
Alloy rim F R polished, Scratch(es), LI - Repair and paint (complete) 95,00

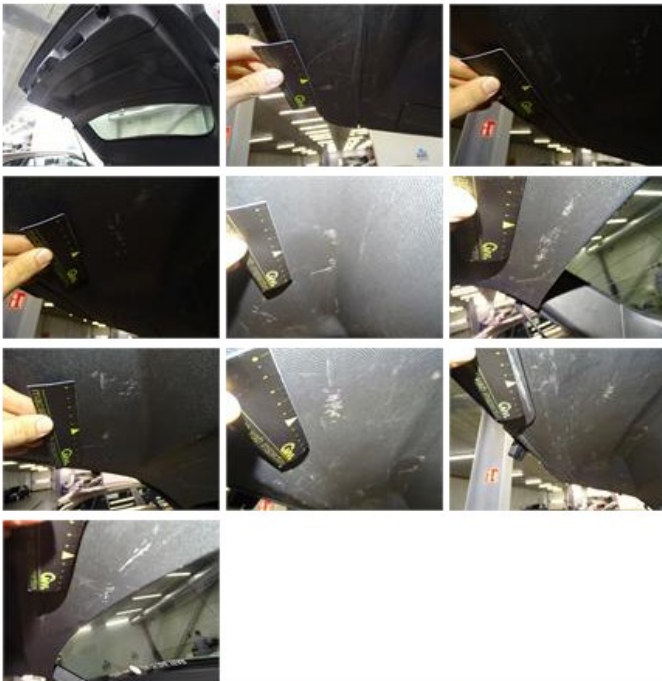
Trunk lid covering R, Scratch(es), Smart repair 110,64

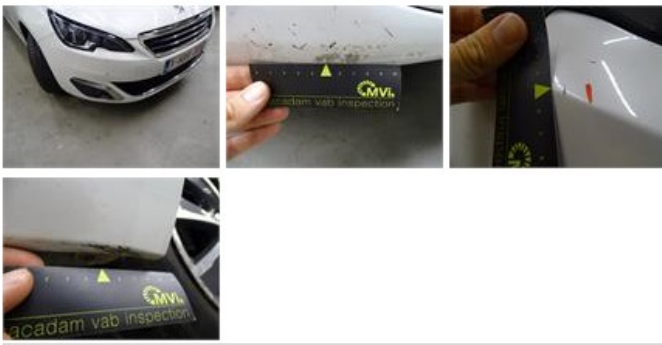
Bumper F, Scratch(es), LI - Repair and paint (complete) 211,80

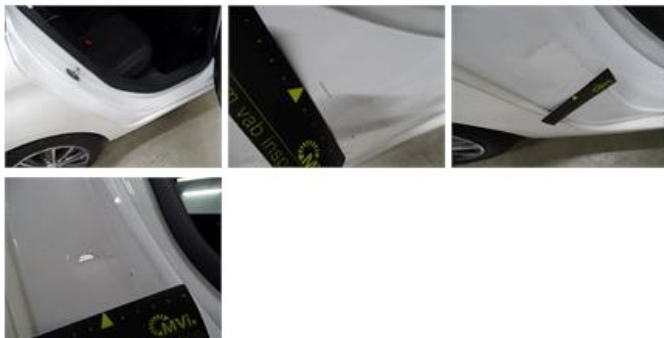
| Rocker panel inner R R, Dent(s), LI - Repair and paint (complete) | 115,56 |

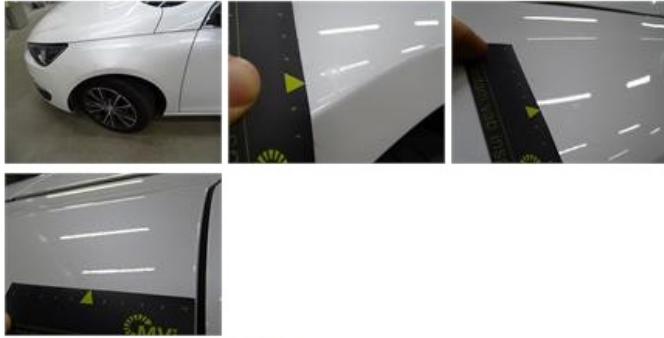
| Wing F L, Bad repair, Acceptable | 0,00 |

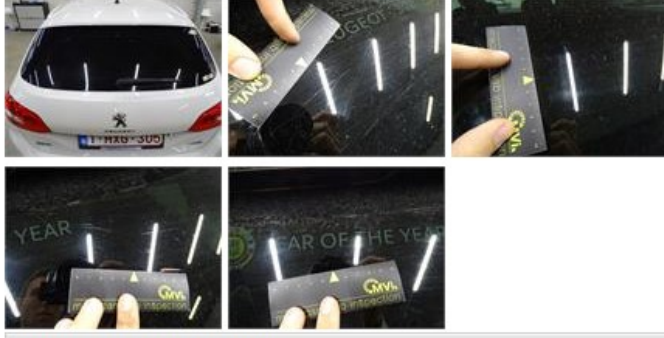
| Rear window, Scratch(es), Acceptable | 0,00 |

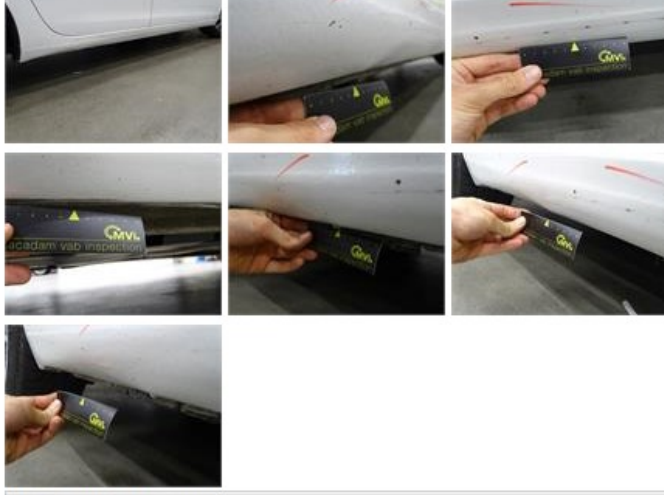
| Sill outer R, Dent(s) and scratch(es), LI - Repair and paint (complete) | 310,50 |

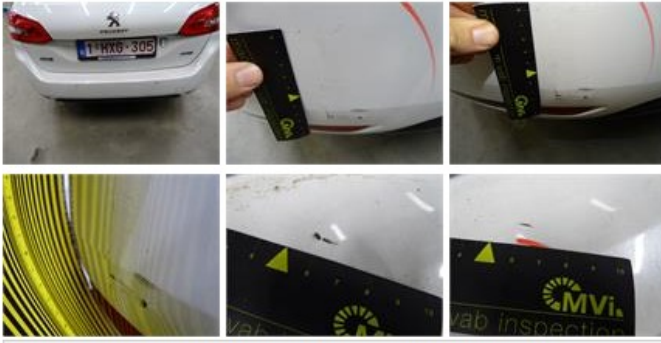
Bumper R, Dent(s) and scratch(es), LI - Repair and paint (complete)

211,80
