VOLKSWAGEN TOURAN: 1KLX355

Limited Technical Inspection

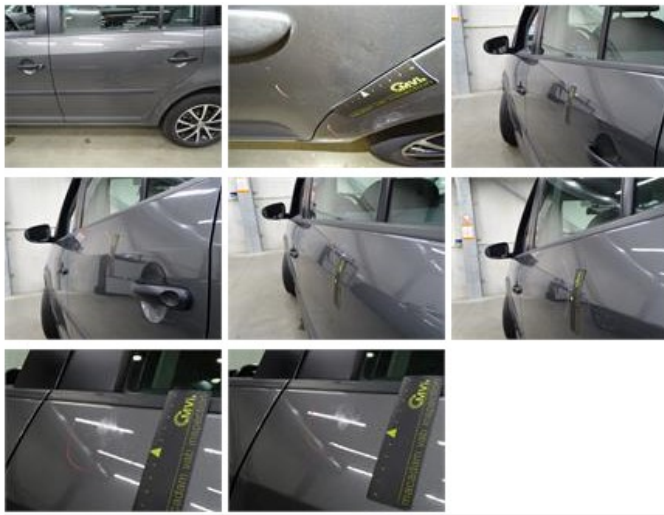
Total cost ex VAT	3417,60
Door R L, Dent(s) and scratch(es), LI - Repair and paint (complete)	318,35

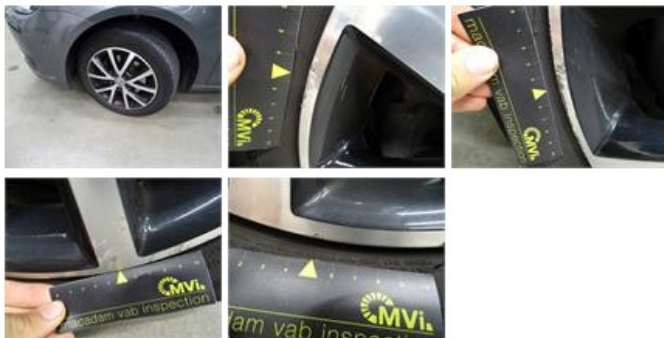
Alloy rim F L polished, Scratch(es), LI - Repair and paint (complete) 95,00

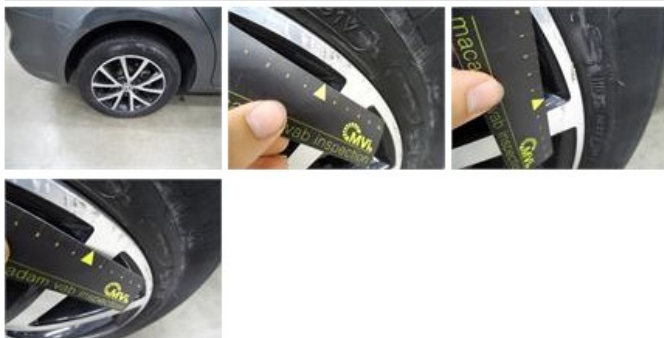
Alloy rim R R polished, Scratch(es), LI - Repair and paint (complete) 95,00

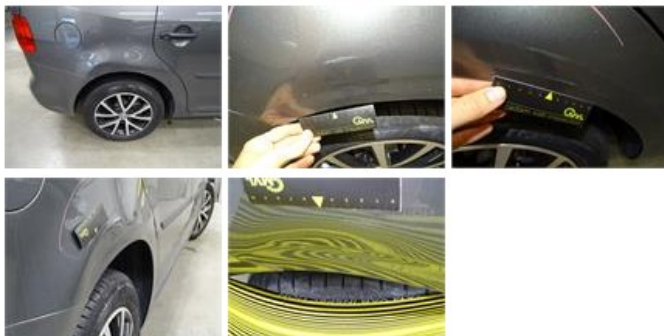
Wing R R, Dent(s) and scratch(es), LI - Repair and paint (complete) 308,20

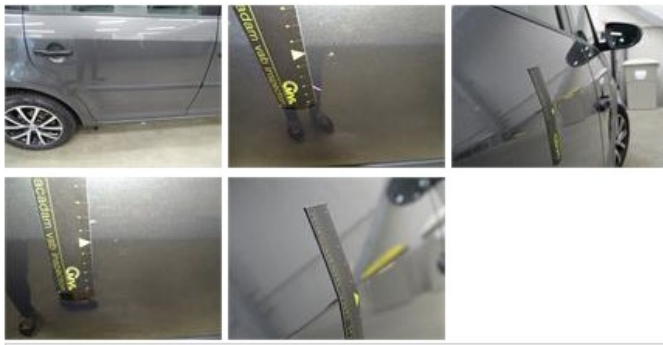
Door R R, Dent(s) and scratch(es), LI - Repair and paint (complete) 318,35

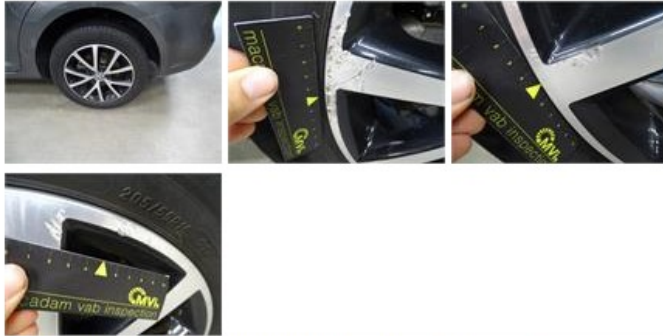
Alloy rim R L polished, Scratch(es), LI - Repair and paint (complete) 95,00

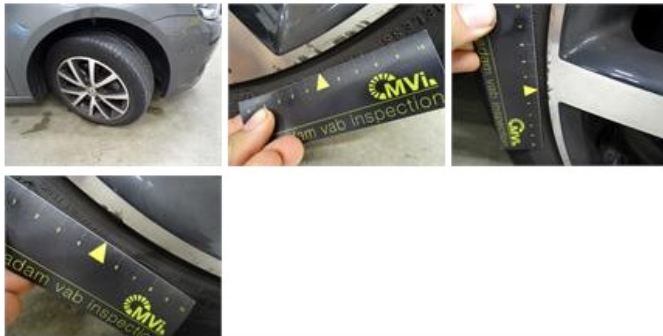
Alloy rim F R polished, Scratch(es), LI - Repair and paint (complete) 95,00

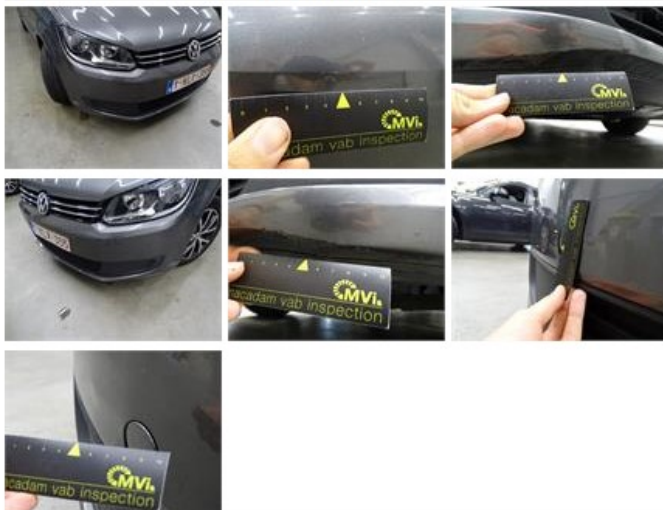
Bumper F, Scratch(es), LI - Repair and paint (complete) 211,80

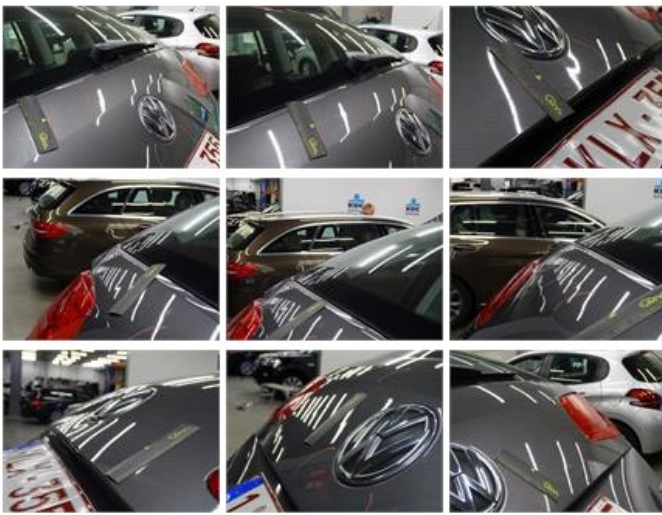
Tailgate, Dent(s), LI - Repair and paint (complete) 301,68

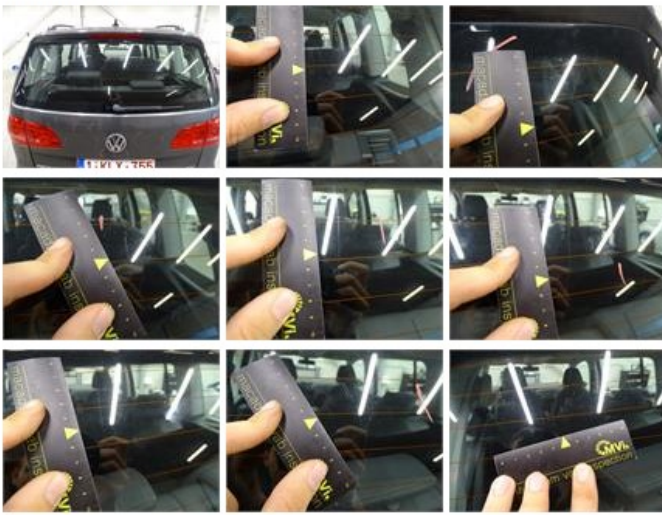
Rear window, Scratch(es), E - Replace 0,00

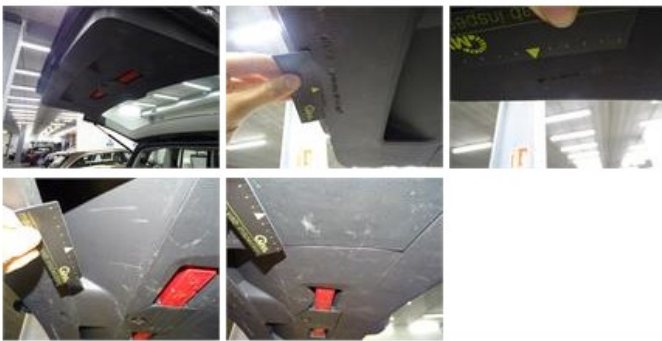
Trunk lid covering R, Scratch(es), Smart repair 110,64

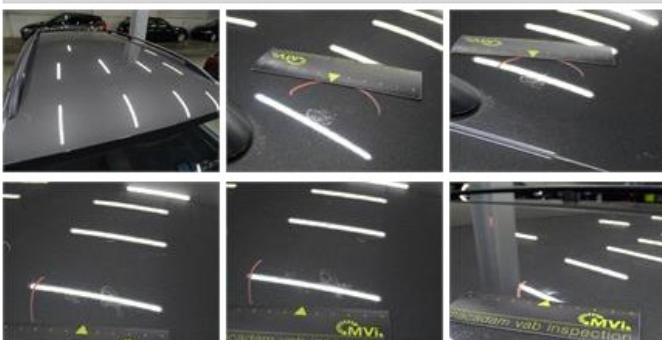
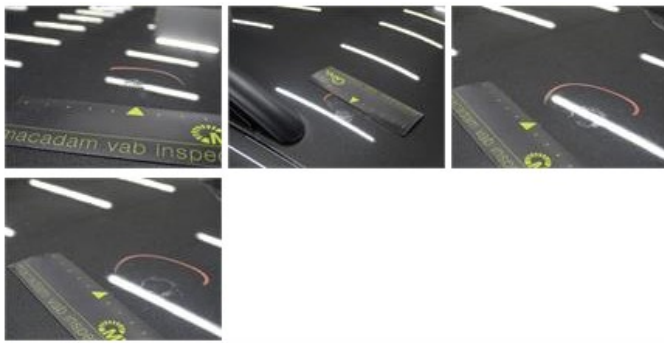
Roof, Chemical polution, LI - Repair and paint (complete) 481,50

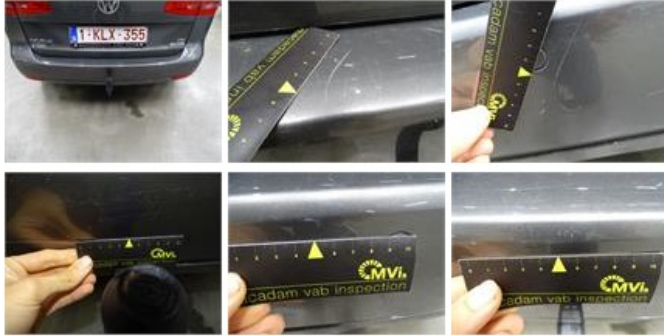
Bumper R, Scratch(es), LI - Repair and paint (complete) 211,80

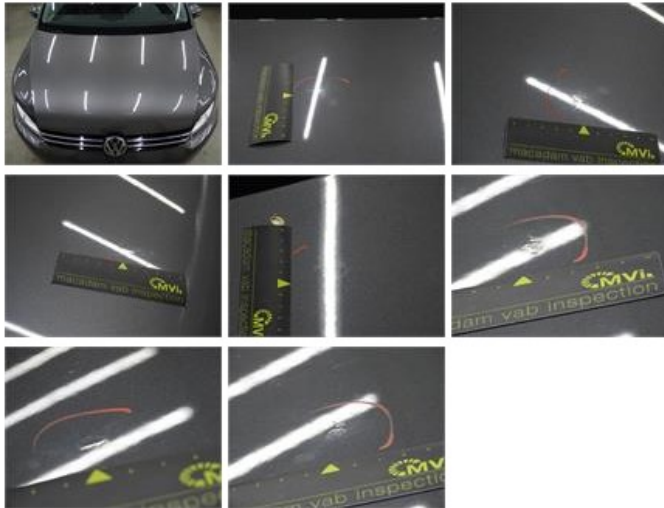
Bonnet, Chemical pollution, LI - Repair and paint (complete) 290,08
