**SKODA OCTAVIA COMBI: 1PBA337**

| Vinnumber: | <b>TMBJG9NE4G0223726</b> | Versionname: | <b>1.6 CRTDI 81KW GREENTEC AMBITION</b> |

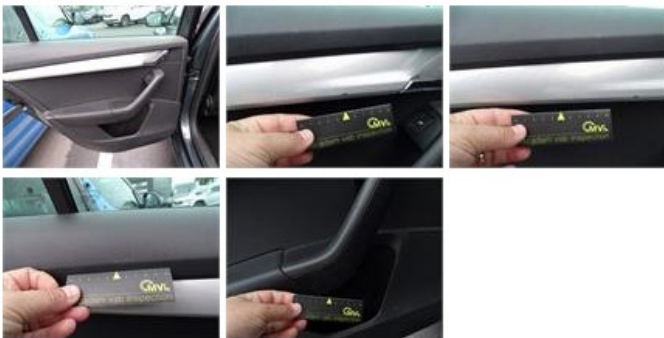
Door panel R L, Scratch(es), E - Replace
