SUZUKI VITARA: VR5877

Limited Technical Inspection

Degree of wear

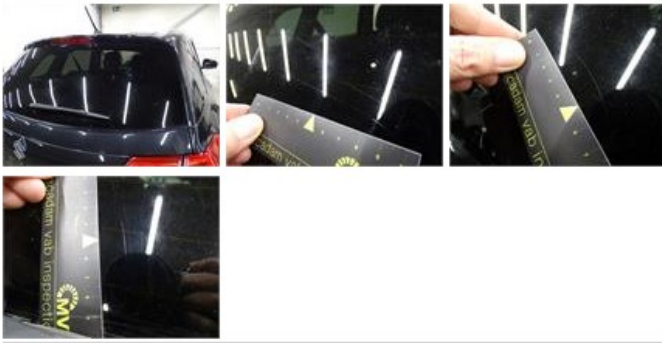
| Rear window, Scratch(es), E - Replace | 370,00 |

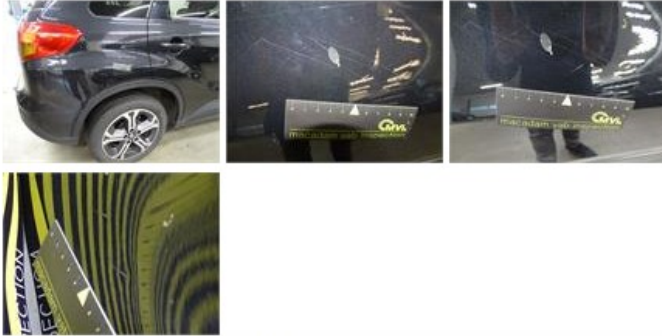
Wing R R, Dent(s) and scratch(es), LI - Repair and paint (complete) 308,20
