SKODA Superb: 1HLF941

| Vinnnummer: | TMBAJ73T3F9012647 | Versionname: | SUPERB BER GreenLine Ambition 105PK |

Limited Technical Inspection

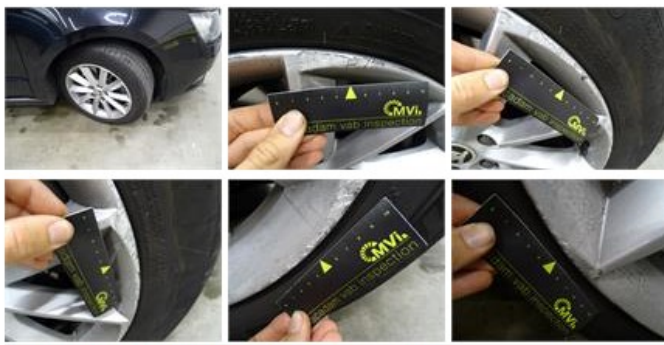
| Alloy rim F R, Scratch(es), LI - Repair and paint (complete) | 95,00 |

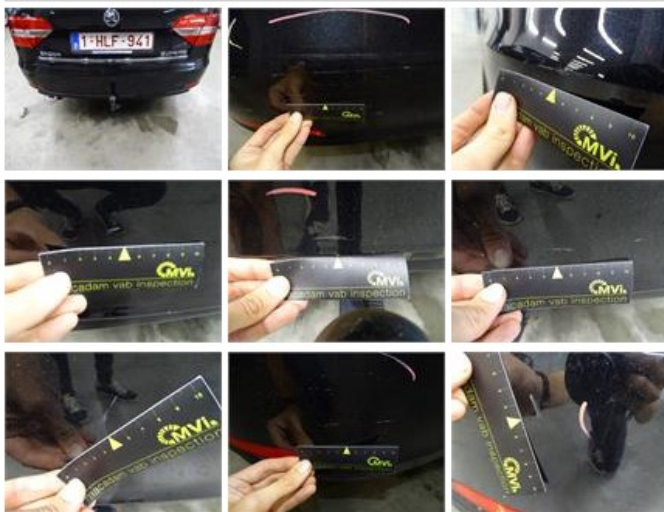
| Bumper R, Scratch(es), LI - Repair and paint (complete) | 254,16 |

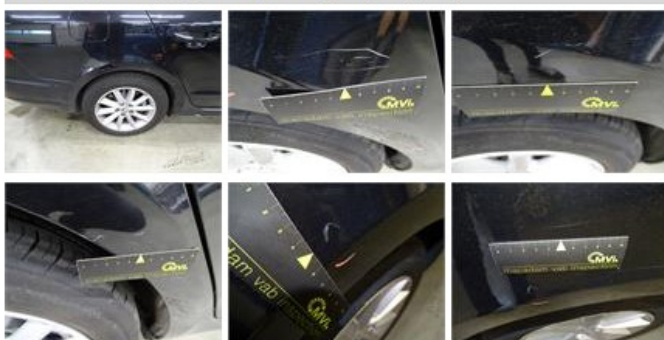
| Wing R R, Scratch(es), LI - Repair and paint (complete) | 369,84 |

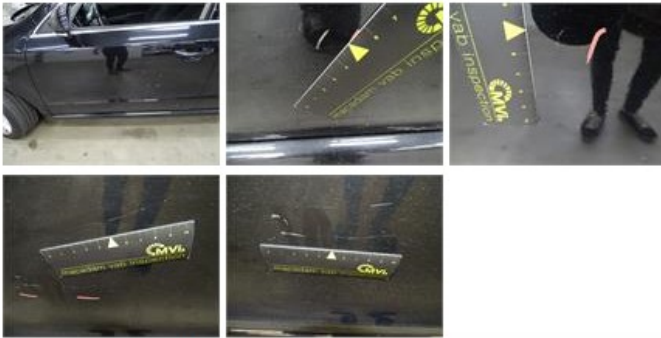
Door F L, Scratch(es), LI - Repair and paint (complete)

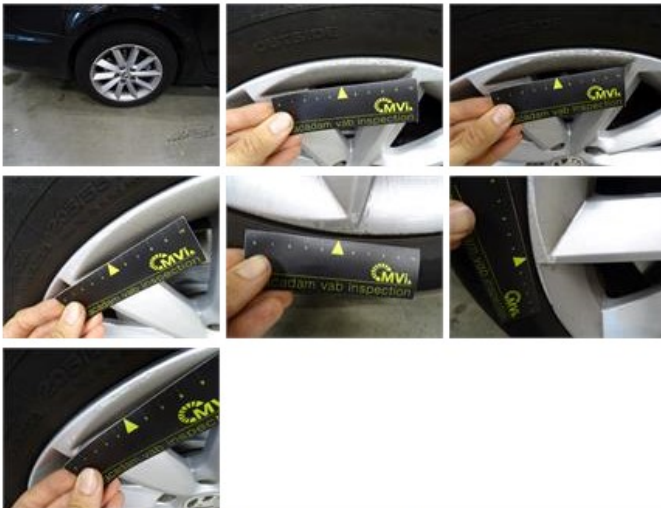
Alloy rim R R, Scratch(es), LI - Repair and paint (complete)
