**BMW 3: 1HRN628**

**Limited Technical Inspection**

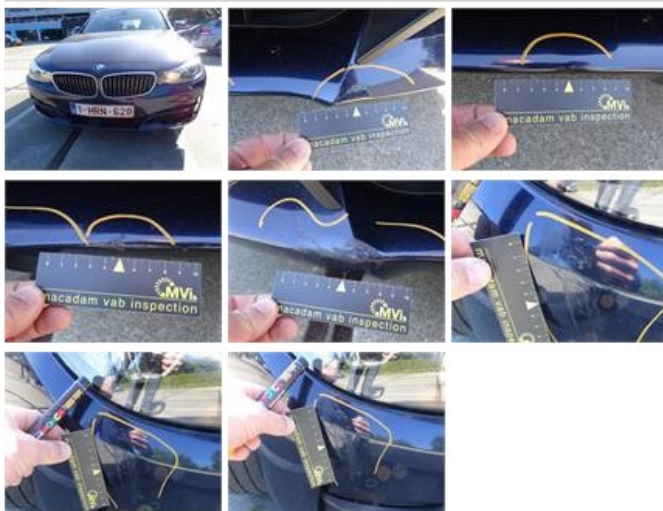
Bumper F, Dent(s) and scratch(es), LI - Repair and paint (complete) 211,80

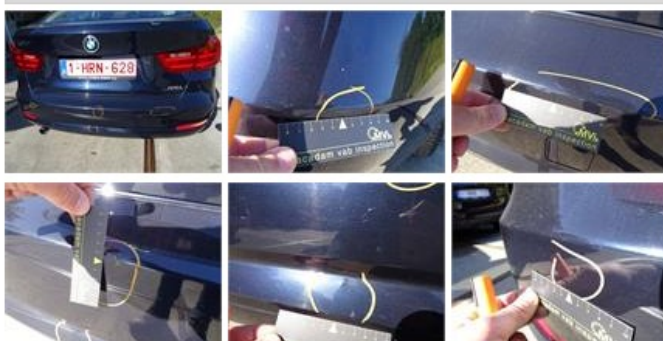
Bumper R, Scratch(es), LI - Repair and paint (complete) 211,80

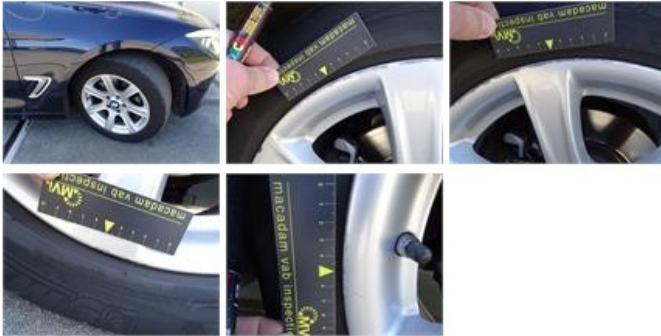
Alloy rim F R, Scratch(es), LI - Repair and paint (complete)

95,00
