AUDI A1 SPORTBACK: 1PUC638

Limited Technical Inspection

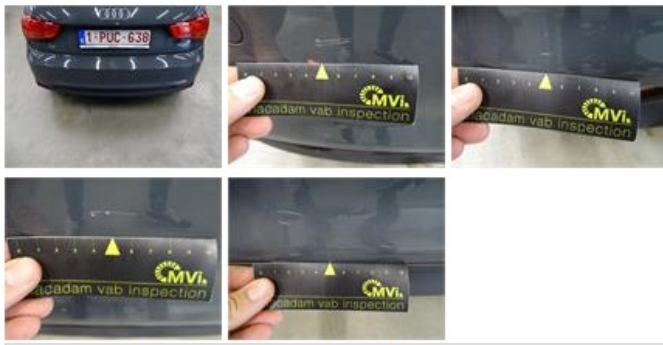
Total cost ex VAT	950,28
Bumper R, Scratch(es), LI - Repair and paint (complete)	169,44

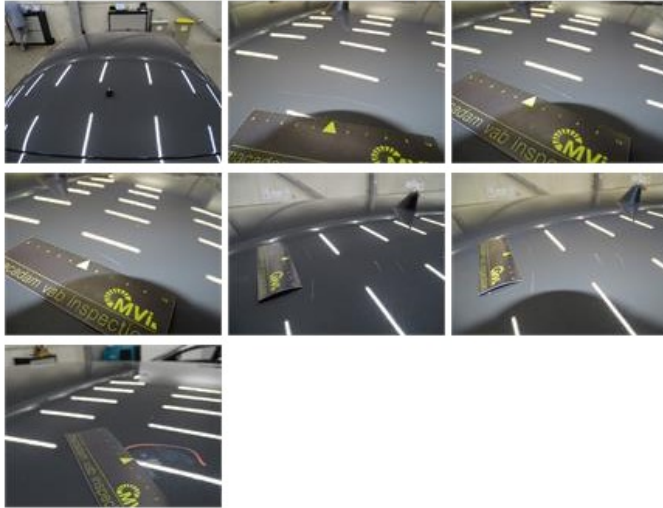
Roof, Scratch(es), LI - Repair and paint (complete)

385,20

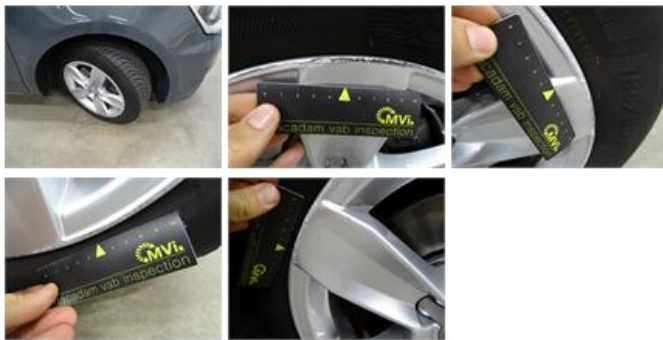
Alloy rim F R, Scratch(es), LI - Repair and paint (complete)

95,00

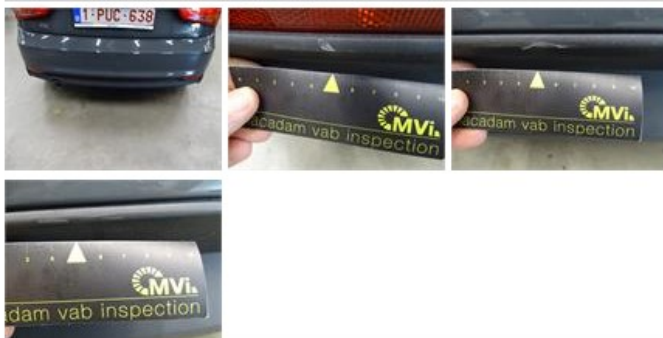
Bumper cover R M, Scratch(es), Smart repair

110,64

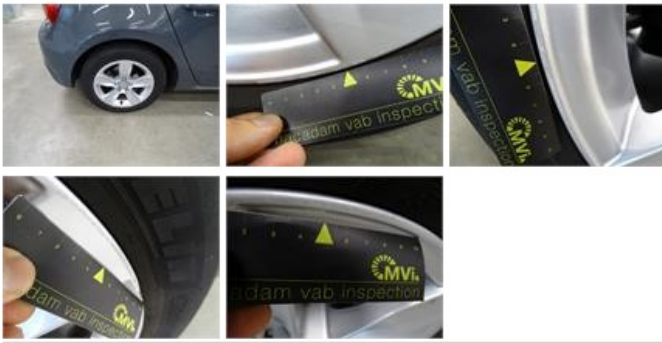
Alloy rim R R, Scratch(es), LI - Repair and paint (complete)

95,00

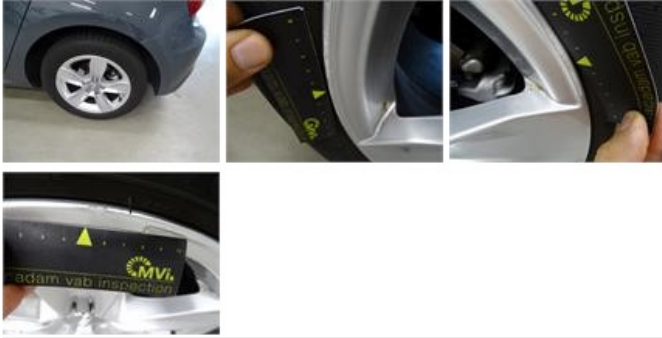
Alloy rim R L, Scratch(es), LI - Repair and paint (complete) 95,00
