**AUDI A6: 1GRP451**

**Limited Technical Inspection**

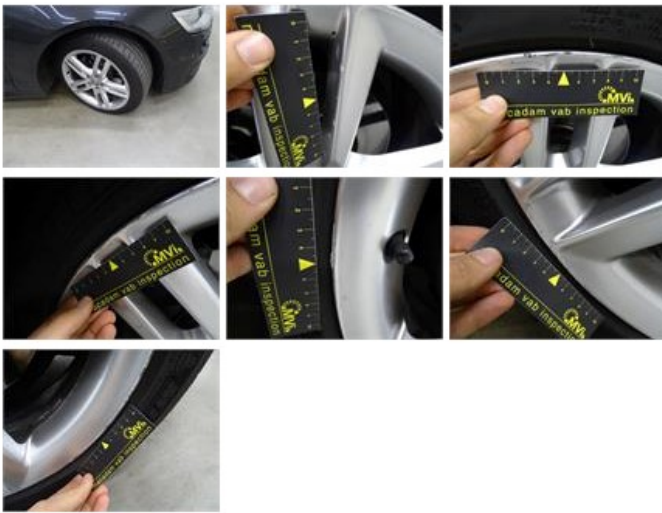
Alloy rim F R, Scratch(es), LI - Repair and paint (complete) 95,00

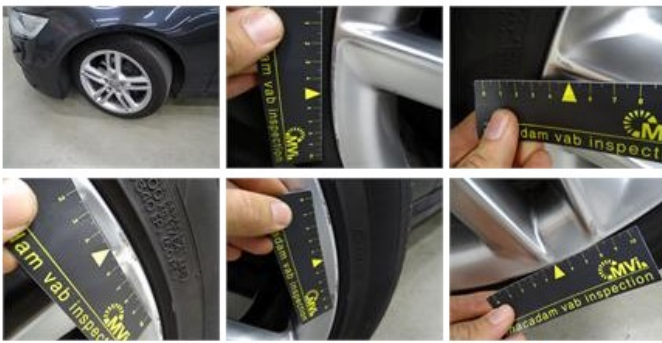
Alloy rim F L, Scratch(es), LI - Repair and paint (complete) 95,00

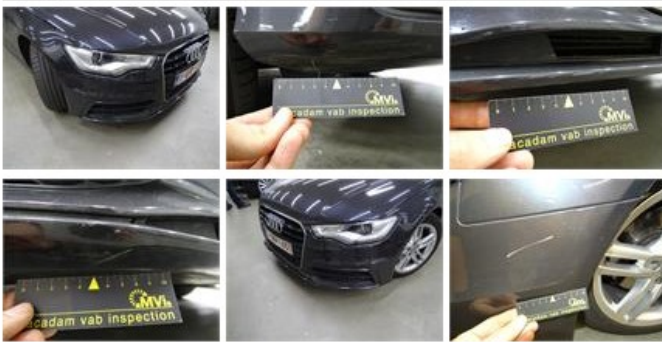
Bumper F, Scratch(es), LI - Repair and paint (complete) 254,16

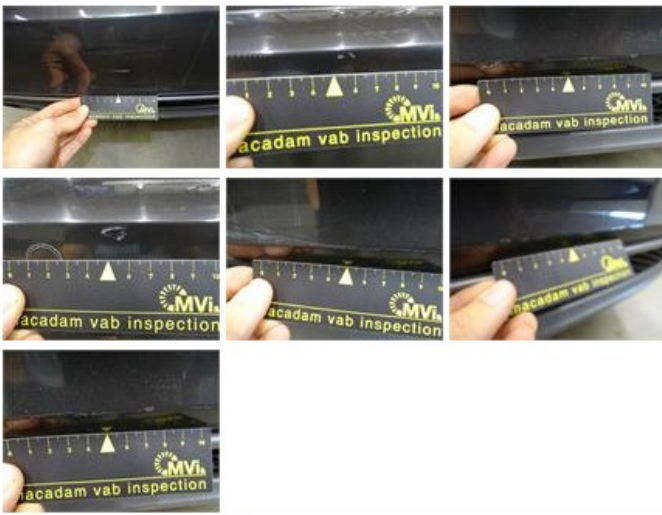
Bumper R, Scratch(es), LI - Repair and paint (complete) 254,16

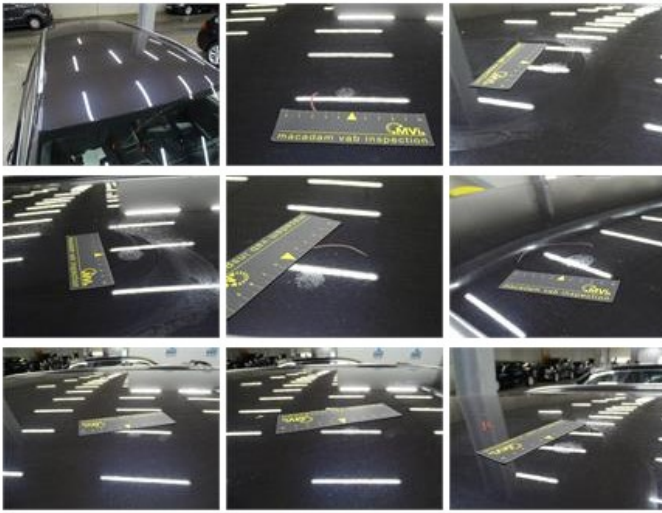
Roof, Chemical polution, LI - Repair and paint (complete)

577,80

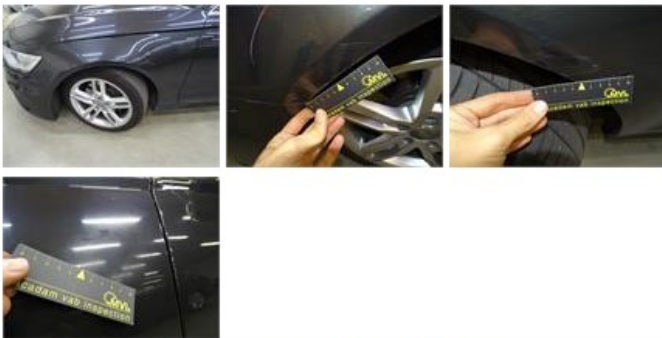
Wing F L, Scratch(es), LI - Repair and paint (complete)

264,21

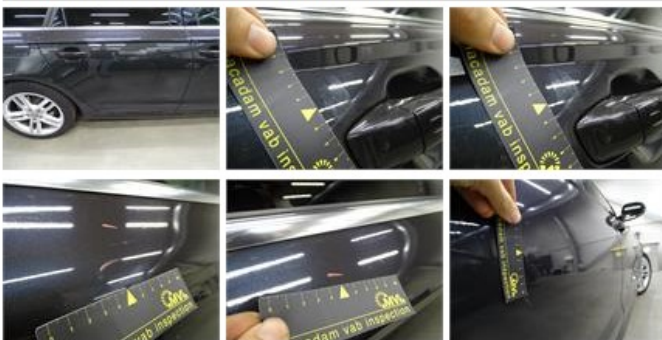
Door R R, Chemical polution, LI - Repair and paint (complete)

382,02

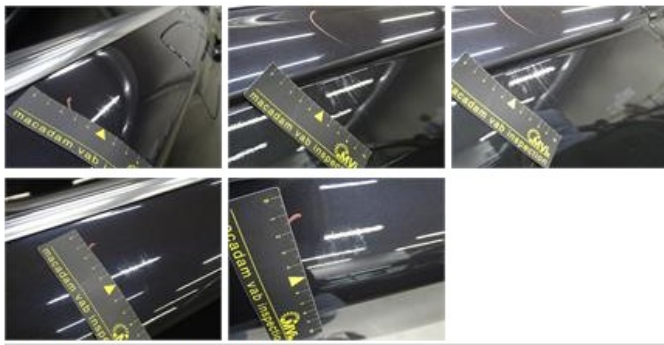
Wing R R, Chemical polution, LI - Repair and paint (complete)

369,84

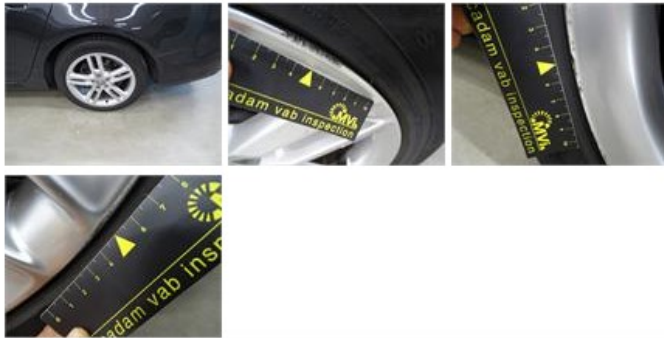
Alloy rim R L, Scratch(es), LI - Repair and paint (complete) 95,00

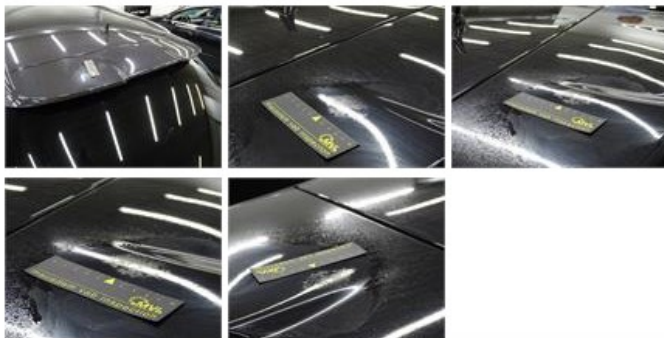
Rear spoiler, Chemical pollution, LI - Repair and paint (complete) 115,56

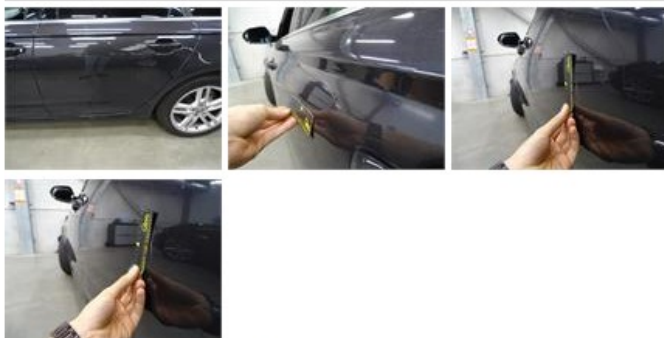
Door R L, Bad repair, Acceptable 0,00
