**BMW 2 ACTIVE TOURER: 1JLG046**

**Limited Technical Inspection**

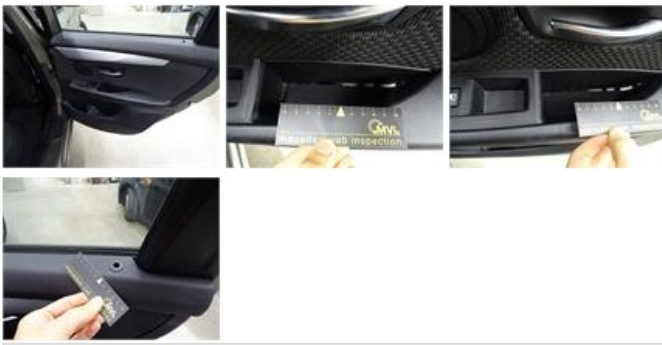
Total cost ex VAT	<b>822,20</b>
Door panel R R, Broken, E - Replace	<b>0,00</b>

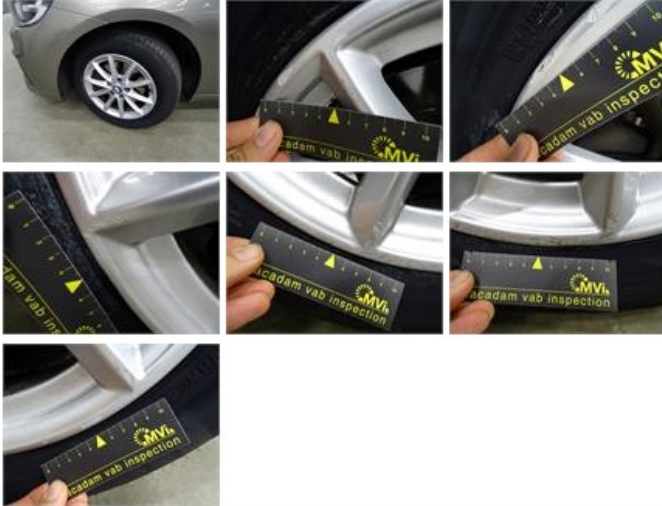
Alloy rim F L, Scratch(es), LI - Repair and paint (complete) 95,00

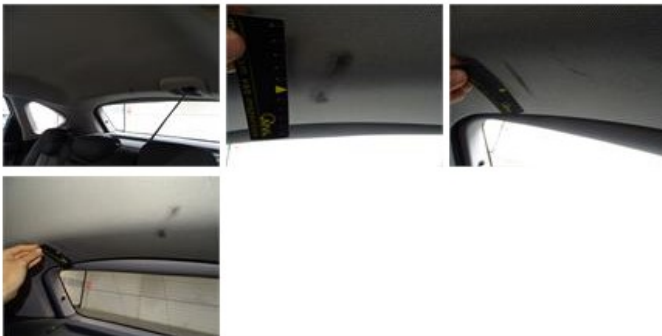
Ceiling, Dirty, Cleaning 50,00

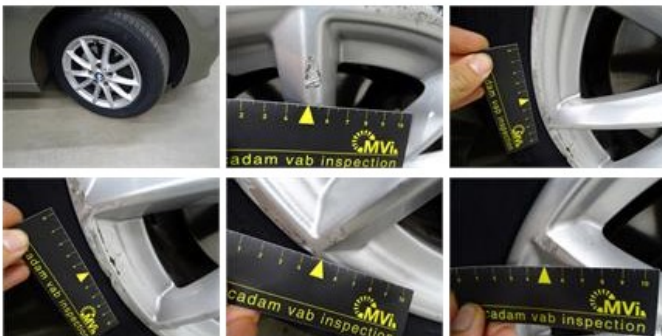
Alloy rim F R, Scratch(es), LI - Repair and paint (complete) 95,00

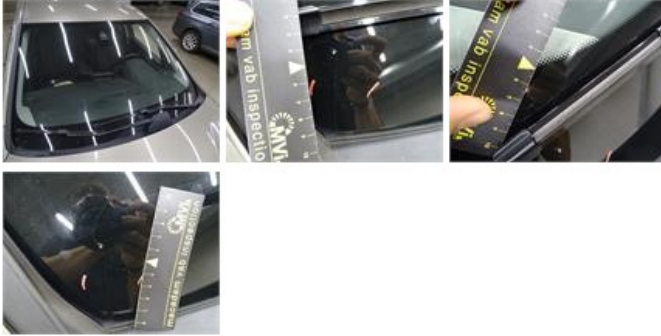
Door R L, Repaired, Acceptable	0,00
<i>No pictures to display</i>	
Roof, Dent(s), Acceptable	0,00
<i>No pictures to display</i>	
Wing F R, Scratch(es), Acceptable	0,00
<i>No pictures to display</i>	
Door frame R L, Scratch(es), Acceptable	0,00
<i>No pictures to display</i>	
Windscreen, Crack, E - Replace	487,20

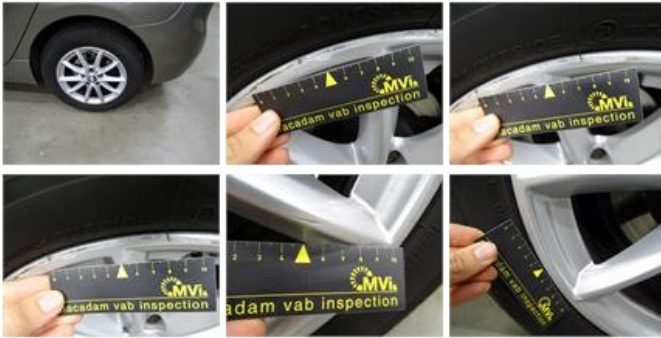
Alloy rim R L, Scratch(es), LI - Repair and paint (complete)	95,00
--	-------
