FORD KUGA: 1LDX967

Limited Technical Inspection

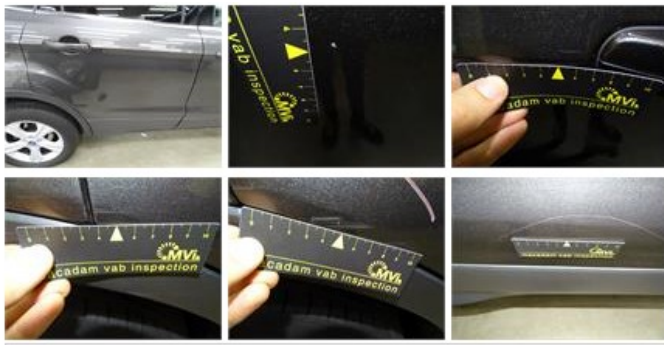
Total cost ex VAT	1065,68
Roof, Chemical polution, Acceptable	0,00
<i>No pictures to display</i>	
Door R R, Scratch(es), LI - Repair and paint (complete)	382,02

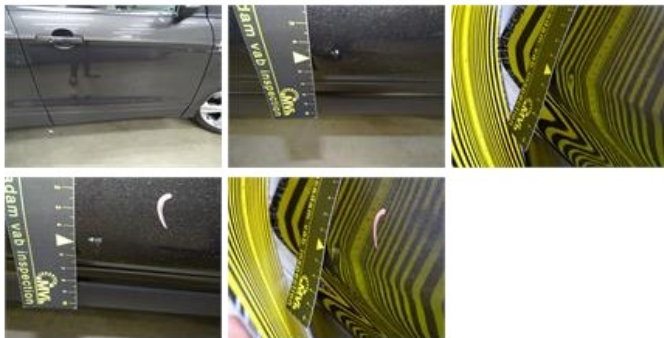
Door F R, Dent(s) and scratch(es), LI - Repair and paint (complete)

382,02

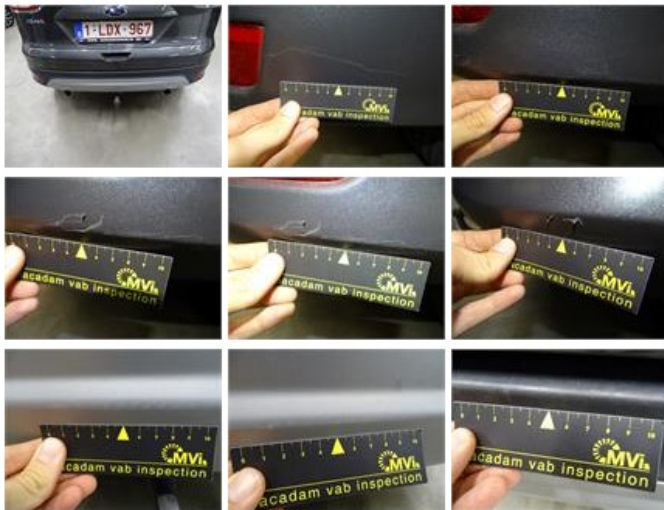
Bumper R, Scratch(es), Smart repair

110,64

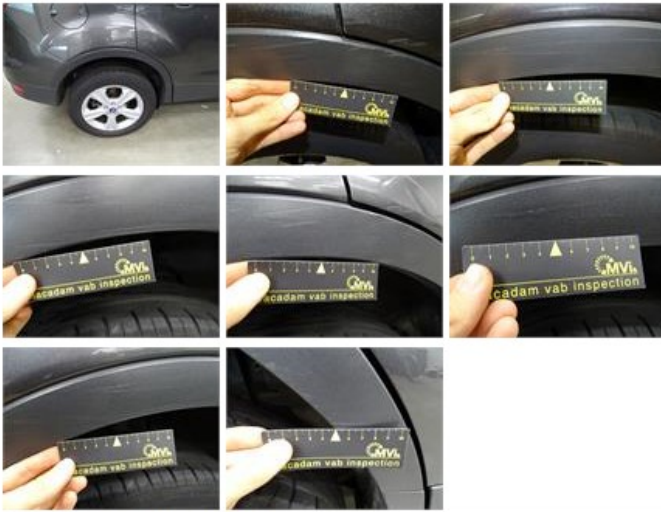
Wing trim R R, Scratch(es), E - Replace

96,00
