**MERCEDES A: 1PZF800**

**Limited Technical Inspection**

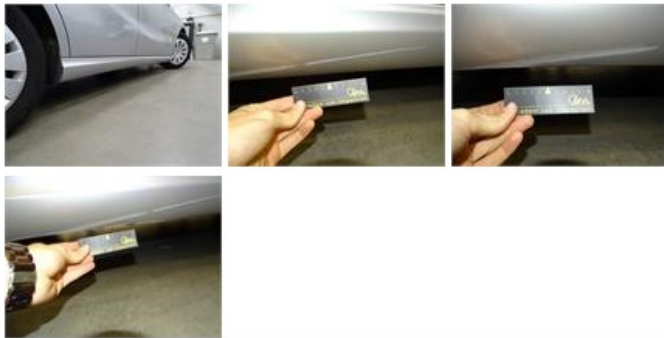
Sill outer R, Scratch(es), LI - Repair and paint (complete) 310,50

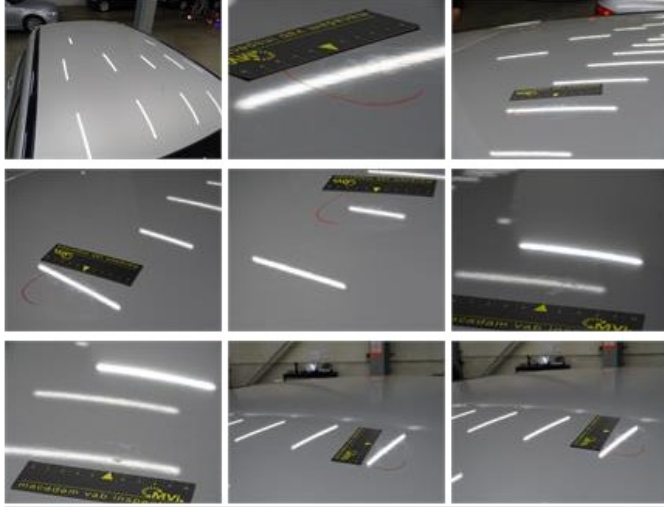
Roof, Chemical polution, LI - Repair and paint (complete) 481,50

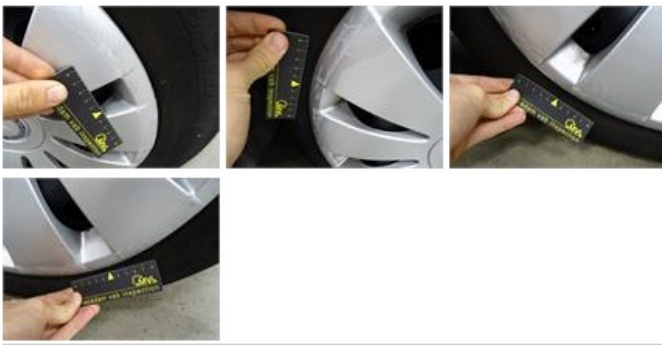
Wheel cover F R, Scratch(es), E - Replace 30,00

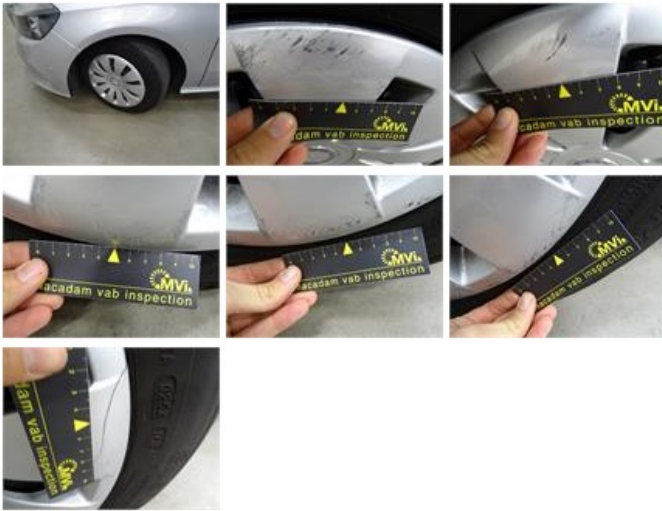
Wheel cover F L, Broken, E - Replace 30,00

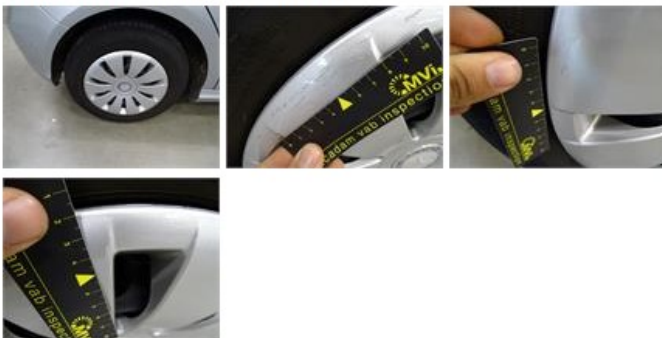
Wheel cover R R, Scratch(es), E - Replace 30,00

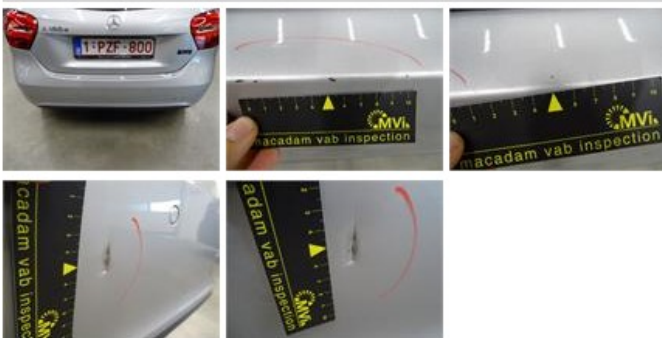
Bumper R, Dent(s) and scratch(es), LI - Repair and paint (complete) 211,80

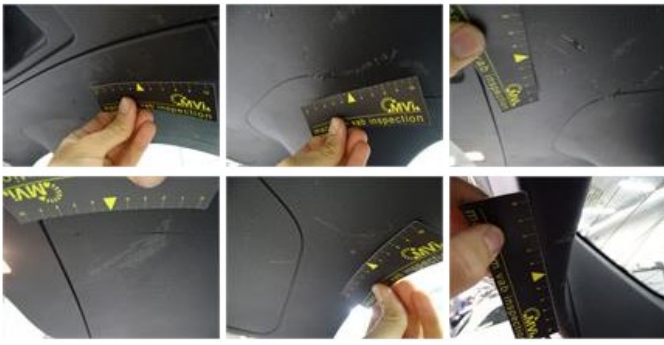
Trunk lid covering R, Scratch(es), Smart repair 110,64
