BMW 1: 1EZQ802			
Vinnumber:	<b>WBA1C91020J510761</b>	Versionname:	<b>1 HATCH 116d Eff.Dyn.Ed. 116PK</b>
First Registrationdate:	<b>30/04/2013</b>	Fiscalpower:	
Expertise Mileage:	<b>169126</b>	Power Kw:	<b>85</b>
Bodytype:		Body color:	<b>Black</b>
Gearbox:	<b>MAN 6 VIT</b>	Paint type:	<b>Metalic</b>
Transmission:	<b>Back</b>	Rims summer:	<b>Aluminium</b>
Fueltype:	<b>Diesel</b>	Oil level:	<b>OK</b>
Battery functioning:	<b>Yes</b>	Parking lot:	<b>2327</b>
Number of doors:	<b>5</b>		
Number of seats:	<b>5</b>		
Number head rests:	<b>5</b>		
Rims summer:	<b>Aluminium</b>		
Category:	<b>Passenger Car</b>		
Oil level:	<b>OK</b>

Total cost ex VAT 1069,16

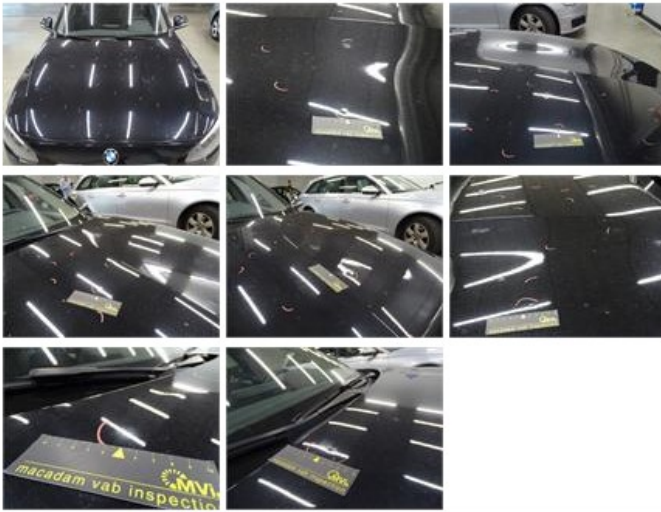
Bonnet, Hail damage, Le - Replace and paint

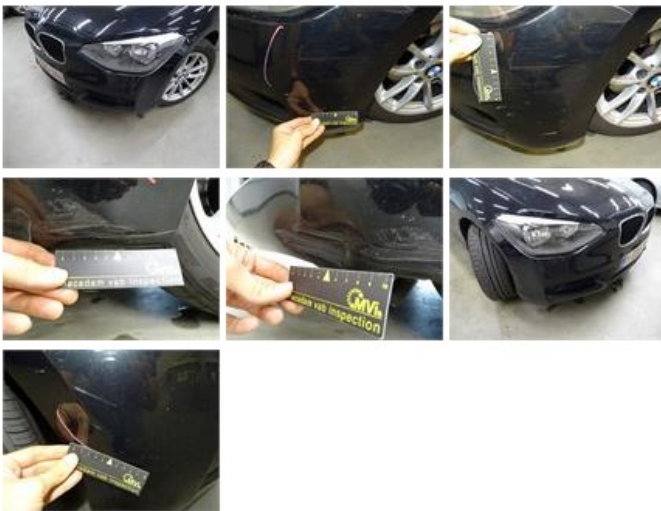
Bumper F, Dent(s) and scratch(es), LI - Repair and paint (complete)

211,80

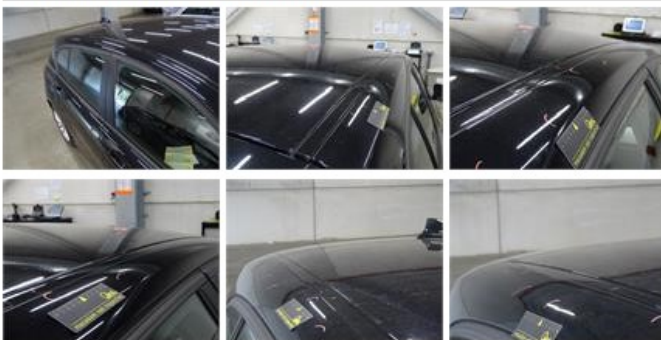
Roof pillar R, Hail damage, PDR - Hail

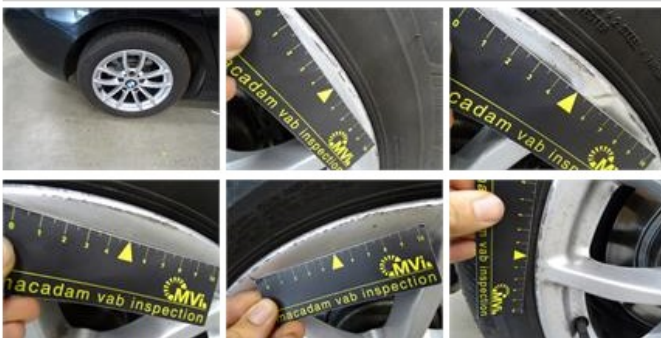
Alloy rim R R, Scratch(es), LI - Repair and paint (complete)

95,00

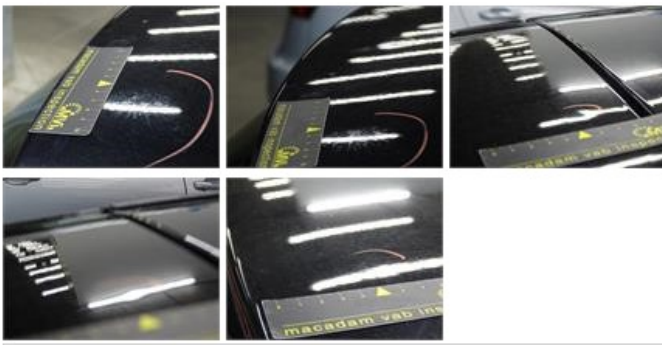
Rear spoiler, Chemical polution, LI - Repair and paint (complete)

115,56

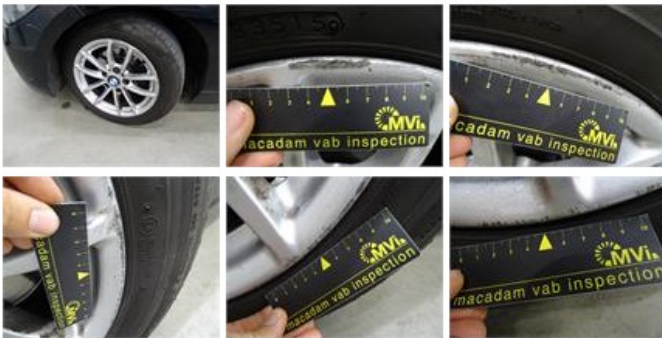
Alloy rim F L, Scratch(es), LI - Repair and paint (complete) 95,00

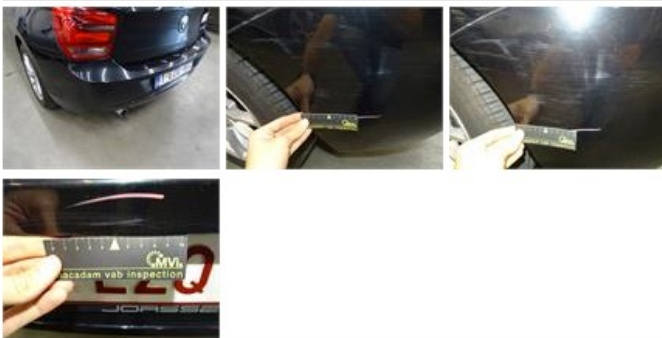
Bumper R, Scratch(es), LI - Repair and paint (complete) 211,80

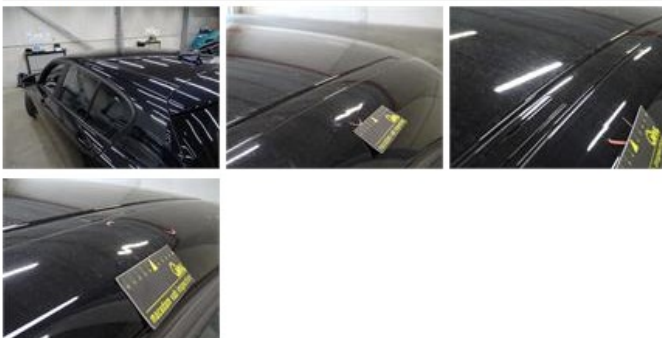
Roof pillar L, Hail damage, PDR - Hail 0,00

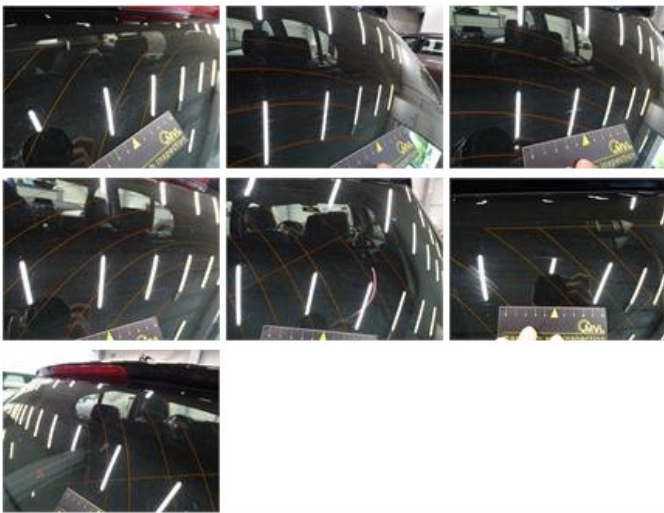
Rear window, Scratch(es), E - Replace 0,00

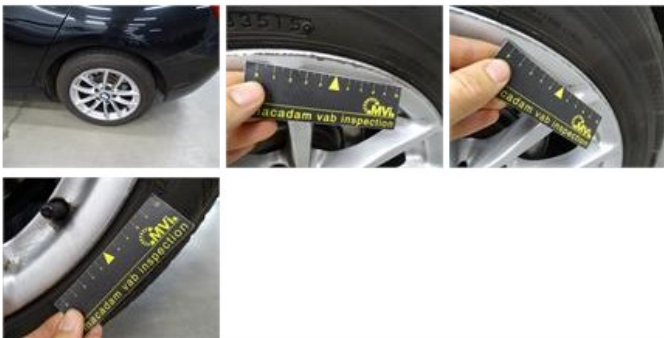
Alloy rim R L, Scratch(es), LI - Repair and paint (complete)

95,00

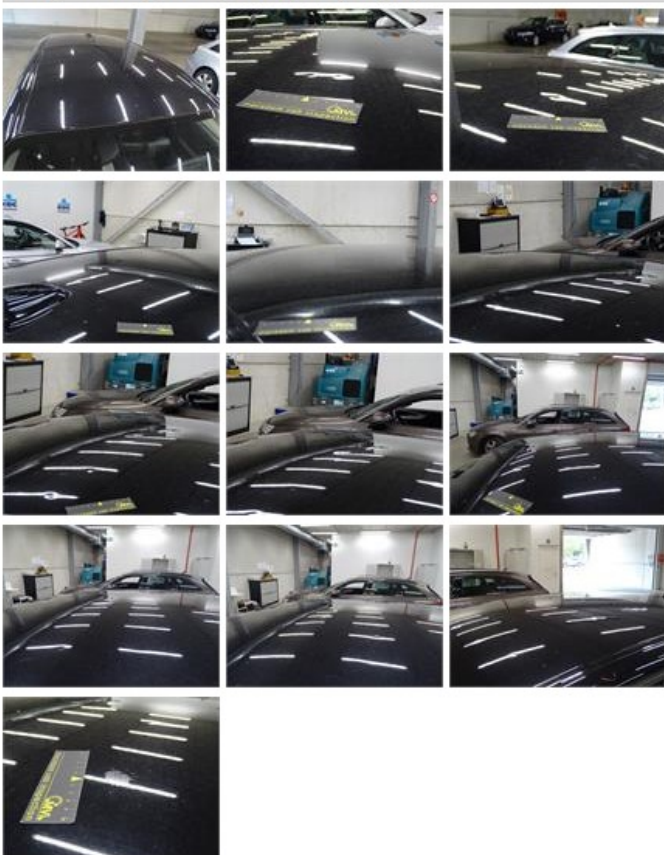
Roof, Hail damage, LI - Repair and paint (complete)
