AUDI A3 SPORTBACK: 1LFB564

| Vinnumber: | WAUZZZ8V6GA019218 | Versionname: | 1.6 TDI 81KW AMBITION |

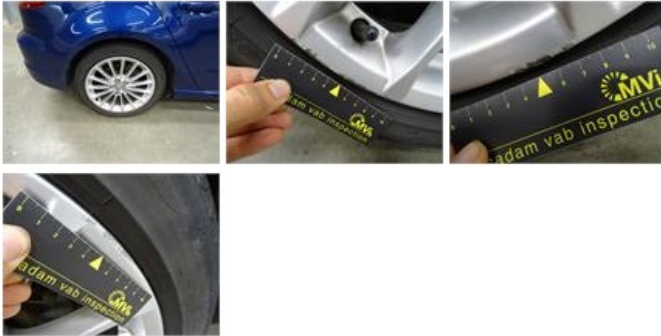
| Alloy rim R R, Scratch(es), LI - Repair and paint (complete) | 95,00 |

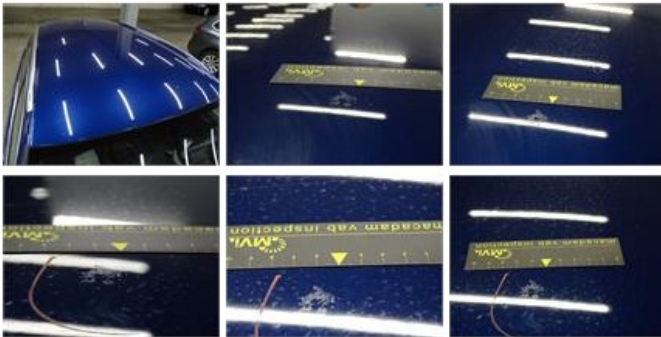
| Roof, Chemical polution, LI - Repair and paint (complete) | 481,50 |
