**OPEL Insignia: 1HEJ592**

**Limited Technical Inspection**

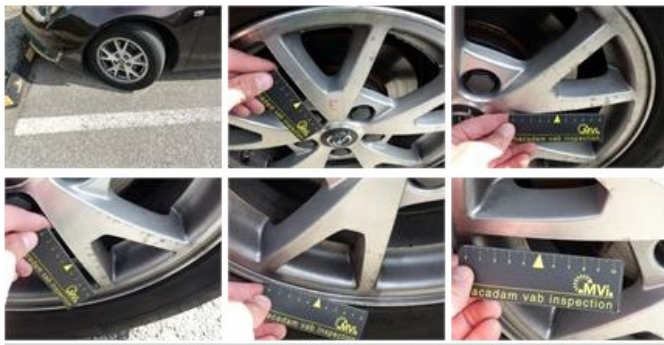
Total cost ex VAT	<b>1296,36</b>
Bumper R, Scratch(es), Acceptable	<b>0,00</b>
<i>No pictures to display</i>	
Alloy rim F L polished, Chemical polution, E - Replace	<b>235,20</b>

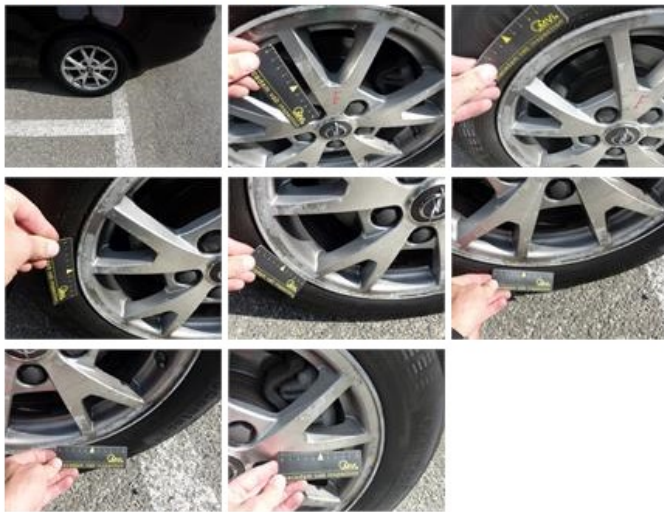
Alloy rim R L polished, Chemical polution, E - Replace 235,20

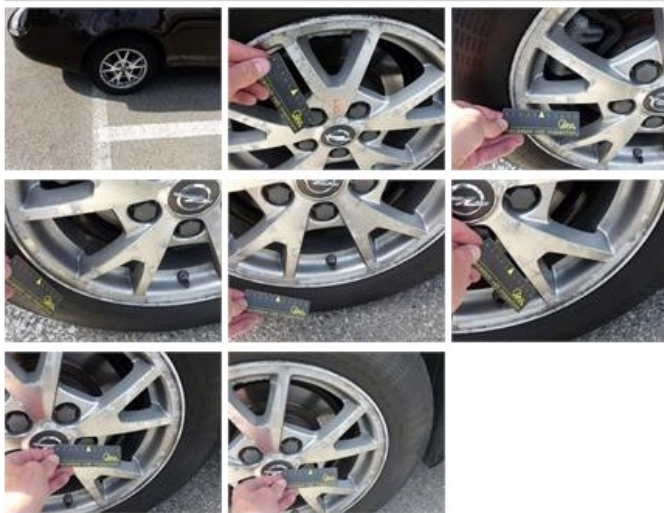
Alloy rim R R polished, Chemical polution, E - Replace 235,20

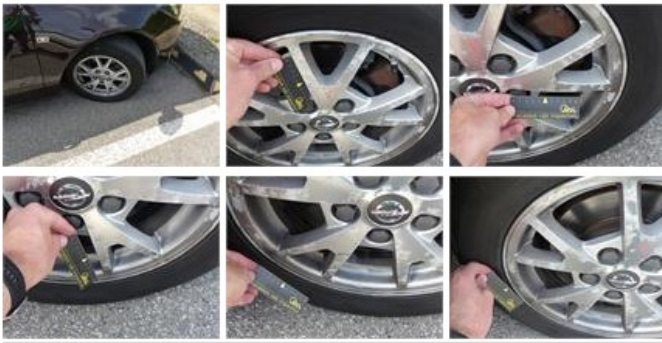
Alloy rim F R polished, Chemical polution, E - Replace 235,20

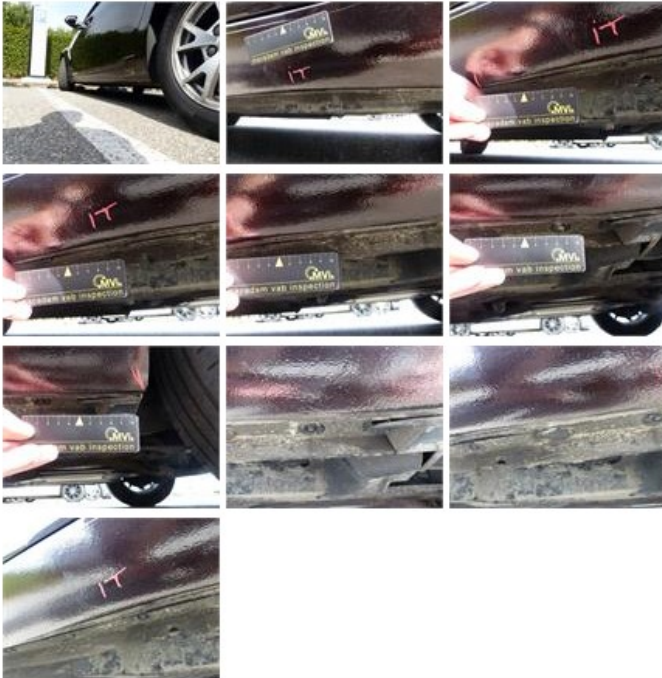
Sill outer L, Scratch(es), It - Spot repair

115,56
