<b>MERCEDES GLA: TN8318</b>			
Vinnumber:	<b>WDC1569081J421869</b>	Versionname:	<b>GLA 200 d</b>
First Registrationdate:	<b>5/09/2017</b>	Fiscalpower:	
Expertise Mileage:	<b>52995</b>	Power Kw:	<b>100</b>
Bodytype:		Body color:	<b>Black</b>
Gearbox:	<b>MAN 6 VIT</b>	Paint type:	<b>Metalic</b>
Transmission:		Rims summer:	<b>Aluminium</b>
Fueltype:	<b>Diesel</b>	Oil level:	<b>OK</b>
Battery functioning:	<b>Yes</b>	Parking lot:	<b>2302</b>
Number of doors:	<b>5</b>		
Number of seats:	<b>5</b>		
Number head rests:	<b>5</b>		
Rims summer:	<b>Aluminium</b>		
Category:	<b>Passenger Car</b>		
Oil level:	<b>OK</b>

<b>Limited Technical Inspection</b>			
Airco functioning	<b>OK</b>	Battery functioning	<b>Yes</b>
Tires wear profile	<b>OK</b>	Power steering	<b>Yes</b>
Idle position	<b>OK</b>	Sound engine	<b>OK</b>
Engine startingtime	<b>OK</b>	Clutch test	<b>OK</b>
Exhaust gass	<b>OK</b>	Wiper fluid level	<b>OK</b>
Handbrake	<b>OK</b>	Transmission	<b>OK</b>
		Lighting	<b>OK</b>
		Wiperblades	<b>OK</b>

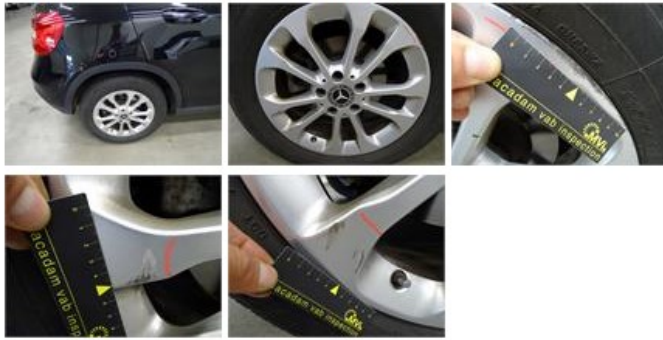
Alloy rim R R, Scratch(es), LI - Repair and paint (complete)

95,00

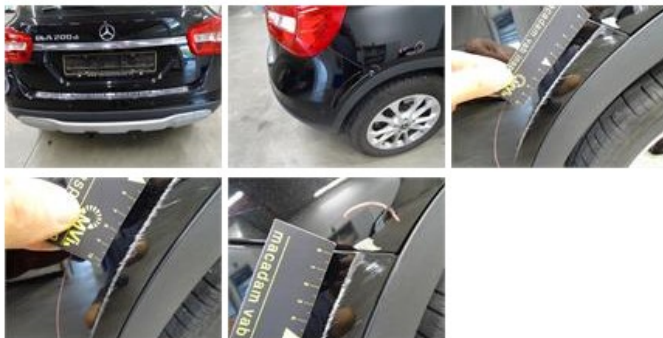
Bumper R, Scratch(es), LI - Repair and paint (complete)

254,16
