OPEL Zafira: 1HRH941

Limited Technical Inspection

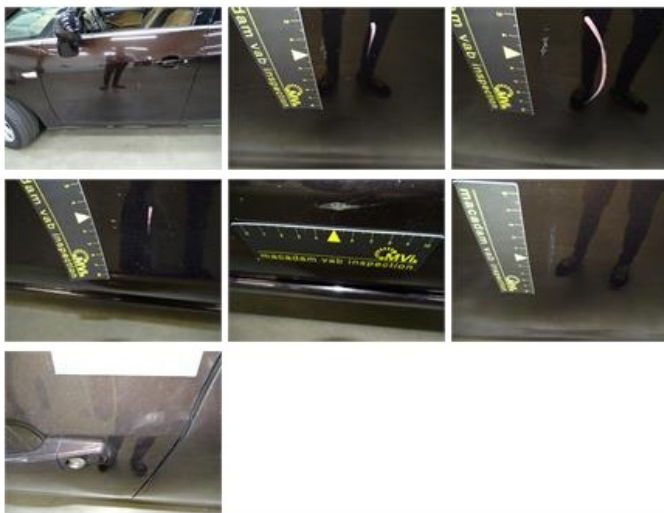
Total cost ex VAT		2097,27
Rearview mirror housing L, Scratch(es), Acceptable		0,00
<i>No pictures to display</i>		
Door F L, Scratch(es), LI - Repair and paint (complete)		318,35

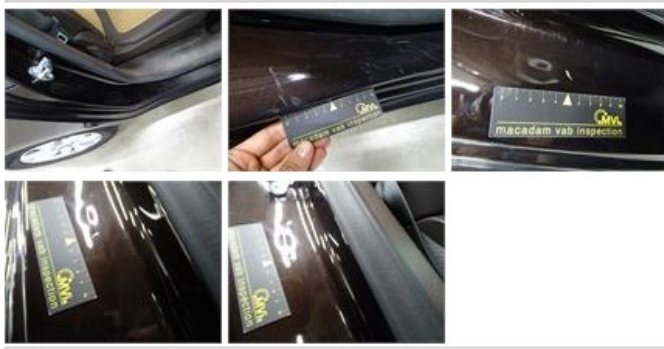
Rocker panel inner R R, Dent(s), LI - Repair and paint (complete) 115,56

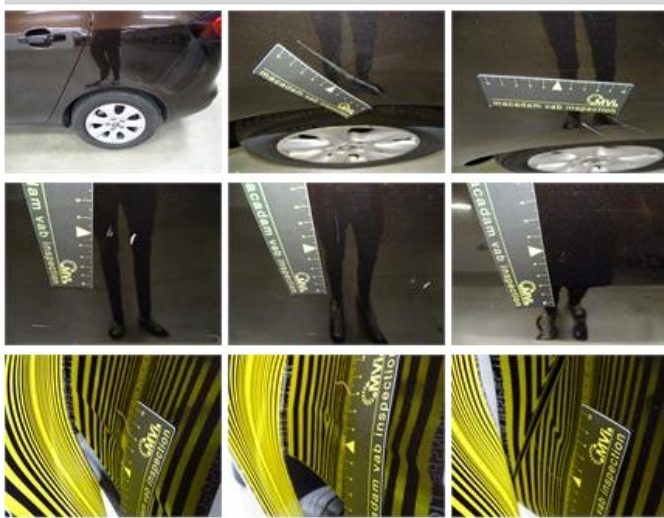
Wing R L, Dent(s) and scratch(es), LI - Repair and paint (complete) 308,20

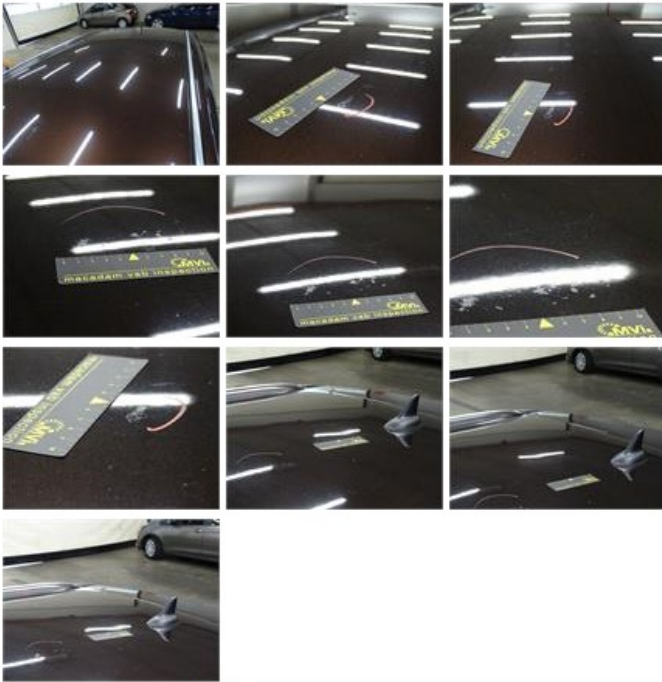
Roof, Chemical pollution, LI - Repair and paint (complete)

481,50

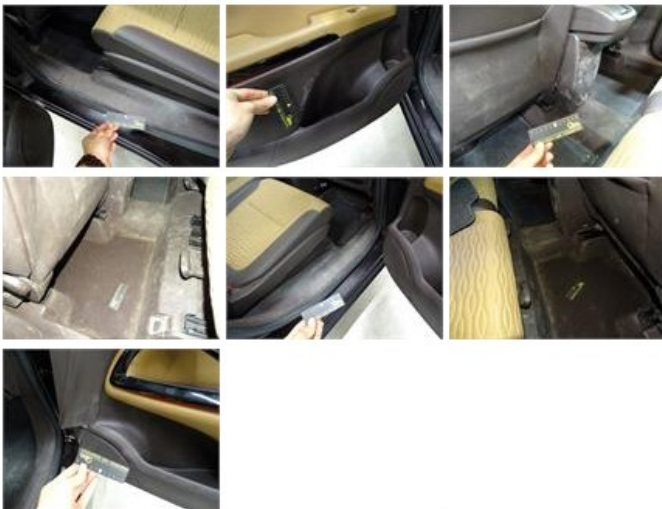
Floor covering F L, Hole, Smart repair

64,32

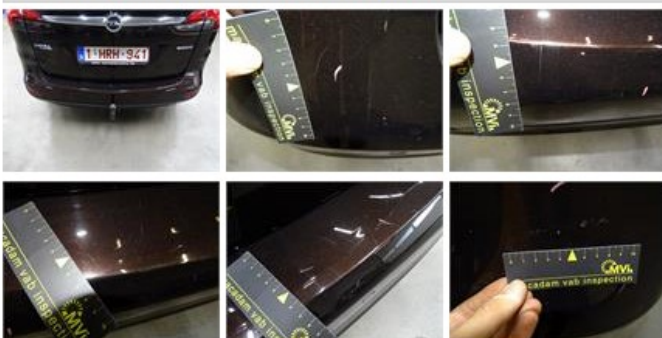
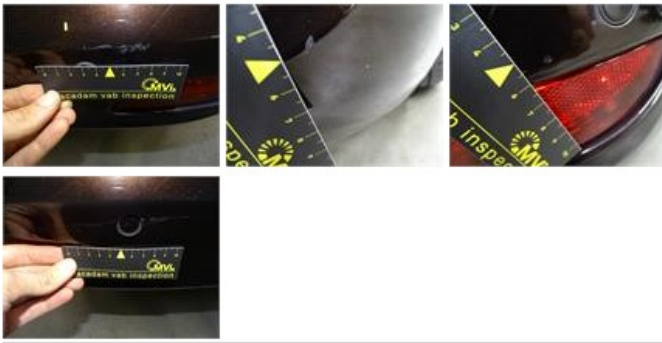
Bumper R, Scratch(es), LI - Repair and paint (complete)

211,80

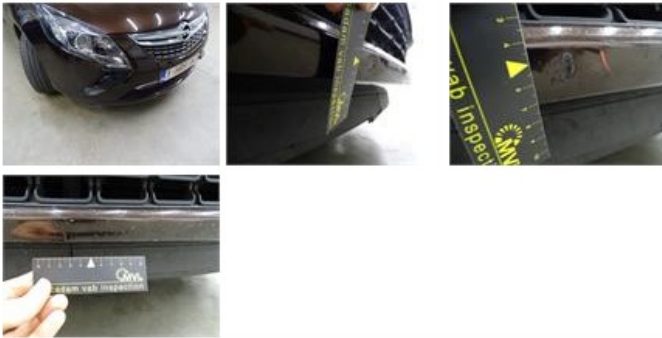
Bumper F, Dent(s) and scratch(es), LI - Repair and paint (complete) 211,80

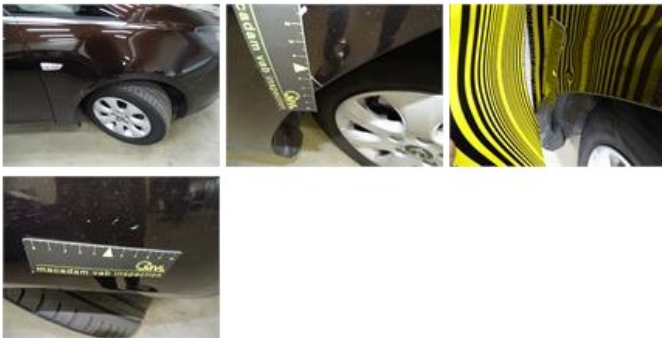
Wing F R, Dent(s) and scratch(es), LI - Repair and paint (complete) 220,18
