VOLVO V60: 1GRJ661

Limited Technical Inspection

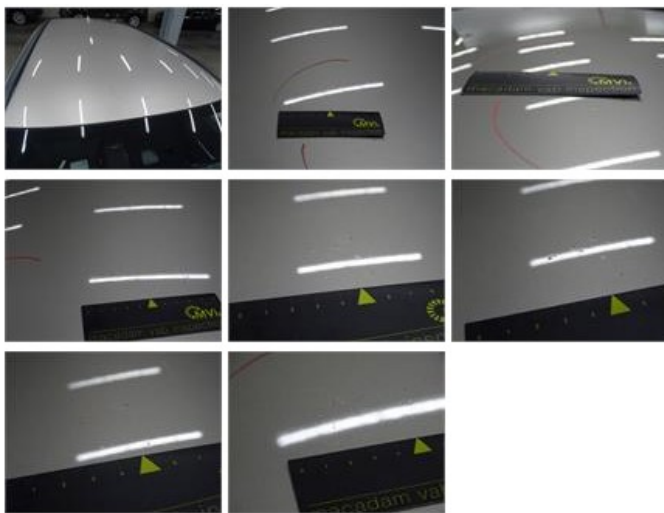
Total cost ex VAT	1421,83
Roof, Chemical polution, LI - Repair and paint (complete)	481,50

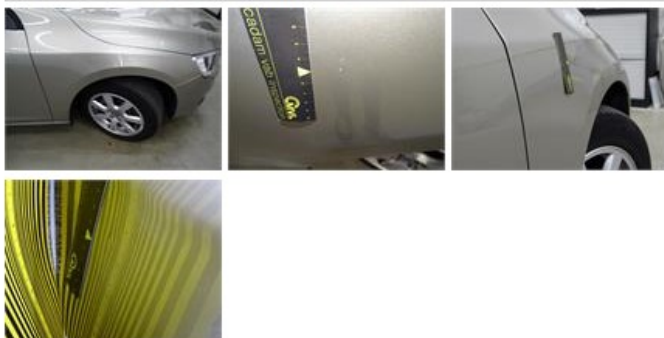
Wing F R, Dent(s) and scratch(es), LI - Repair and paint (complete)

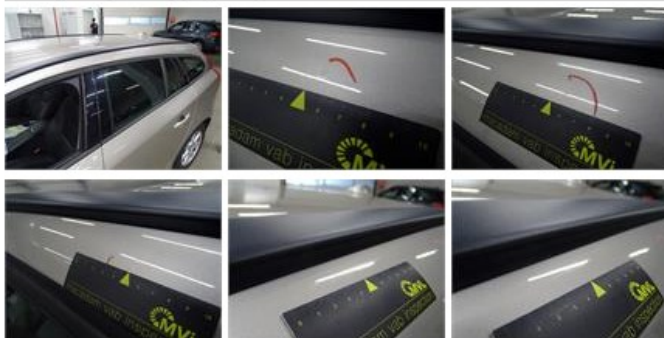
Roof pillar L, Bad repair, Acceptable

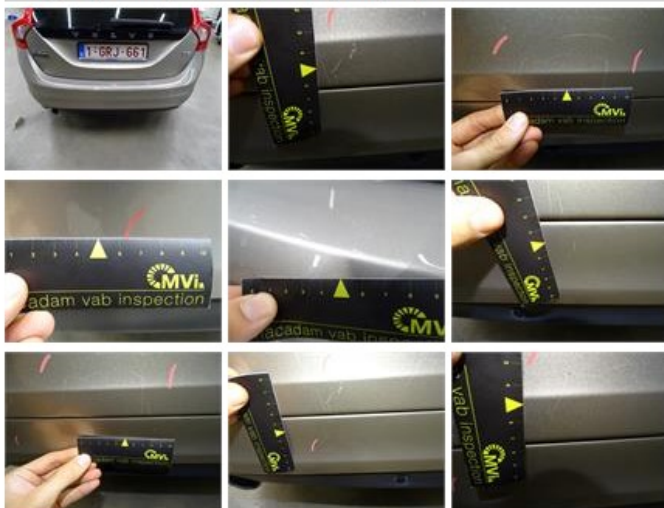
Bumper R, Scratch(es), LI - Repair and paint (complete)
