VOLVO V60: 1KKG058

Limited Technical Inspection

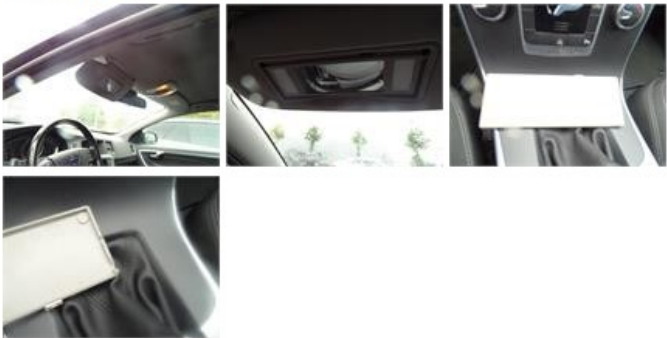
Interior, Stain, Acceptable		0,00
<i>No pictures to display</i>		
Sunblind L, Broken, E - Replace		150,00

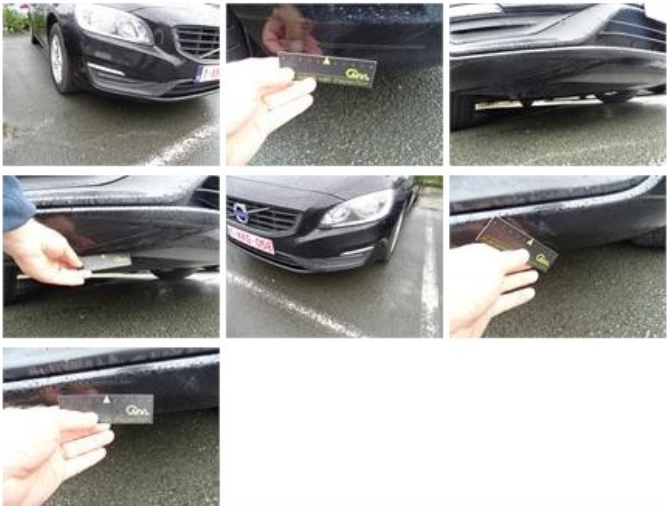
Door F R, Scratch(es), Acceptable		0,00
<i>No pictures to display</i>		
Bumper F, Scratch(es), It - Spot repair		115,56
