VOLVO V40: 1KDS101

Limited Technical Inspection

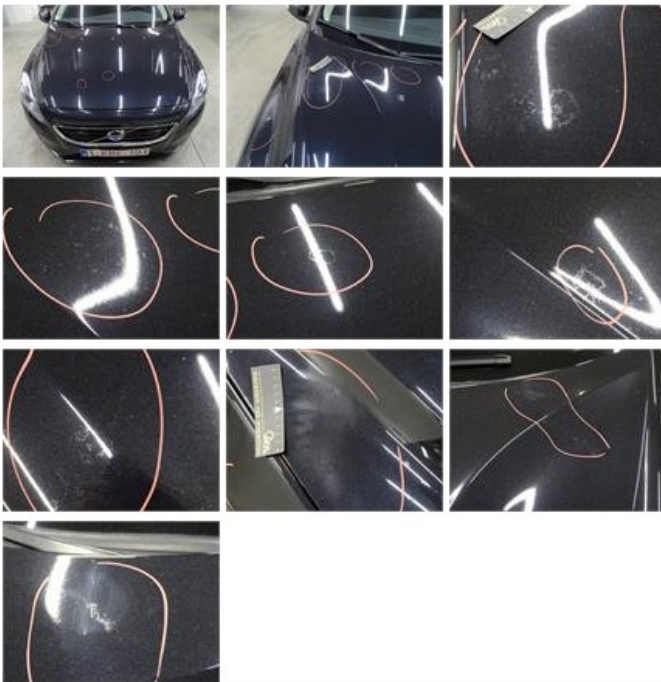
Bonnet, Chemical polution, LI - Repair and paint (complete)

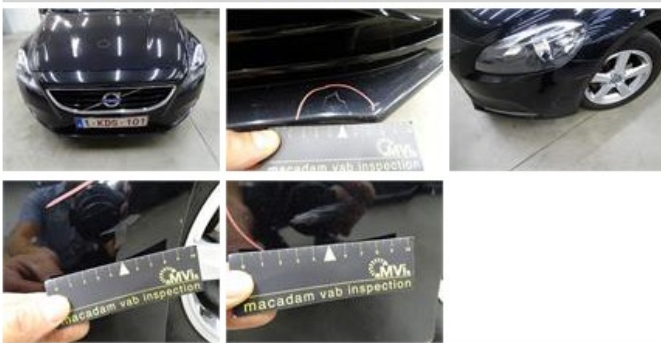
Bumper F, Scratch(es), LI - Repair and paint (complete)

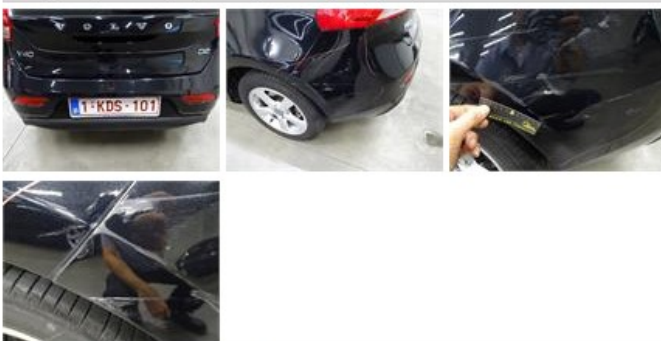
Bumper R, Scratch(es), LI - Repair and paint (complete)

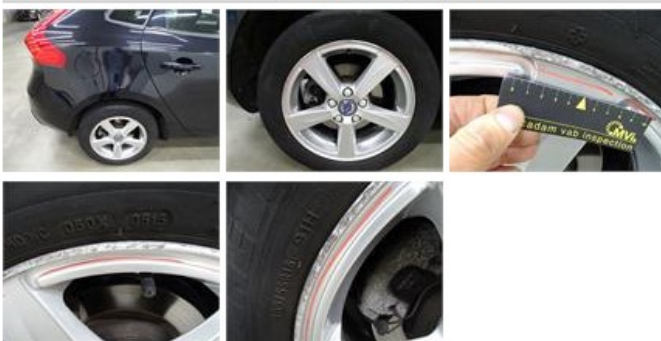
Alloy rim R R, Scratch(es), LI - Repair and paint (complete)

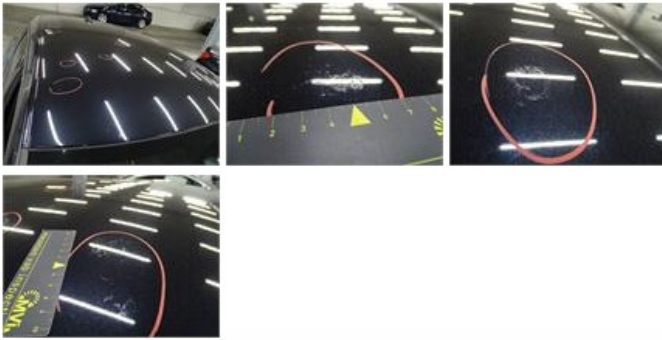
Roof, Chemical polution, LI - Repair and paint (complete)
