BMW 1 HATCH: 1SZE584

| Vinnumber: | WBA1V51060V998771 | Versionname: | 114d (70 kW) |

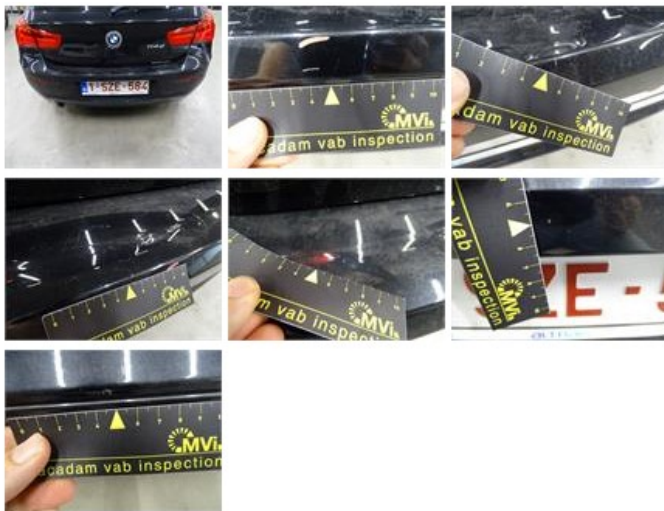
| Bumper R, Scratch(es), LI - Repair and paint (complete) | 211,80 |
