OPEL Combo Cargo: 1HPN949			
Vinnumber:	WOL6VYC1AF9553453	Versionname:	COMBO COMBI SWB St/St(EU5)90PK
First Registrationdate:	5/09/2014	Fiscalpower:	
Expertise Mileage:	121055	Power Kw:	66
Bodytype:		Body color:	White
Gearbox:	MAN 5 VIT	Paint type:	Opaque
Transmission:	Front	Rims summer:	Steel
Fueltype:	Diesel	Oil level:	OK
Battery functioning:	Yes	Parking lot:	2705
Number of doors:	5		
Number of seats:	5		
Number head rests:	5		
Rims summer:	Steel		
Category:	Light Commercial Vehicle		
Oil level:	OK		
Registration Certificate Car (BE):	Yes

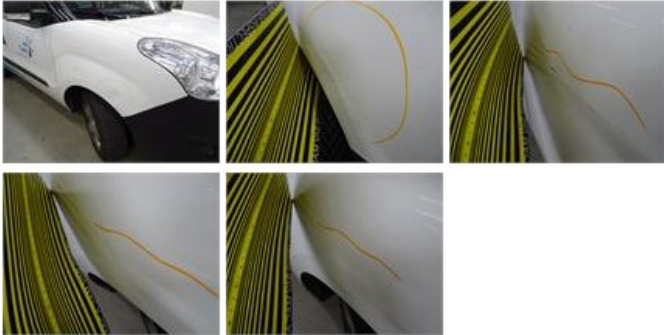
Wing F R, Dent(s) and scratch(es), LI - Repair and paint (complete) 165,13

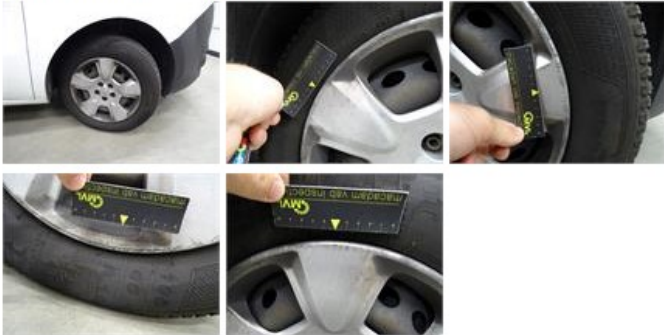
Wheel cover F R, Scratch(es), E - Replace 22,50

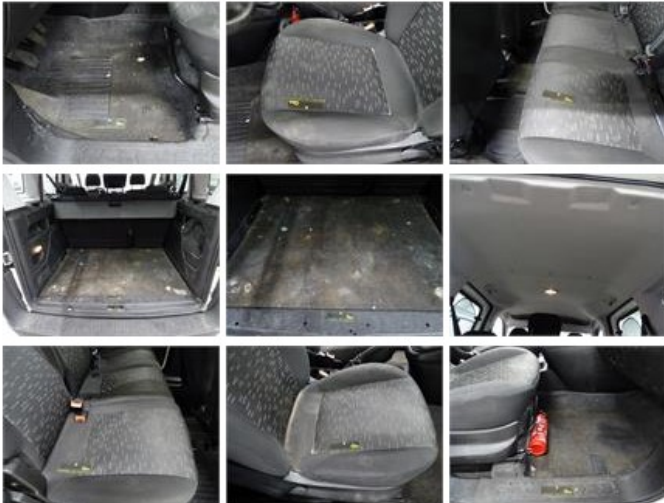
Interior, Dirty, Cleaning 100,00

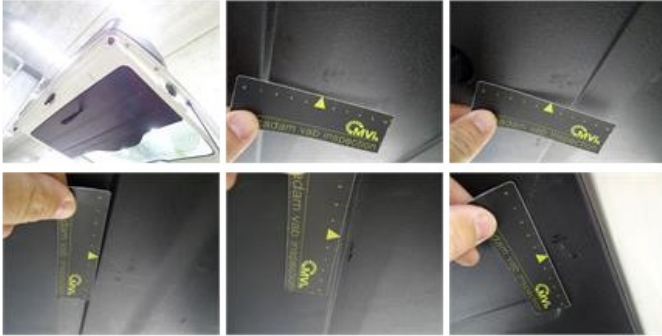
Trunk lid covering R, Scratch(es), Smart repair 110,64
